North Jersey Transportation Planning Authority

Concept Development Report

Hackettstown Bridge over Drain Weight Restriction Elimination Project

November 2020

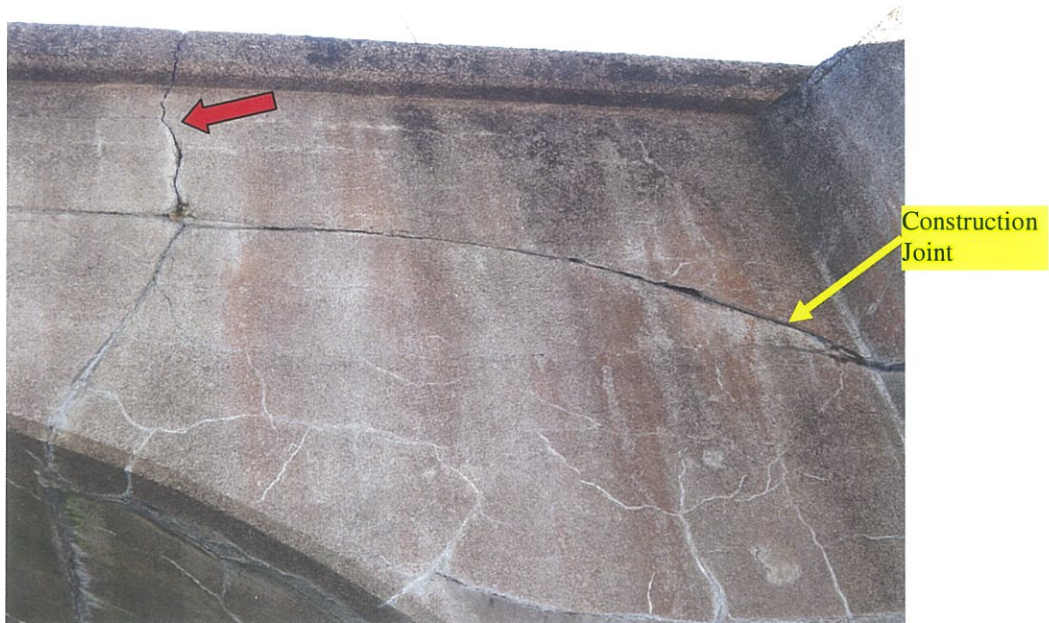
PHOTO 5-9: Spalled and or delaminated concrete throughout the top of south headwall, looking northeast. Note fine cracks with efflorescence at random locations of the headwall.

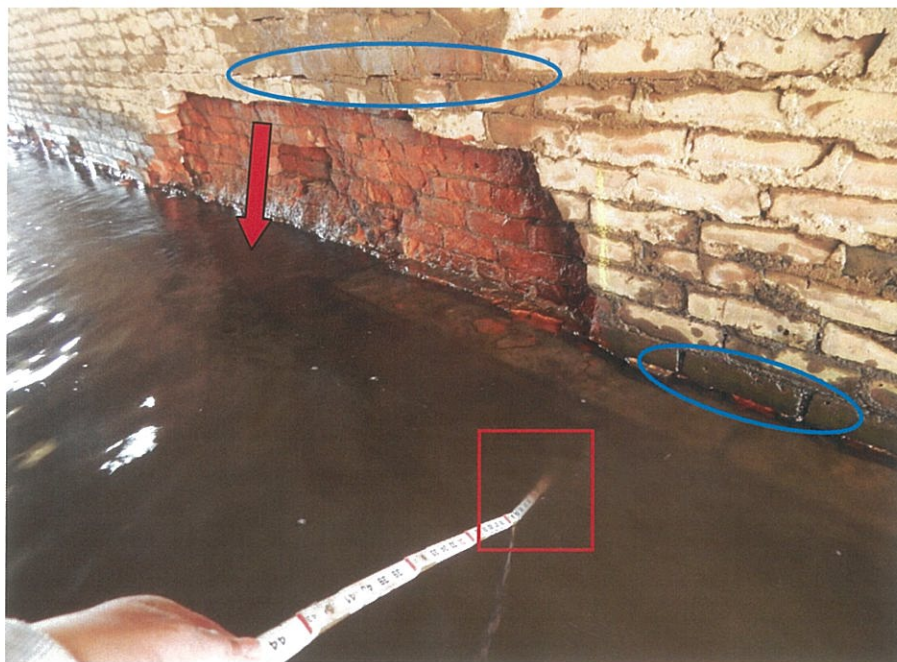
PHOTO 5-11: Moderate to severe scaling along the bottom of east abutment breastwall of concrete deck slab, looking northeast. Note exposed footing at south end (typical throughout the length of the breastwall).

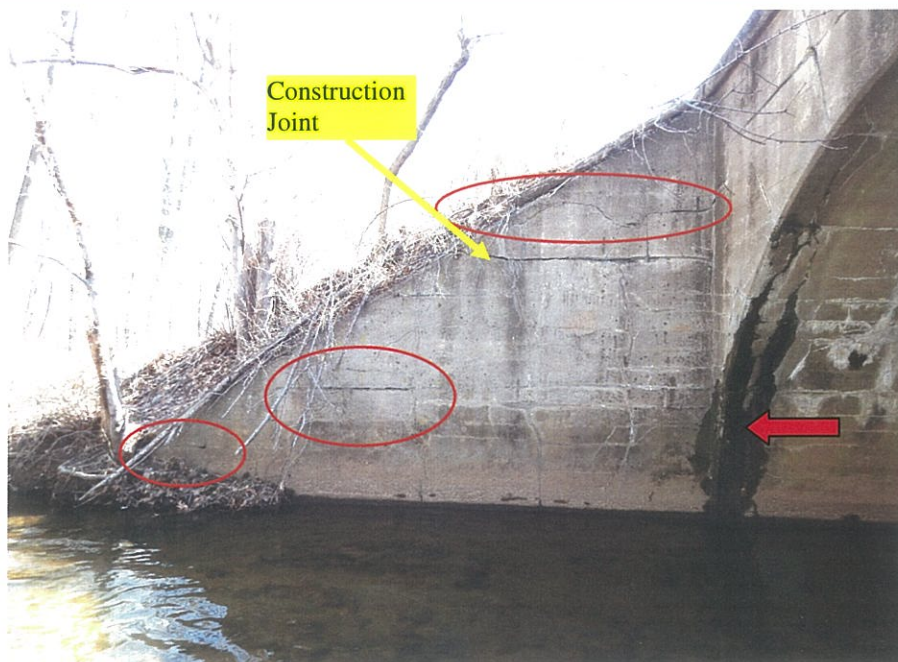
PHOTO 5-13: Large spall (circle) along the top face of the southeast wingwall, looking northeast. Note scattered fine cracks with efflorescence (arrow) at the vertical face of the wingwall.

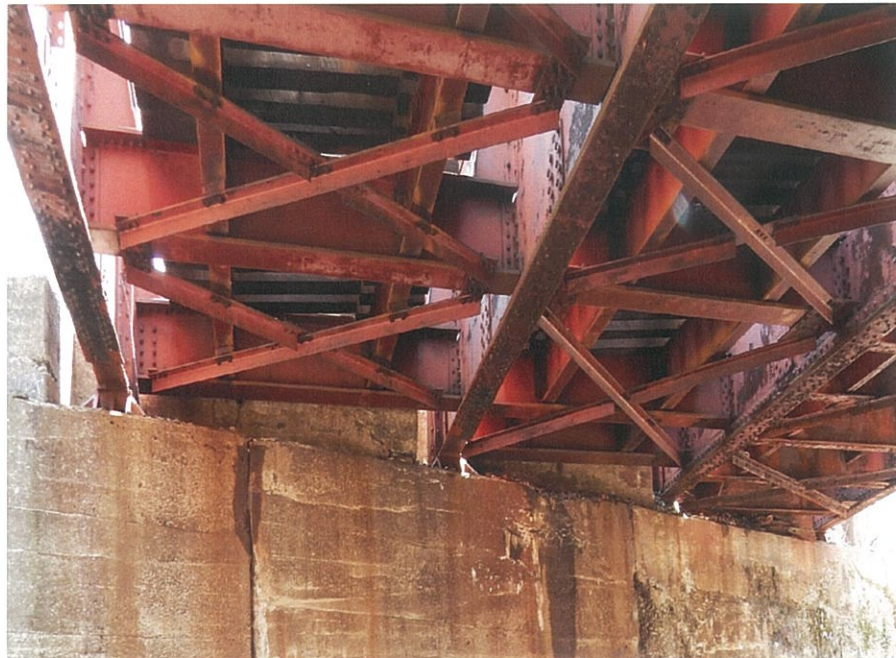
PHOTO 5-5: General view of bridge ties, Track #1, looking west.

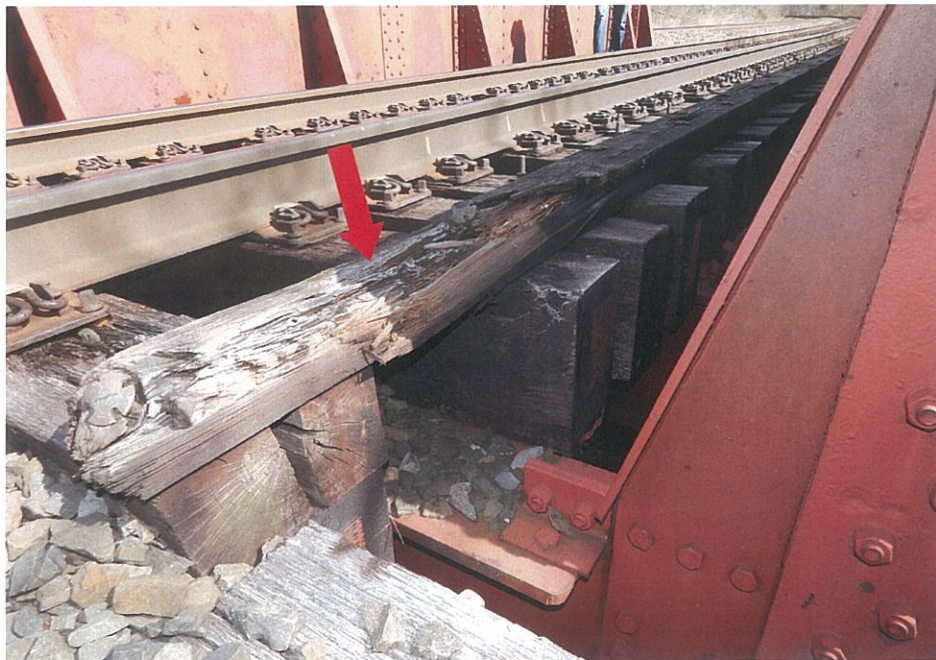
PHOTO 5-9: Decayed ties at the west approach on Track #1, looking northeast. Note low ballast adjacent to the bridge (Arrow) and graffiti at the web plate of Girder G4.

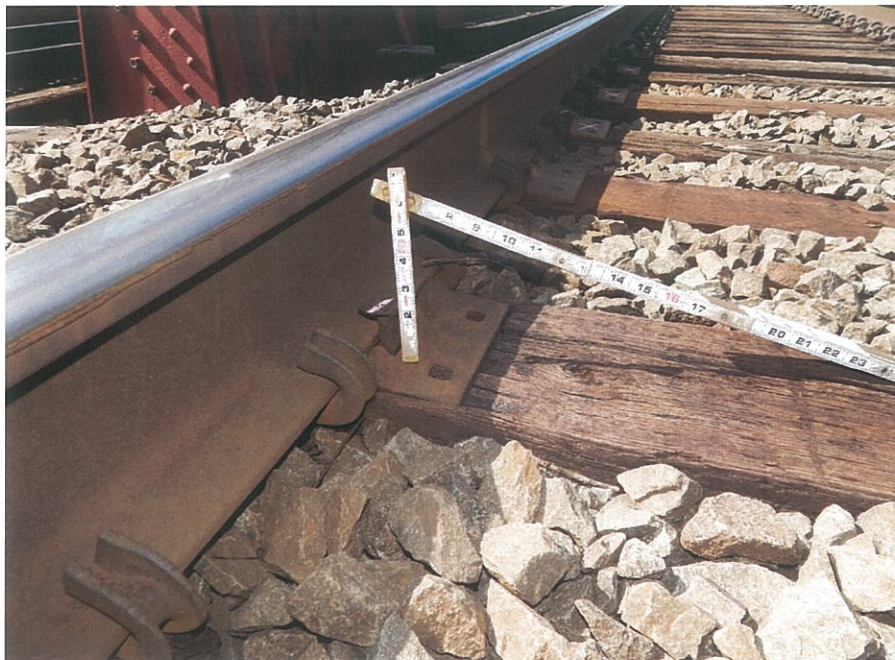
PHOTO 5-11 Missing J-hook bolts at the south side of Track #2, looking east.

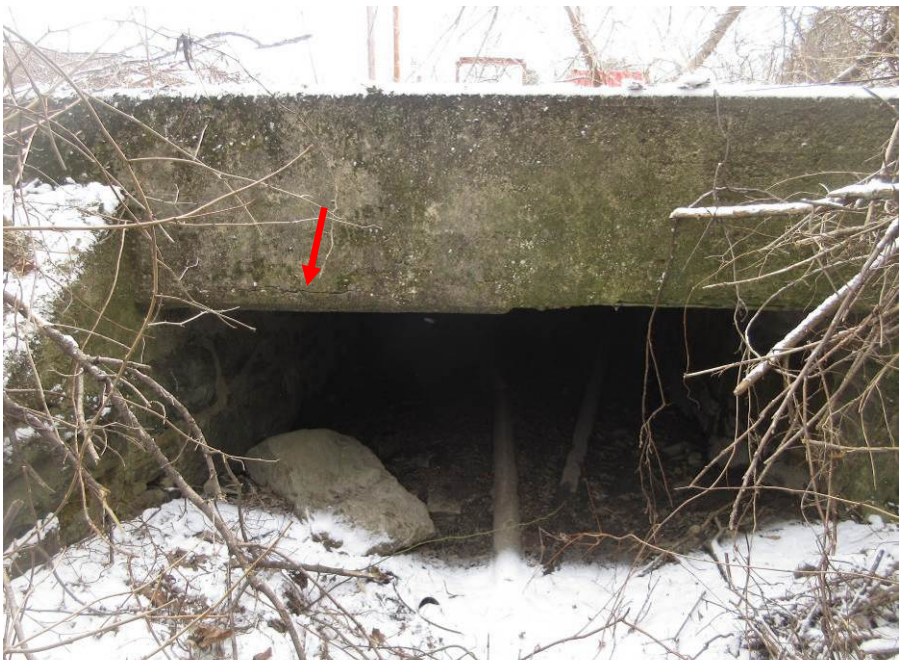
Photo No: 5-01
Location:	South elevation, looking north.	
Description:	General view (backfilled inlet opening).

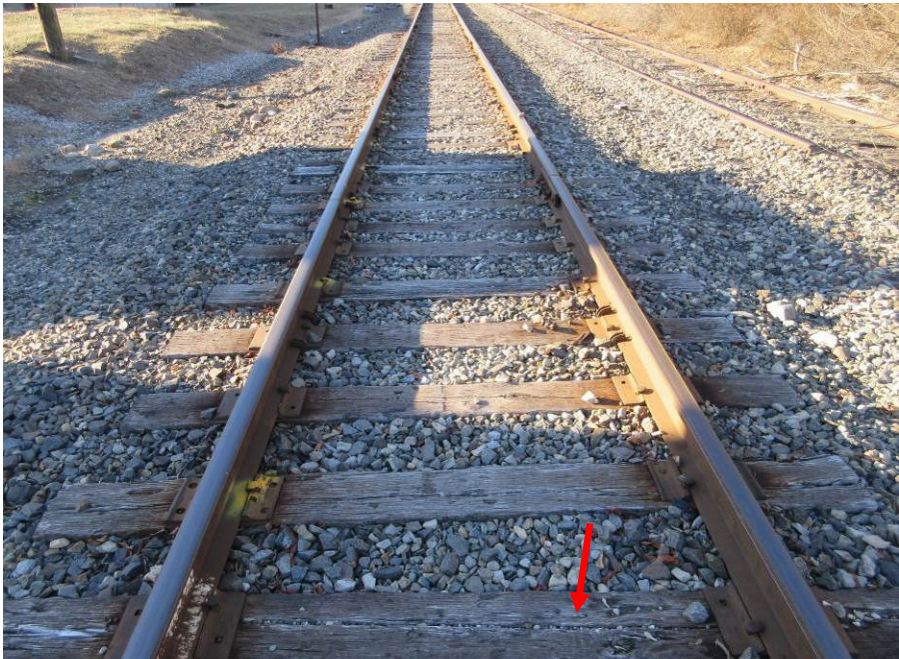
Location:	West approach, looking east.
Description:	General view. Note: Work Done: Several ties have been replaced since previous cycle.

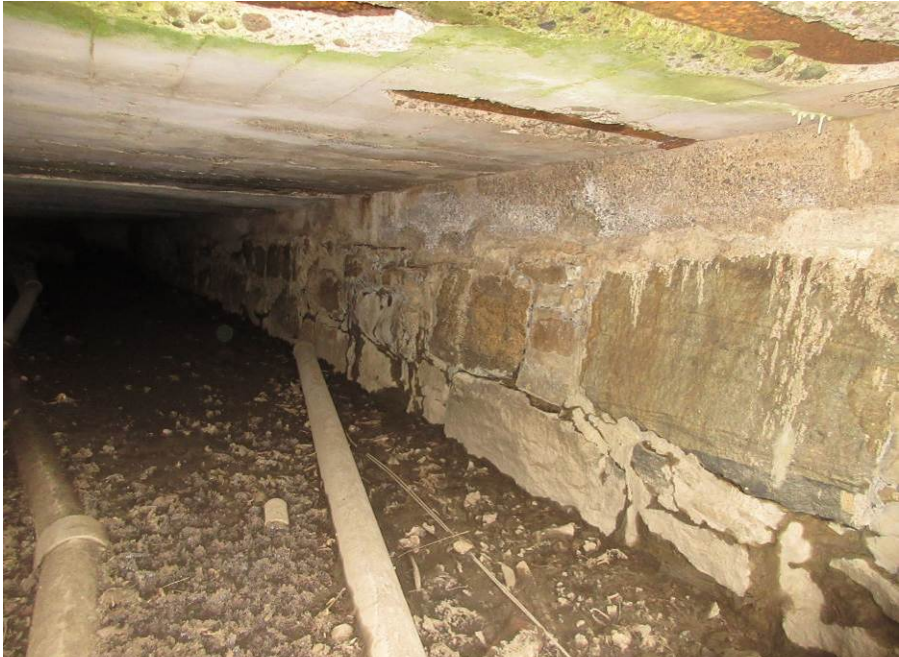
Photo No: 5-06
Location:	Underside of superstructure, looking south.	
Description:	General view. Note: Spalled concrete and exposed steel rails on underside of concrete deck slab.

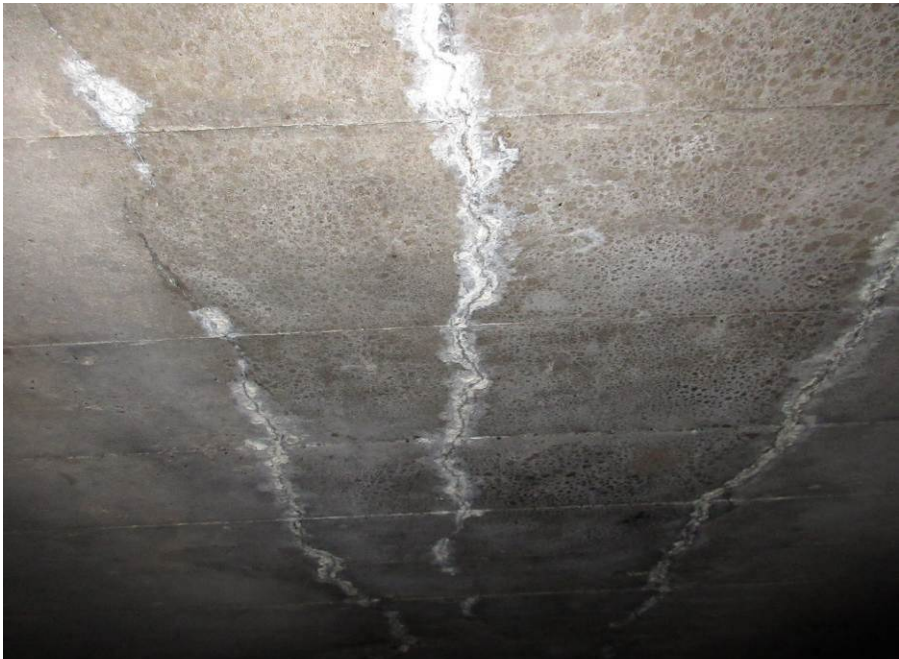
<p>Photo No: 5-11</p>
Location:	Underside of concrete deck slab, looking west.	
Description:	Several full width, fine transverse cracks with efflorescence near midspan.

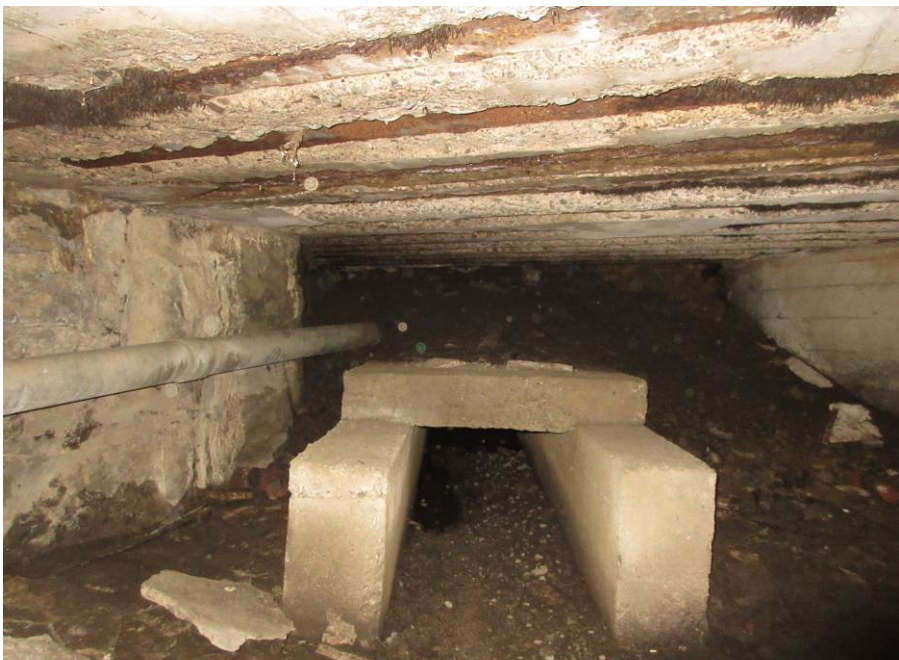
<p>Photo No: 5-12</p>
Location:	Drain at south end of structure, looking south.	
Description:	Exposed bottom flanges of nine steel rails at south end due to concrete spalls on underside of deck slab (typical at north end of structure).

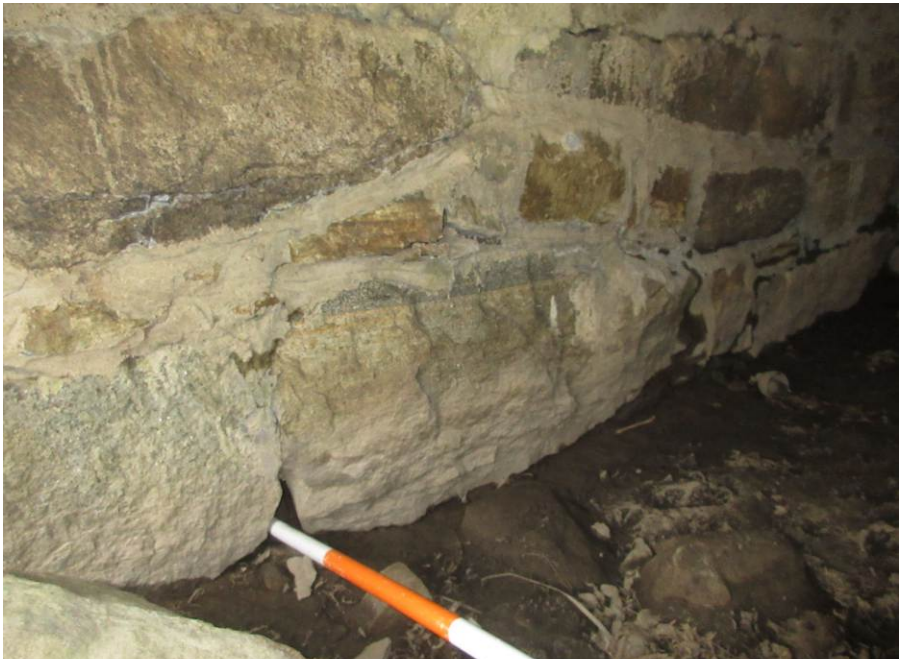
Photo No: 5-13
Location:	East abutment, north end, looking southeast.	
Description:	Small void near base of wall (typical at west abutment).

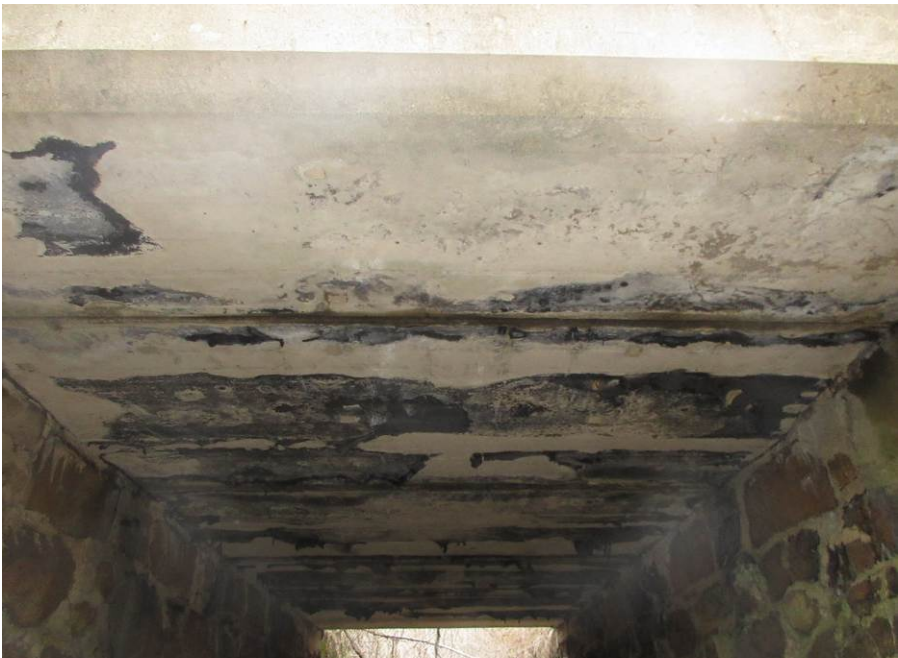
<p>Photo No: 5-06</p>
<p>Location:</p>	<p>Underside of superstructure, looking north.</p>	
<p>Description:</p>	<p>General view. Note: Deteriorated and peeling waterproofing membrane on roof slab.</p>

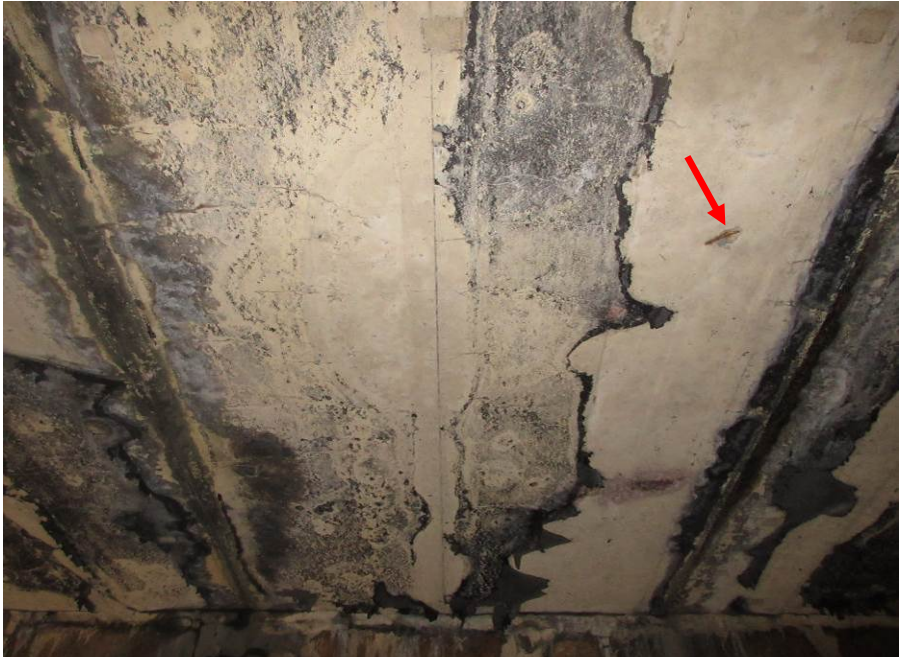
<p>Photo No: 5-11</p>
<p>Location:</p>	<p>Underside of superstructure near midspan, looking west.</p>	
<p>Description:</p>	<p>Peeling asphaltic waterproofing membrane and water staining throughout slab. Hairline transverse cracks with minor efflorescence. Small popout with exposed rebar.</p>

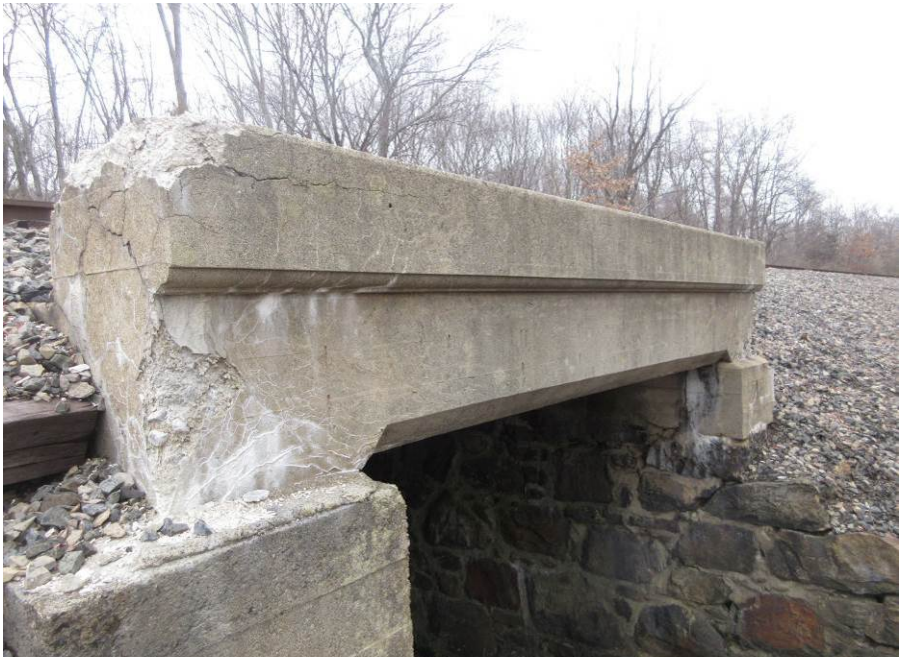
<p>Photo No: 5-12</p>
<p>Location:</p>	<p>South slab fascia, looking northeast.</p>	
<p>Description:</p>	<p>Spalls and light map cracking at both ends of slab/parapet. Delaminated area at west end of slab/parapet and fine to medium cracks throughout. Note moderate erosion of ballast at the steep south embankments near the bridge.</p>

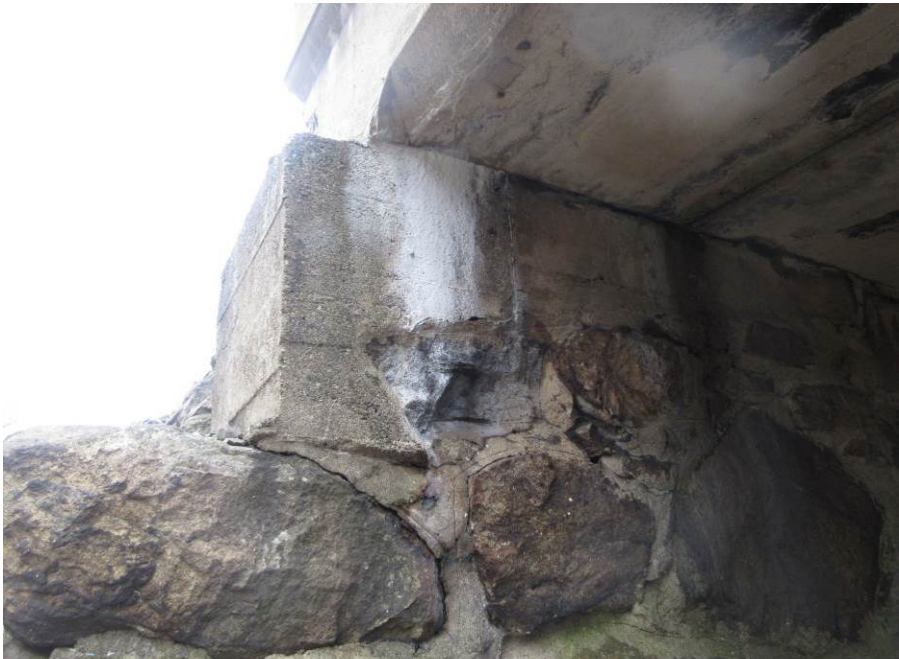
<p>Photo No: 5-15</p>
<p>Location:</p>	<p>West abutment, south end, looking northwest.</p>	
<p>Description:</p>	<p>Spall with efflorescence in concrete portion near south fascia.</p>

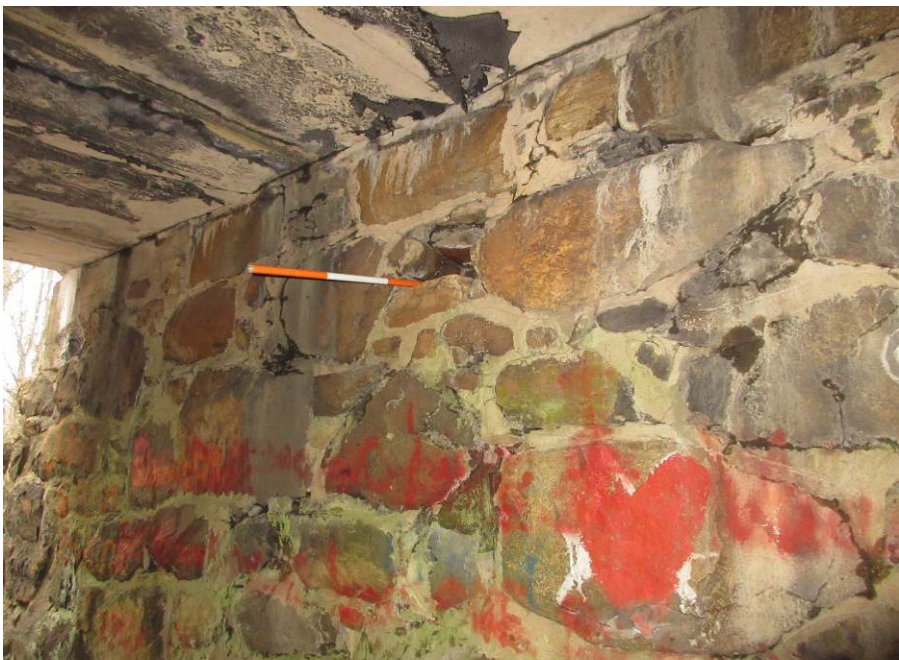
<p>Photo No: 5-16</p>
<p>Location:</p>	<p>West abutment, below slab panels 3 & 4, looking southwest.</p>	
<p>Description:</p>	<p>Area of large voids/missing and deteriorated mortar/missing stones. Note graffiti on breastwall (typical at east abutment and southeast wingwall).</p>

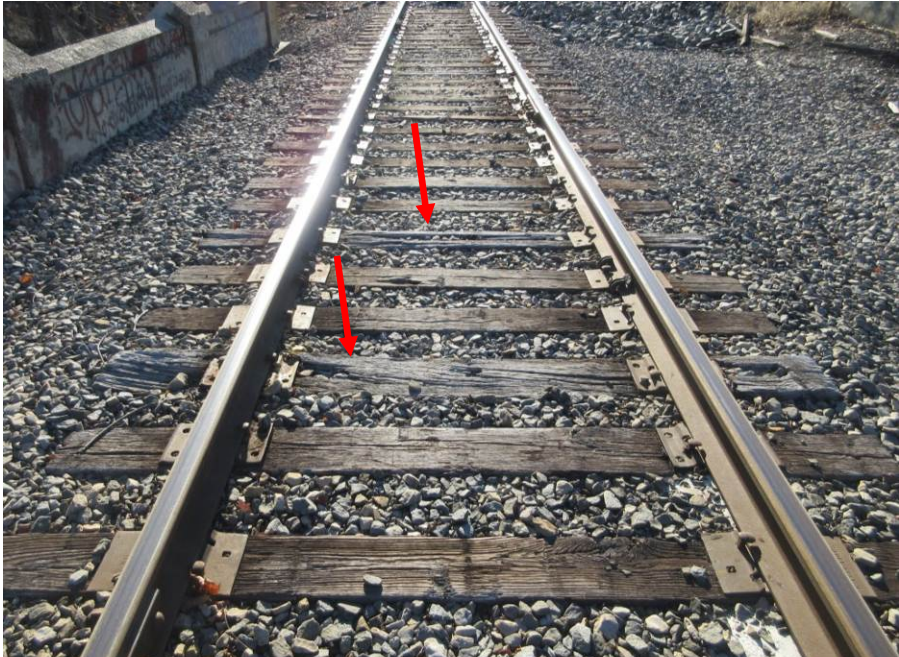
Photo No: 5-05
Location:	Deck ties on bridge, looking west.	
Description:	General view. Note: Several ties exhibit wide splits and checks and rot and require replacement (typical on east approach).

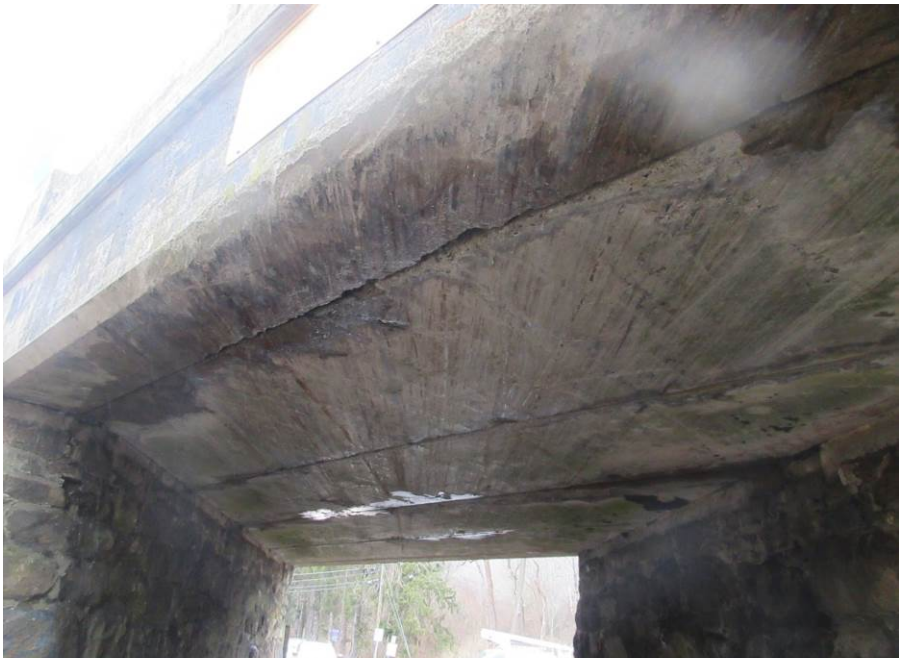
Photo No: 5-06
Location:	Underside of superstructure, looking north.	
Description:	General view. Note: Minor edge spalling and water leakage/staining between slab panels (typical). Impact damage (scrape marks and minor chipping) throughout.

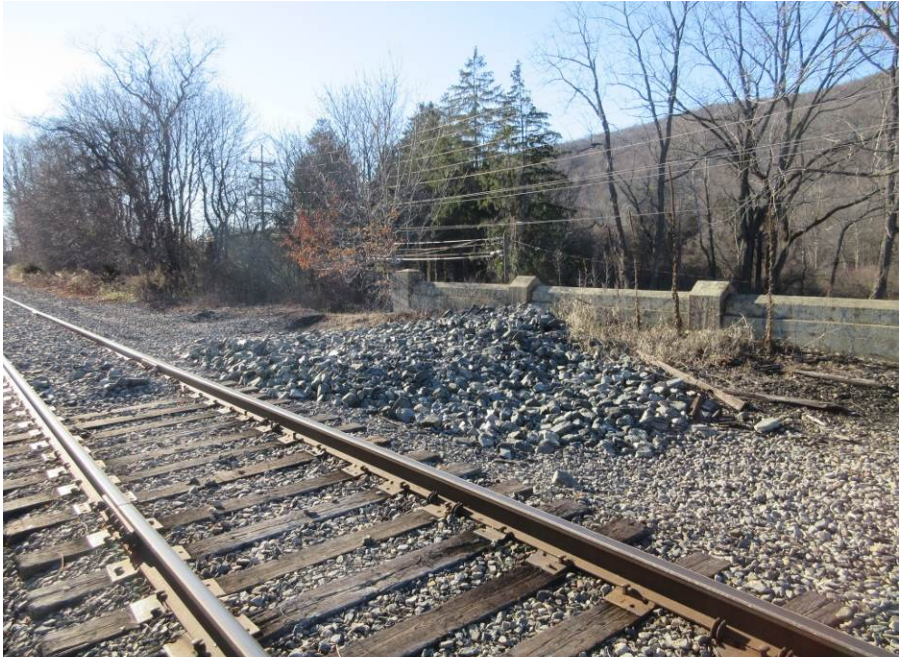
<p>Photo No: 5-11</p>
Location:	West end of structure, looking northwest.	
Description:	Large stones are covering the north shoulder of the bridge. Light graffiti on parapet face (100% covered).

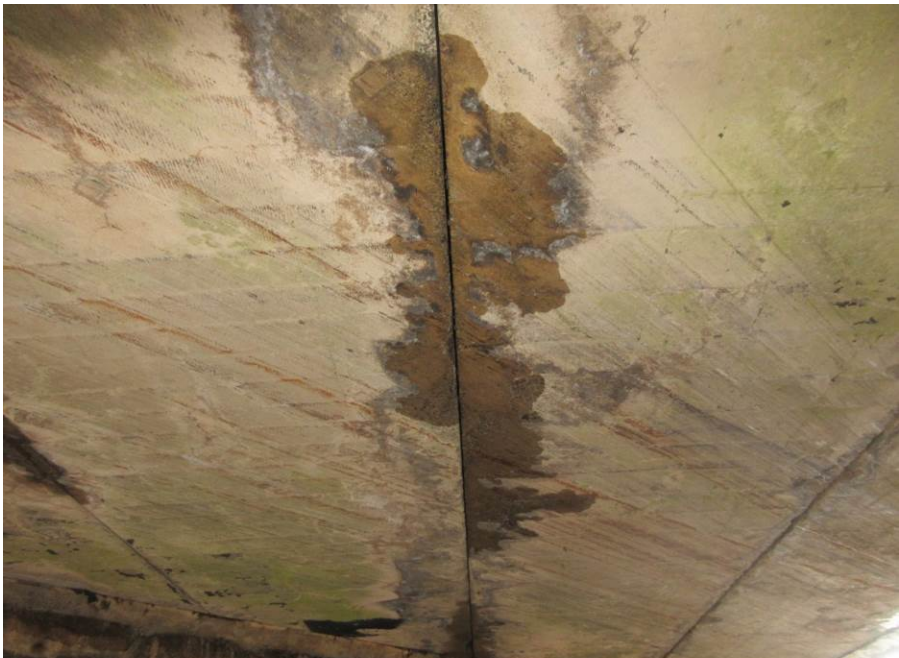
<p>Photo No: 5-12</p>
Location:	Underside of superstructure at panel joints, looking east.	
Description:	Water leakage and staining with light efflorescence and minor edge chipping at panel joint. Scrape marks on underside of deck slab (typical throughout).
