Morris County Department of Engineering

East Hanover Avenue  
Corridor Study

Multimodal Survey

Scale: 1" = 800' EXHIBIT 4

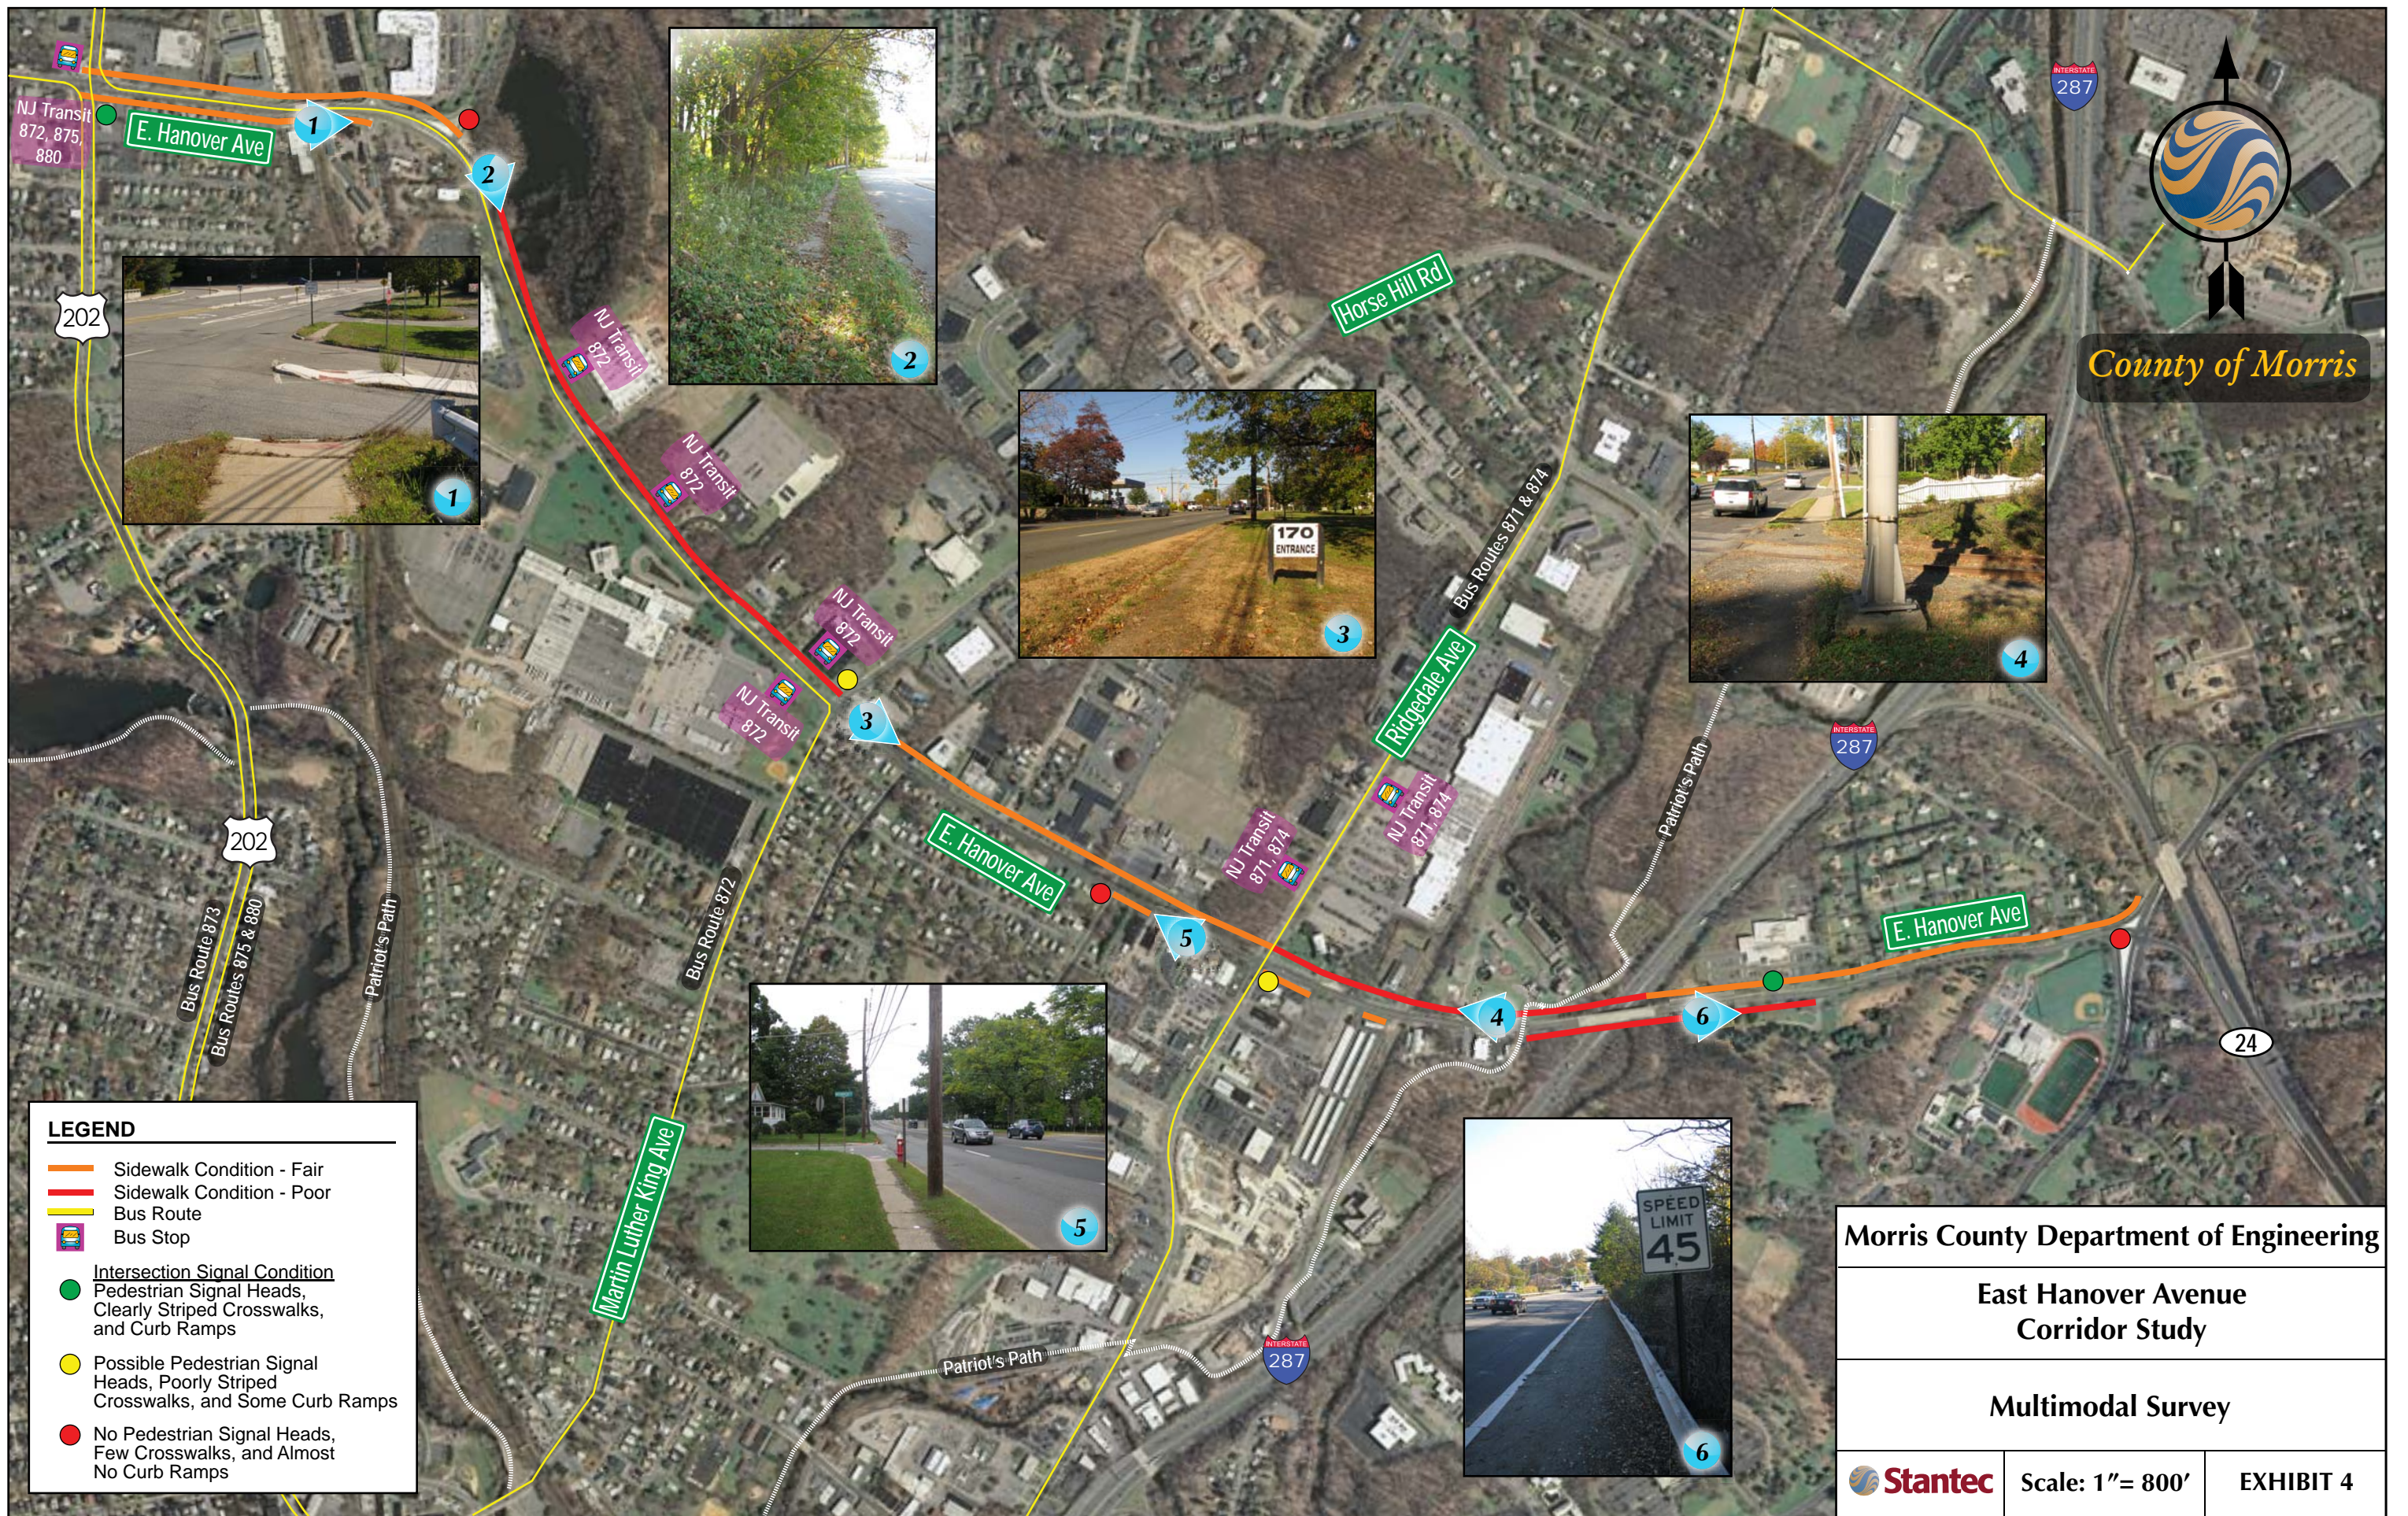
- Sidewalk Condition - Fair
- Sidewalk Condition - Poor
- Bus Route
- Bus Stop
- Intersection Signal Condition  
Pedestrian Signal Heads,  
Clearly Striped Crosswalks,  
and Curb Ramps
- Possible Pedestrian Signal  
Heads, Poorly Striped  
Crosswalks, and Some Curb Ramps
- No Pedestrian Signal Heads,  
Few Crosswalks, and Almost  
No Curb Ramps
