North Jersey Transportation Planning Authority

Concept Development Report

Hackettstown Bridge over Drain Weight Restriction Elimination Project

November 2020

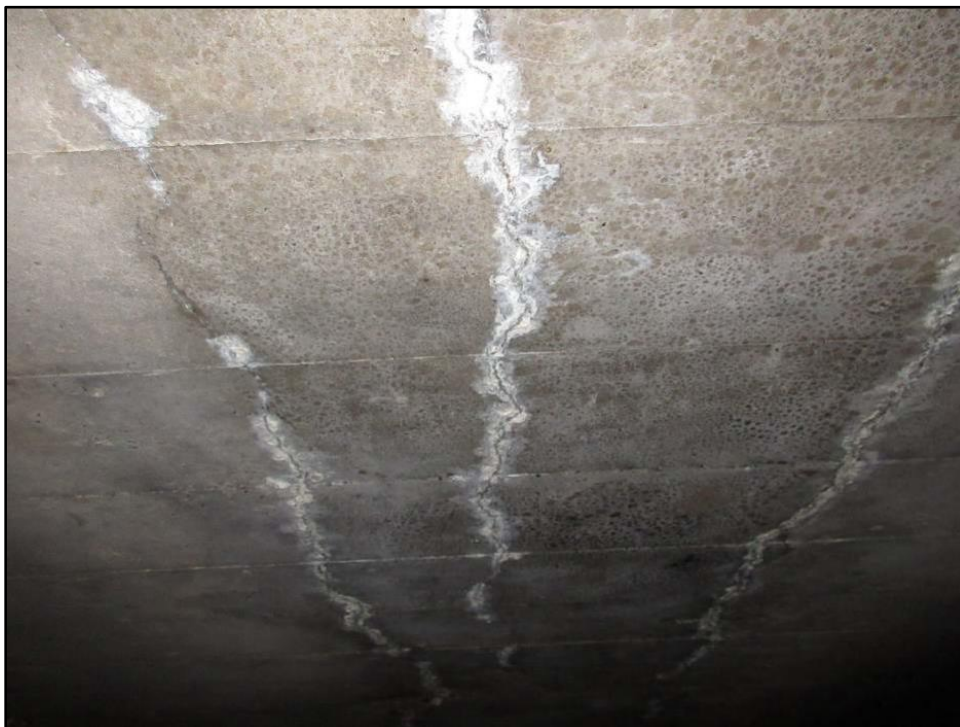
Figure 4.7: Underside of Concrete Slab – Looking Southeast

- The superstructure is in fair condition. The concrete slab exhibits several fine transverse cracks with efflorescence throughout the length of the slab. There are several spalls and delaminations on the underside of the slab, partially exposing the moderately corroded bottom flange of six encased steel rails near the north end and nine steel rail bottom flanges near the south end.

- There is active leakage for half of the slab area. There are fine to medium cracks, light moss growth, and edge spalling on the north headwall extending approximately 1 foot into the slab.
- The substructure is in good condition. The stone masonry abutments exhibit several areas of missing and deteriorated mortar with a small void at the north end of the east abutment and the south end of the west abutment near the base of the walls. There is a displaced stone 15 feet from the south end of the east abutment.
- The top concrete portion of the east abutment breast wall exhibits several fine vertical cracks throughout with minor scaling at isolated locations. The north wingwalls exhibit areas of missing mortar/small voids with heavy debris, moderate vegetation, and moss growth.

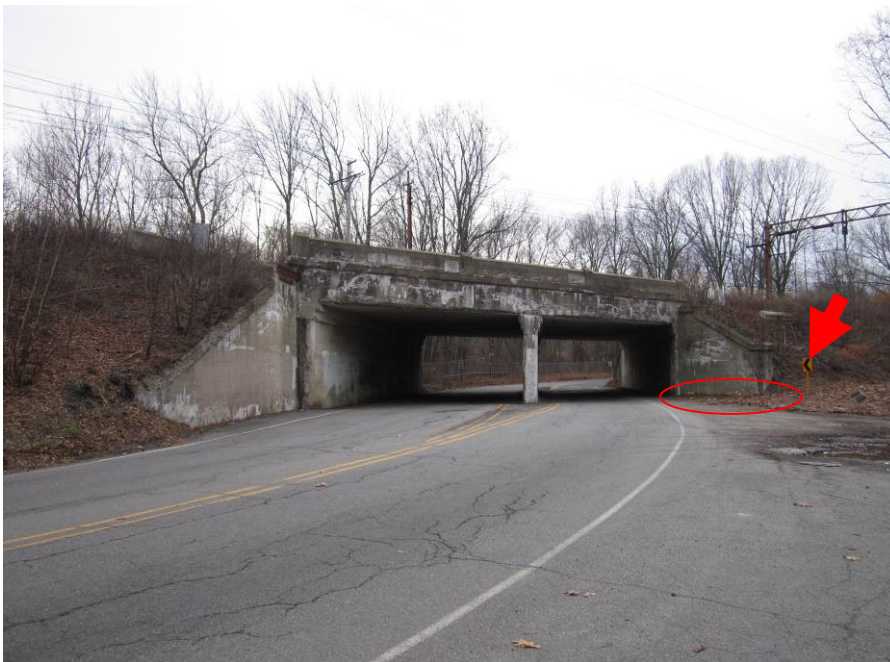
Photo No. 6-1

WORK DONE: New chevron signs were installed in front of the northwest wingwall. Previous guiderail was removed. ([Photo 6-1](#)).

Location: North elevation, looking southwest.

Description: General view. Note lack of substructure protection and vegetation growth behind both wingwalls. Also note the new chevron signs and removal of guide rail in front of the northwest wingwall.

4. Replace missing and broken clips on both tracks at span one ([Photo 6-9](#)).
5. Remove vegetation and tree growth behind the northeast, northwest and southwest wingwalls ([Photos 6-1 and 6-2](#)).

6. Install guide rails along northwest and southeast wingwalls; install an impact attenuator at the north and south end of the pier column ([Photos 6-1, 6-2 and 6-7](#)).

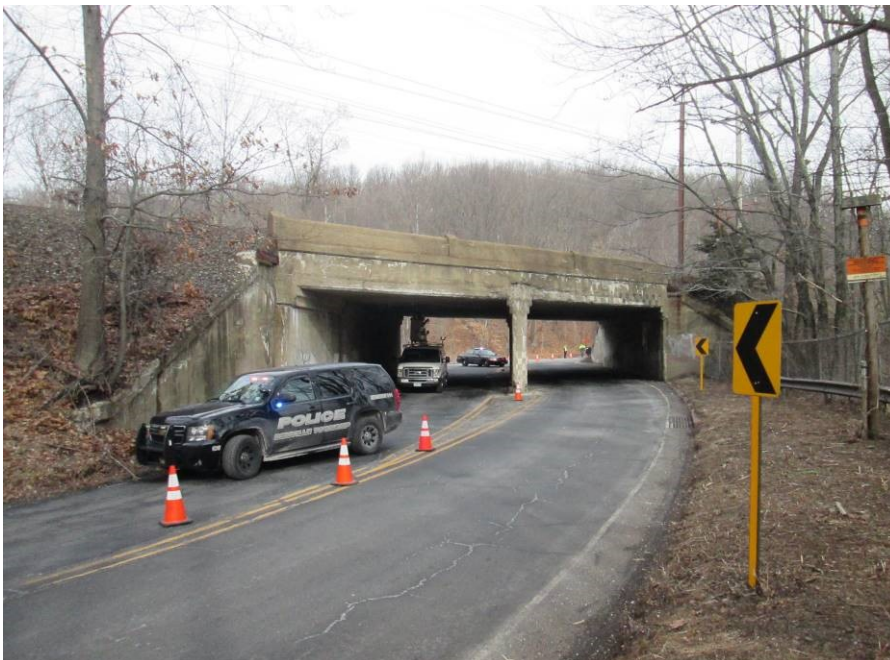
Photo No. 6-2

Location: South elevation, looking northeast.

Description: General view. Note lack of substructure protection and vegetation growth behind the wingwall.

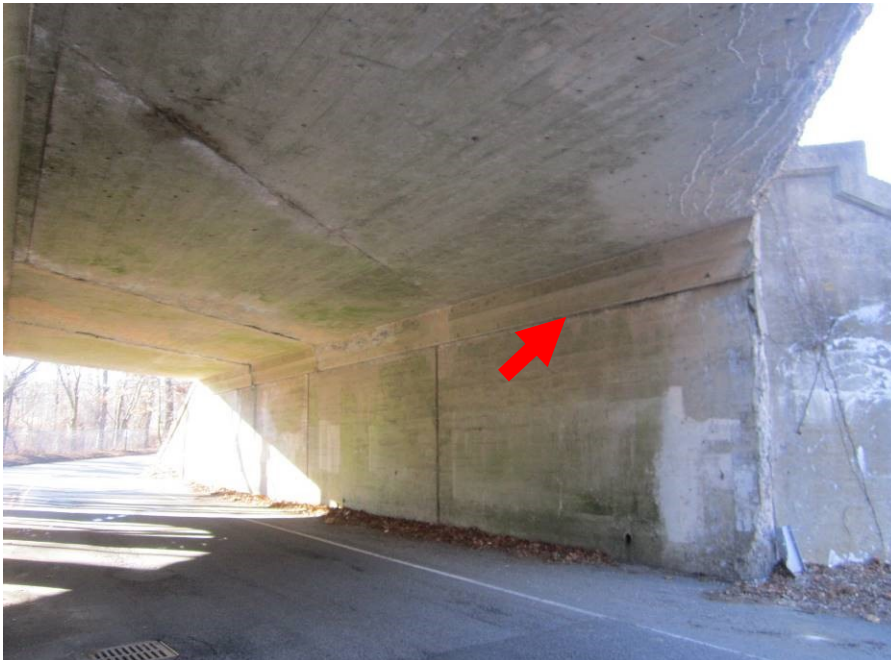
Photo No. 6-7

Location: West abutment, looking southwest.

Description: General view. Lack of guiderail along northwest wingwall. Moderate crack along the entire length of the abutment breastwall.

2. Seal the medium cracks in the fascias, abutment breastwalls, pier and wingwalls with pressure injected epoxy sealer ([Photo 6-7](#)).
3. Install a waterproof membrane to prevent water leakage through the concrete slab and provide adequate drains in the slab ([Photos 6-8 and 6-13](#)).

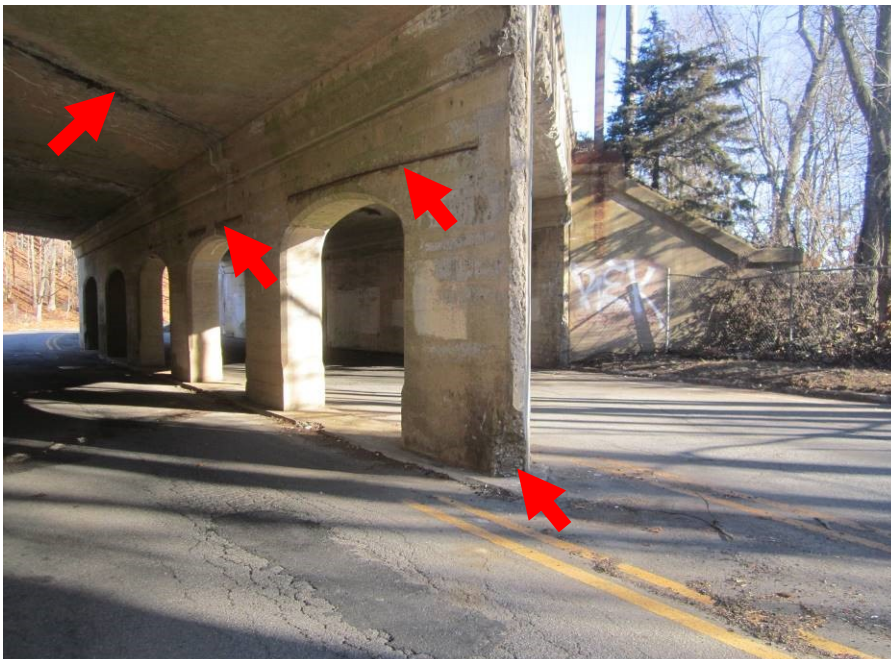
Photo No. 6-8

Location: Span 2, west face of pier, looking east.

Description: General view. Note spall at bottom of pier at south end. Spall with exposed reinforcement on top of pier. Active water leak mark at first joint.

1. Remove all the deteriorated concrete from the underside of the concrete slab, parapets, fascias, abutments, pier column and wingwalls, clean any exposed rebar and patch the areas with epoxy concrete. ([Photos 6-8, 6-11, 6-12, and 6-14 through 6-16](#)).

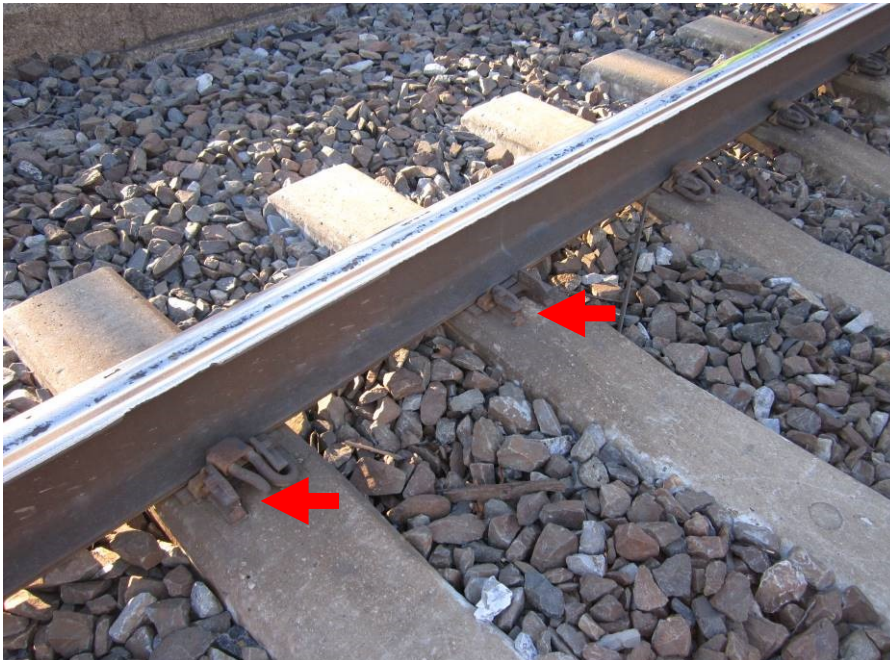
Photo No. 6-9

Location: South rail of Track 2 at Span 1, looking southwest.

Description: Missing and broken pandrol clip.

CONDITION OF SPIKES: Pandrol clips are in good condition with light surface rust. Track 1: South rail (span 1) 1 missing clip at north side. Track 2: South rail (span 1) 2 broken and 1 missing clip (north side). Track 2: South rail (span 1) area of low ballast.

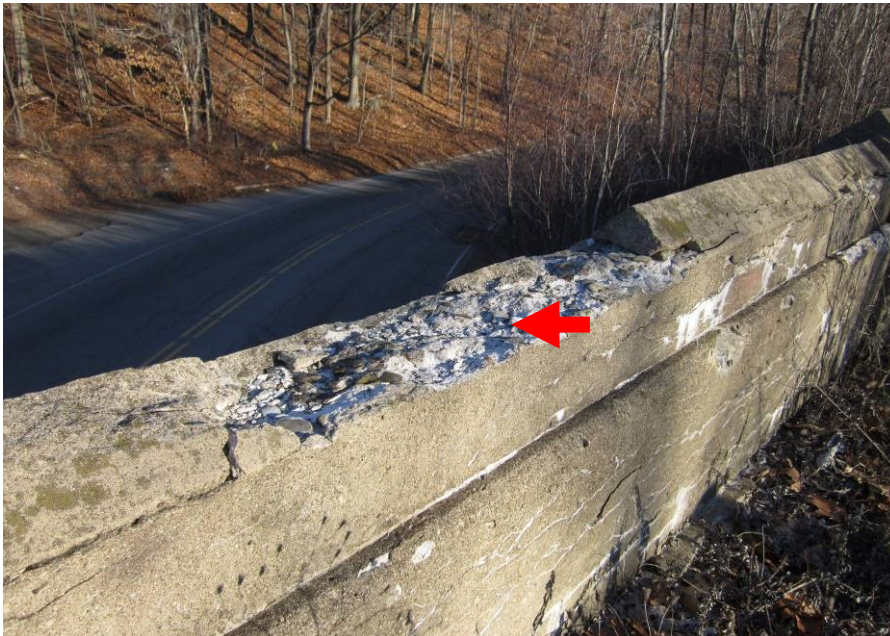
Photo No. 6-11

Location: North parapet in Span 1, looking northeast.

Description: Spall on top of parapet.

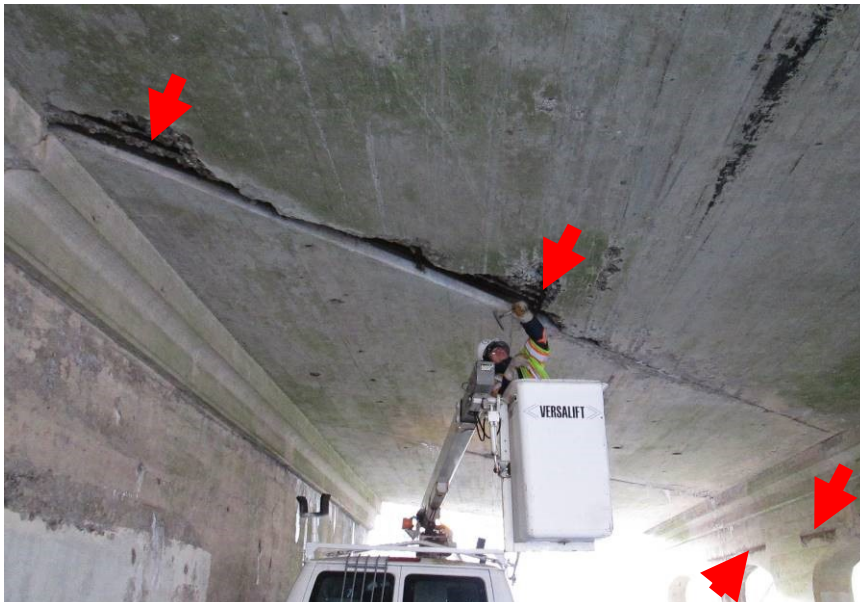
Photo No. 6-12

Location: Span 1 adjacent to east abutment, looking southwest.

Description: Large spall with exposed reinforcement at the underside of slab at joint. Spall with exposed reinforcement at east face of pier.

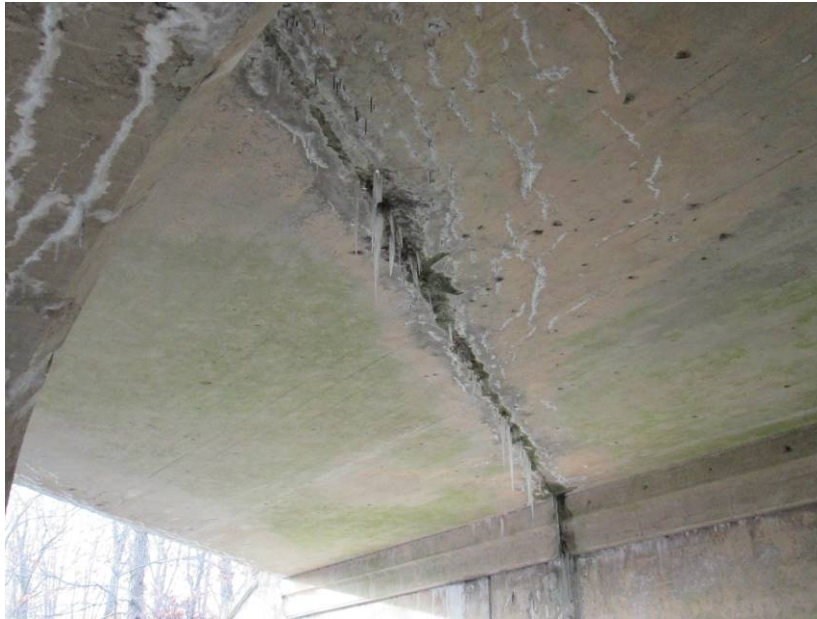
Photo No. 6-13

Location: Span 2 at first joint from south fascia, looking southwest.

Description: Active water leakage at joint.

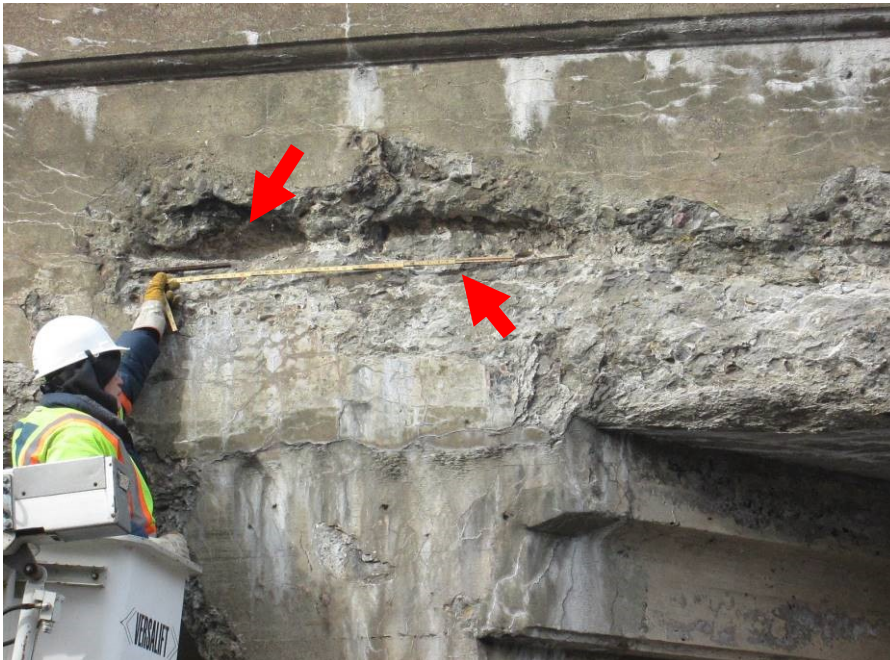
Photo No. 6-15

Location: Top of pier at south fascia, looking northwest.

Description: Large spall at top of pier at south fascia with exposed reinforcement.

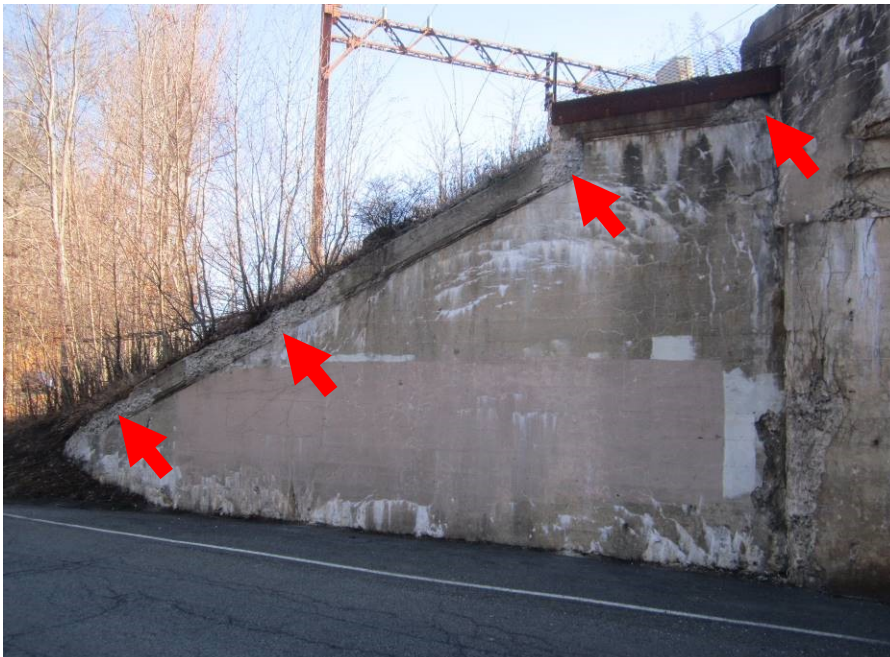
Photo No. 6-16

Location: Northeast wingwall, looking southeast.

Description: Areas of spalls with exposed reinforcement and map cracking with heavy efflorescence throughout the northeast wingwall.

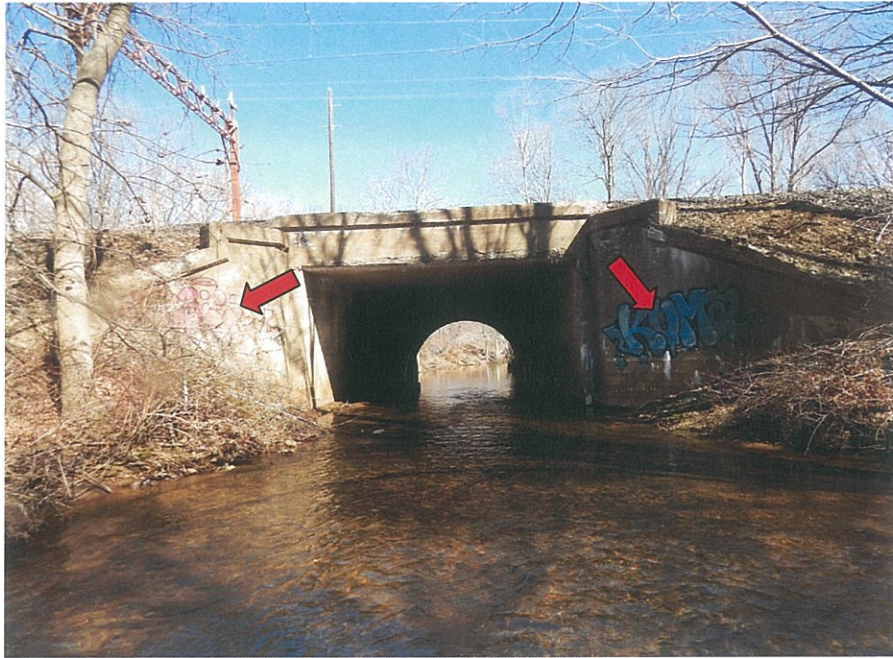
PHOTO 5-1: South elevation, looking north. Note tree growth in front of the southwest wingwall and graffiti (arrows) at the southeast and southwest wingwalls.

7. Remove the vegetation and or tree growth behind the northeast and northwest wingwalls (Photos 5-1, 5-2 and 5-14).
8. Remove graffiti and apply anti-graffiti coating at the northeast corner of the concrete arch intrados, west abutment breastwall, southeast and southwest wingwalls (Photo 5-1 and 5-6).

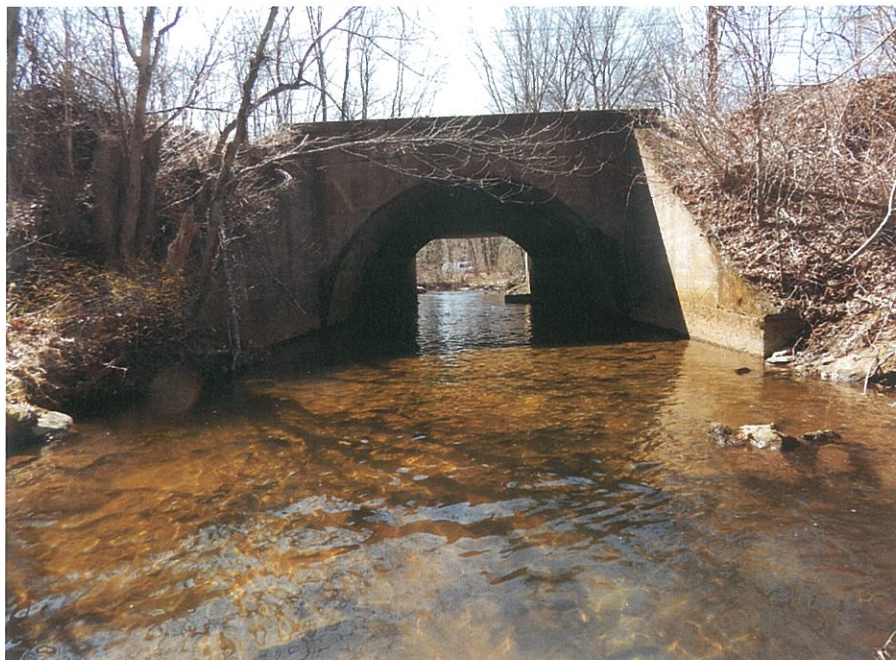
PHOTO 5-2: North elevation, looking south. Note tree and vegetation growth behind the northeast and northwest wingwalls.

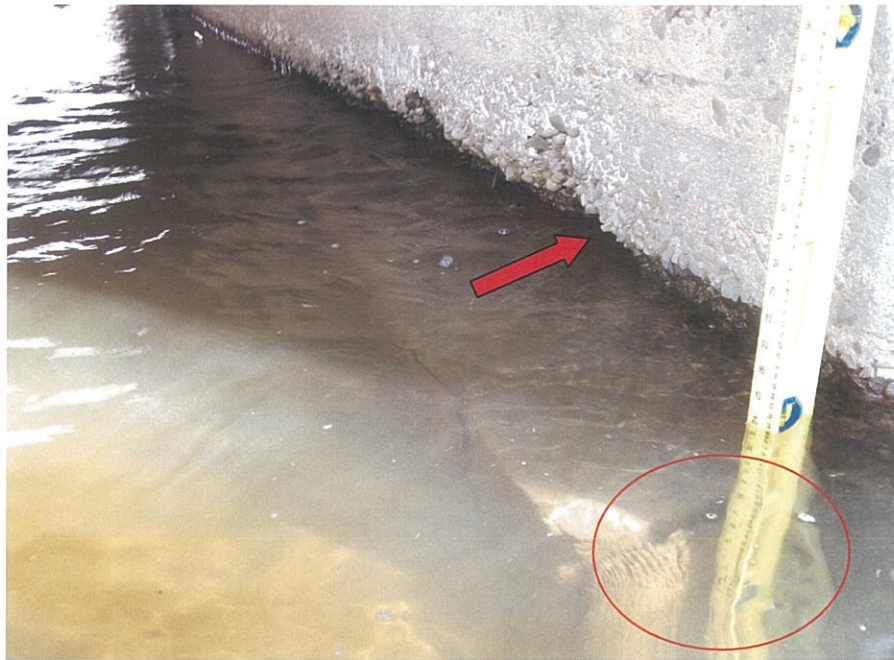
PHOTO 5-11: Moderate to severe scaling along the bottom of east abutment breastwall of concrete deck slab, looking northeast. Note exposed footing at south end (typical throughout the length of the breastwall).

6. Replace the missing section of stone course along the west side of the brick arch. Place rip-rap along the abutments, arch skewbacks, northeast and northwest wingwalls to prevent further scour (Photos 5-11 and 5-12).

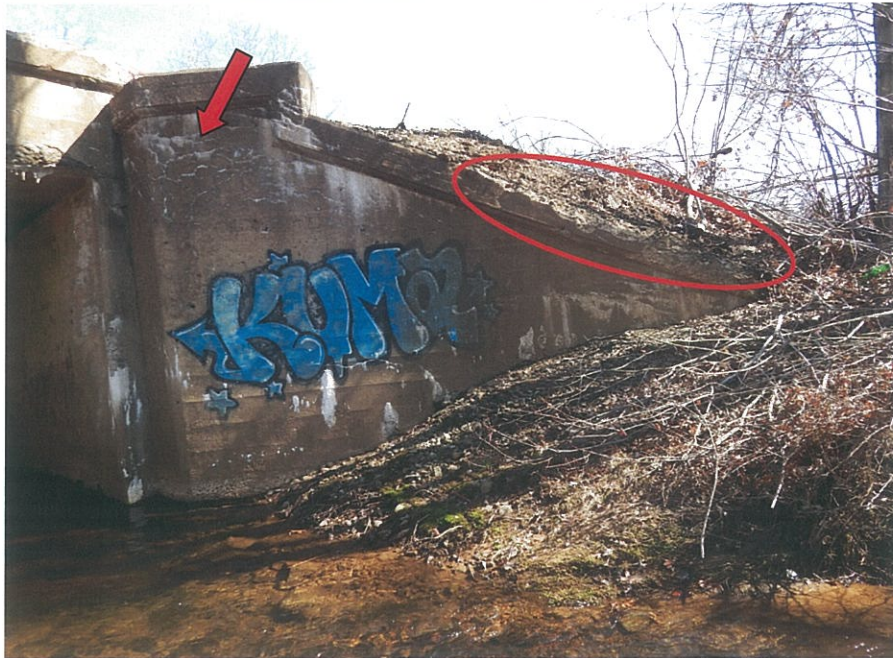
PHOTO 5-13: Large spall (circle) along the top face of the southeast wingwall, looking northeast. Note scattered fine cracks with efflorescence (arrow) at the vertical face of the wingwall.

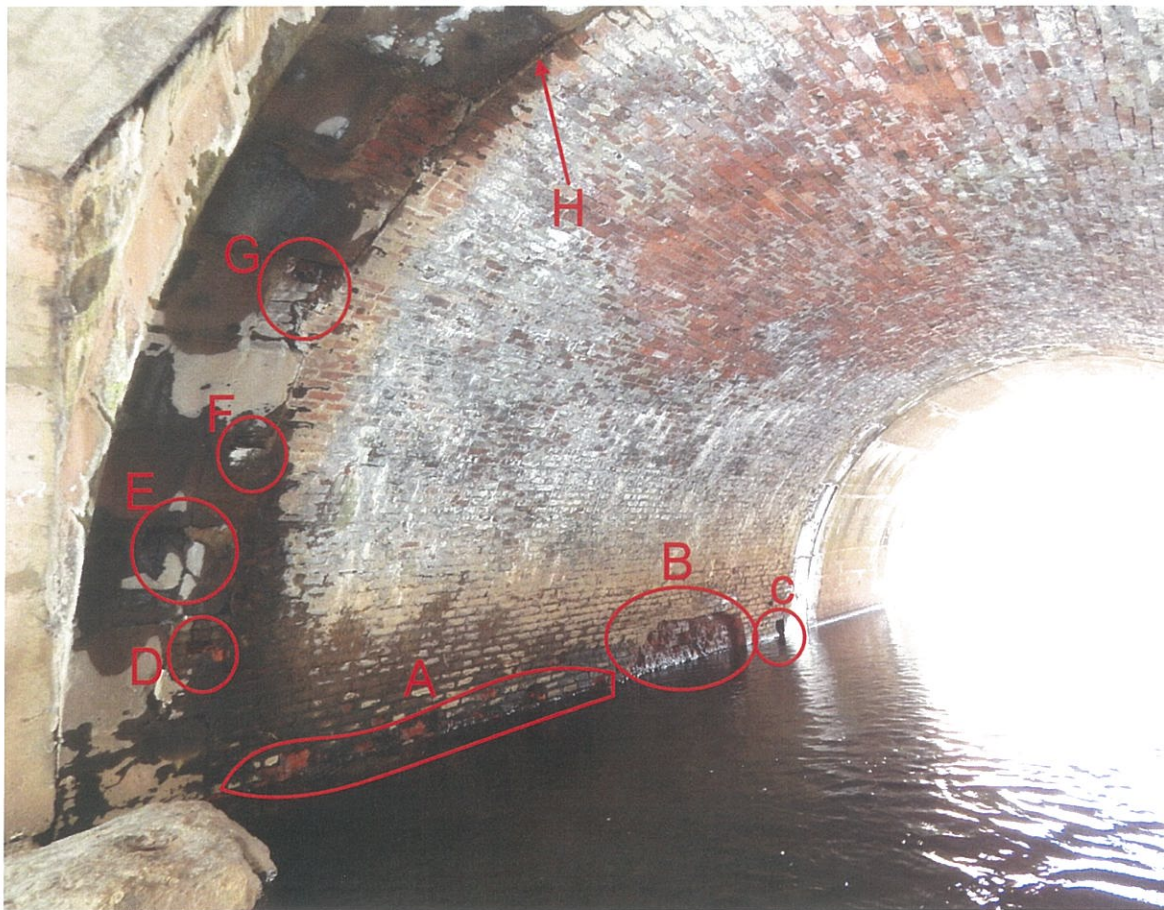
PHOTOS: 5-12

WEST SIDE OF BRICK ARCH

- (A) One layer of missing and or deteriorated bricks (9 SF +/-).
- (B) Up to two layers of missing bricks (12 SF +/-).
- (C) One layer of missing bricks (< 1 SF).
- (D) Loose and missing bricks (2 SF +/-).
- (E) Spalled/ cracked stone (2 SF +/-).
- (F) One brick is missing (< 0.5 SF).
- (G) Missing bricks (2 SF +/-).
- (H) Up to 1" gap between south stone arch ring and brick arch (typical throughout).

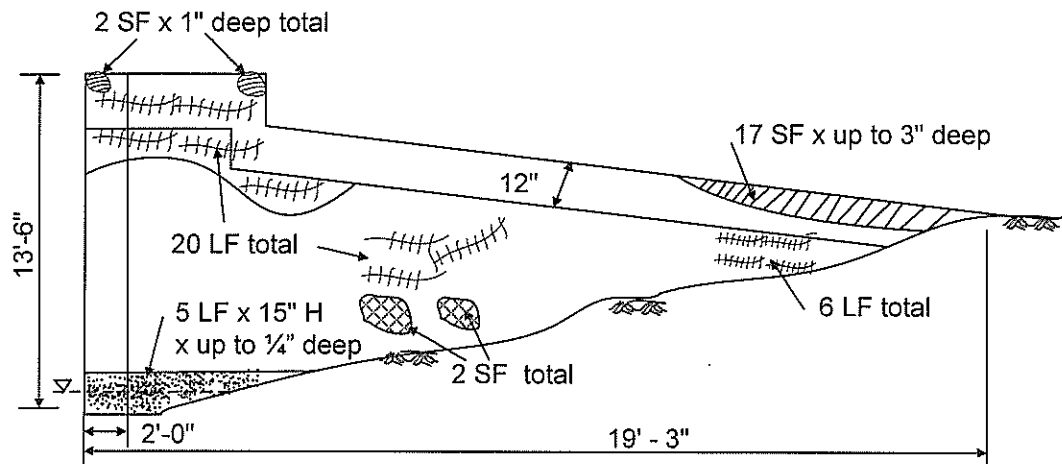
CONDITIONS: See sketch below.

Total spalled area to be repaired = 19 SF.

FOUNDATIONS: West end of footing is exposed (3'L x 13"H).

OTHER OBSERVATIONS: Minor ballast and dirt is spilling from top of the wingwall.

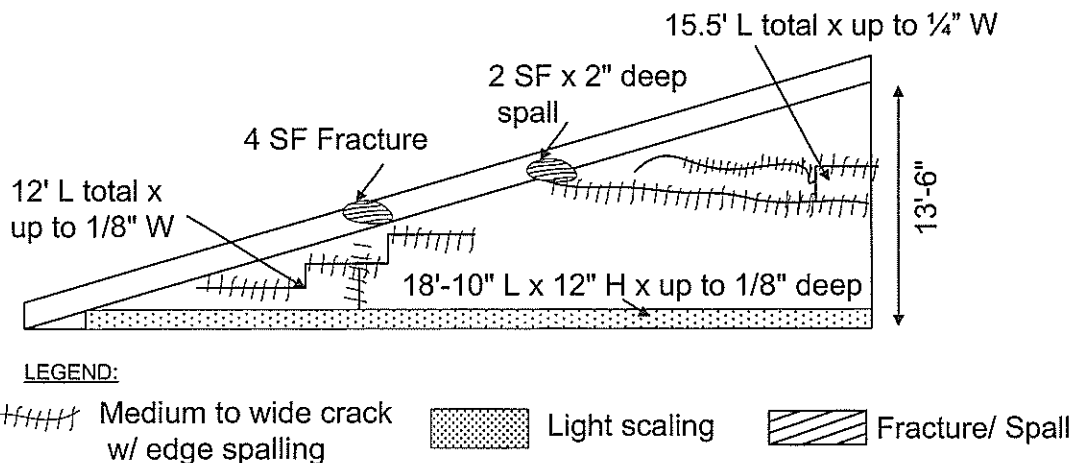
CONDITIONS: Several fine cracks with efflorescence at east end of the wingwall.

See sketch below for additional conditions.

Total spalled/ fractured area to be repaired = 6 SF.

Total cracks to be repaired = 15.5 LF + 12 LF = 27.5 LF (Say 28 LF).

FOUNDATIONS: Footing is exposed for full length and up to 10" H (No undermining was observed).

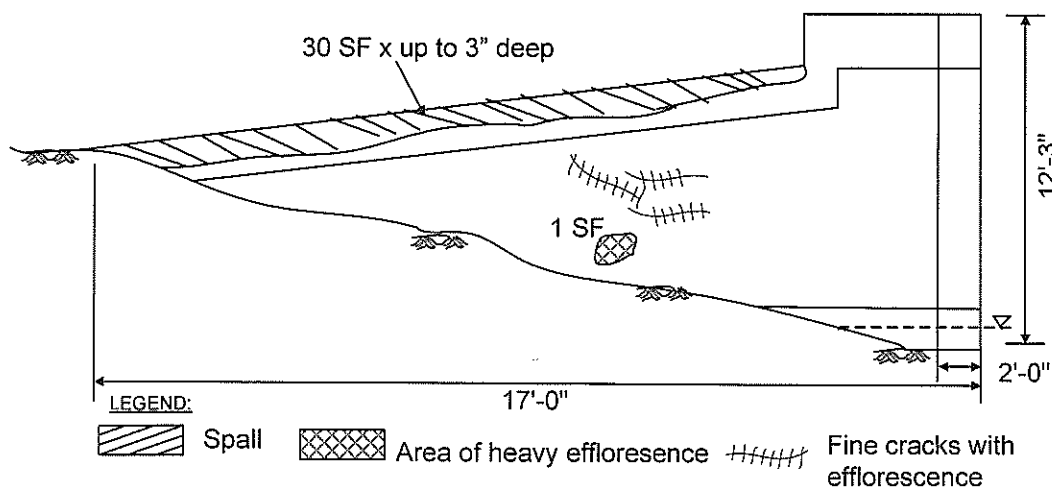
CONDITIONS: See sketch below.

Total spalled area to be repaired = 30 SF.

OTHER OBSERVATIONS: Minor ballast and dirt is spilling from top of the wingwall.

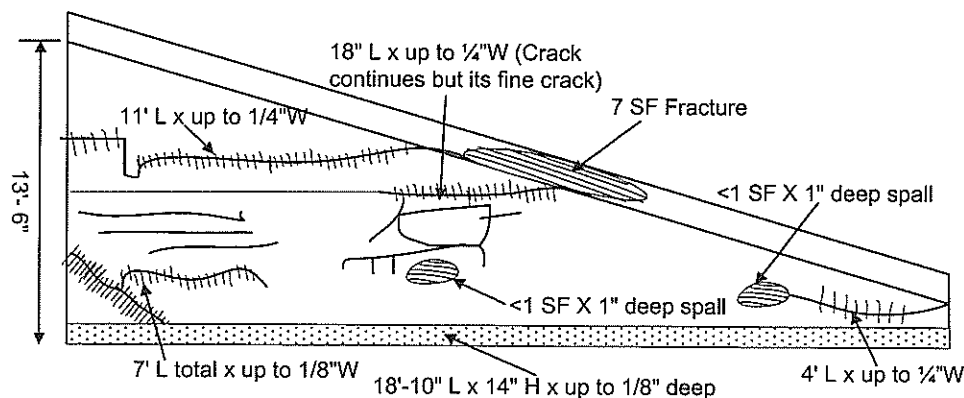
CONDITIONS: See sketch below.

Total spalled/ fractured area to be repaired = 7 SF.

Total cracks to be repaired = 11 LF + 7 LF + 1.5 LF + 4 LF = 23.5 LF (Say 24 LF).

FOUNDATIONS: Footing is exposed for full length and up to 9"H (No undermining was observed).

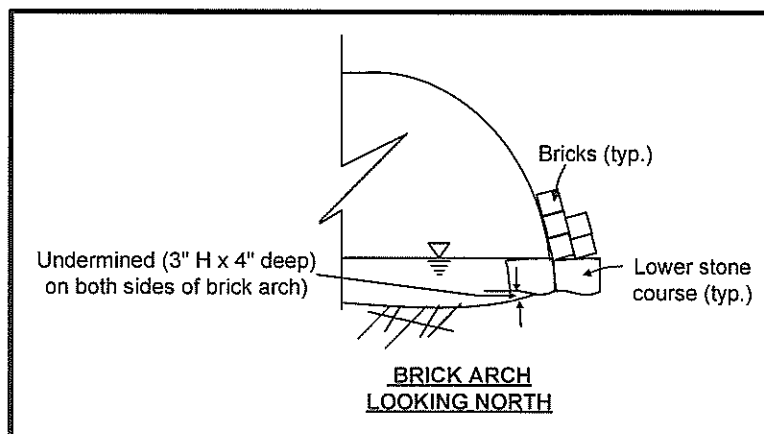
SCOUR: General scour throughout, exposing stone foundation of both abutment breastwalls, northeast wingwall, southeast wingwall and northwest wingwall (concrete footings).

UNDERMINING: East and west stone foundations of brick arch exhibits undermining up to 3" H and 4" deep for full length of the brick arch, see sketch below.
No undermining observed along the wingwalls.

OTHER OBSERVATIONS: Moderate accumulation of debris (wood/ large stone) along the east abutment of concrete slab. Flow centerline is shifted slightly to east through structure.

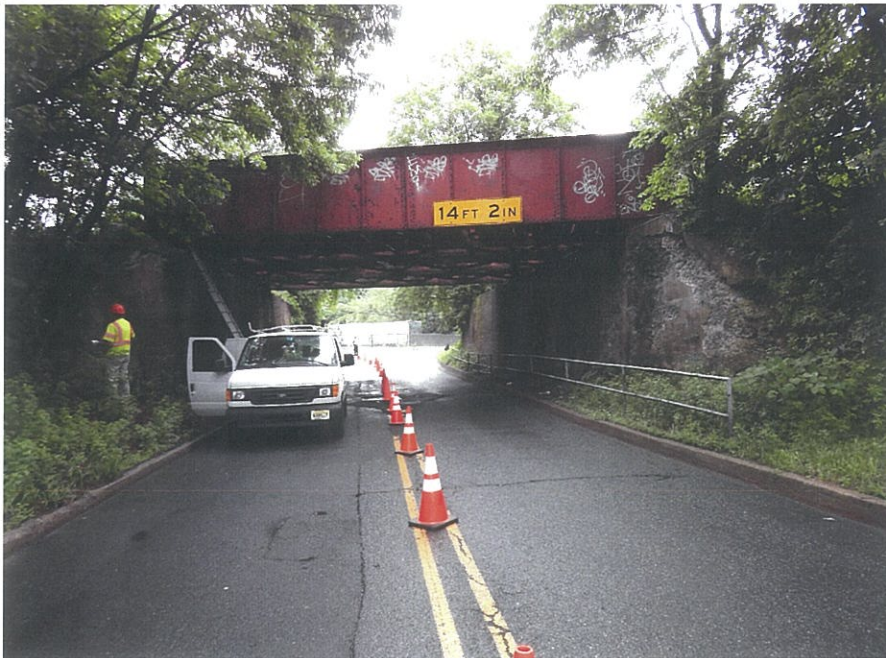
PHOTO 5-1: South elevation, looking north. Work Done: 14'-2" Vertical clearance sign has been installed at the south fascia.

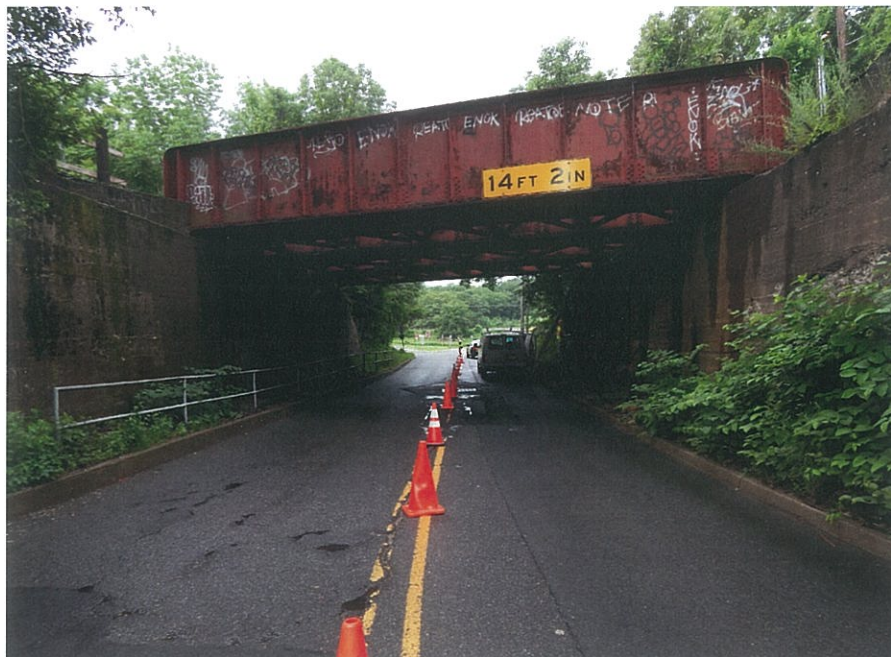
PHOTO 5-2: North elevation, looking south. Work Done: 14'-2" Vertical clearance sign has been installed at the north fascia.

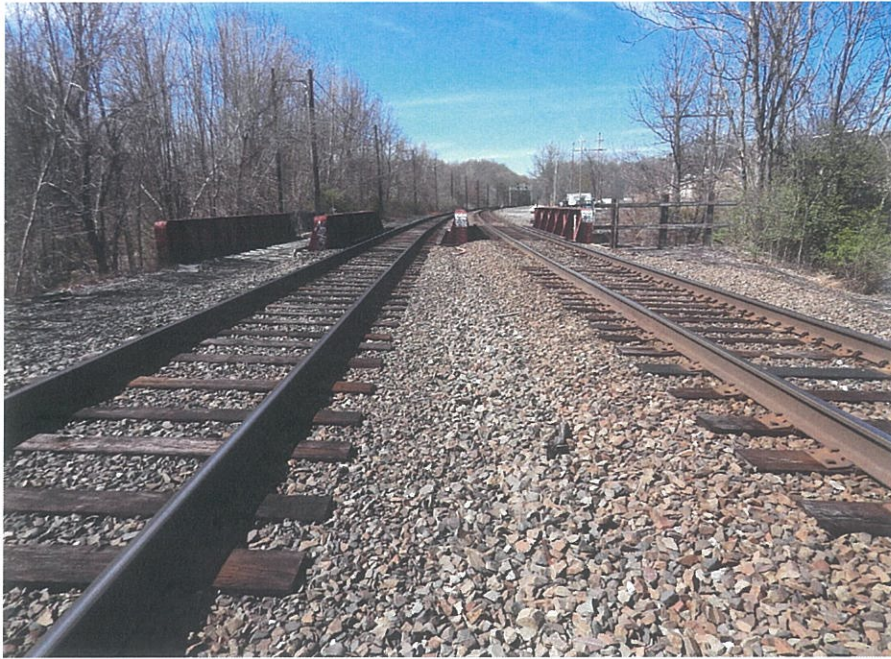
PHOTO 5-3: East approach, looking west.

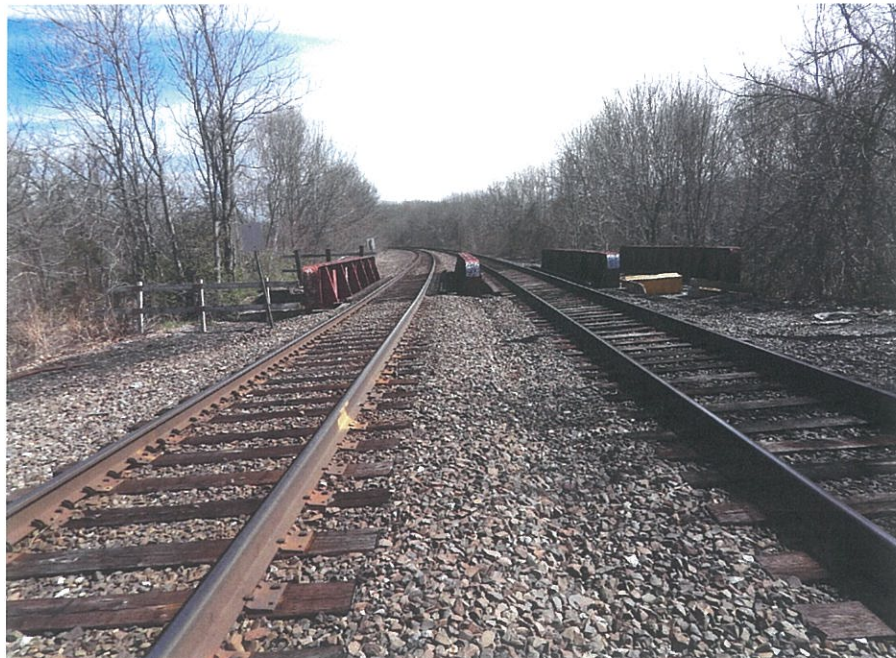
PHOTO 5-4: West approach, looking east.

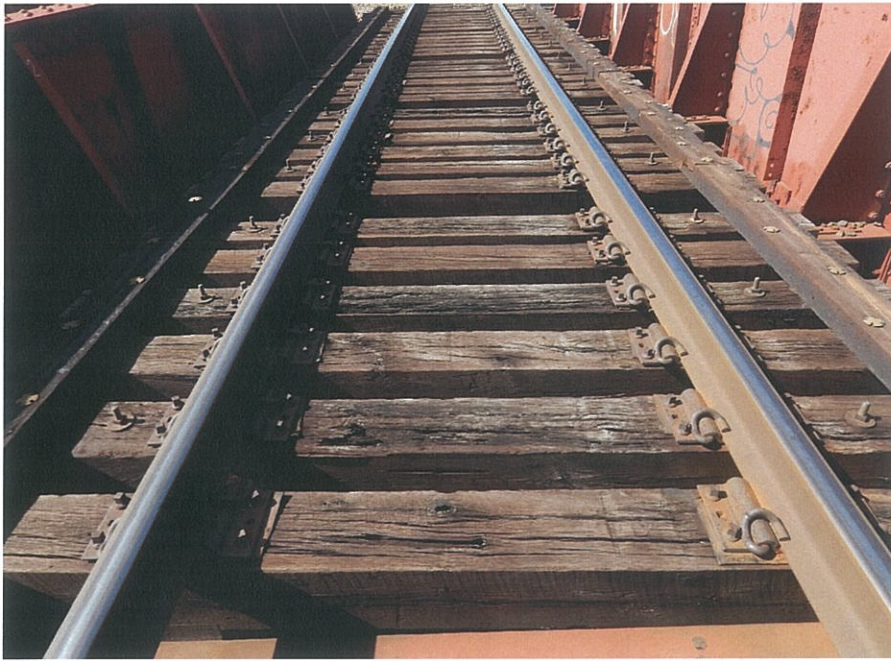
PHOTO 5-5: General view of bridge ties, Track #1, looking west.

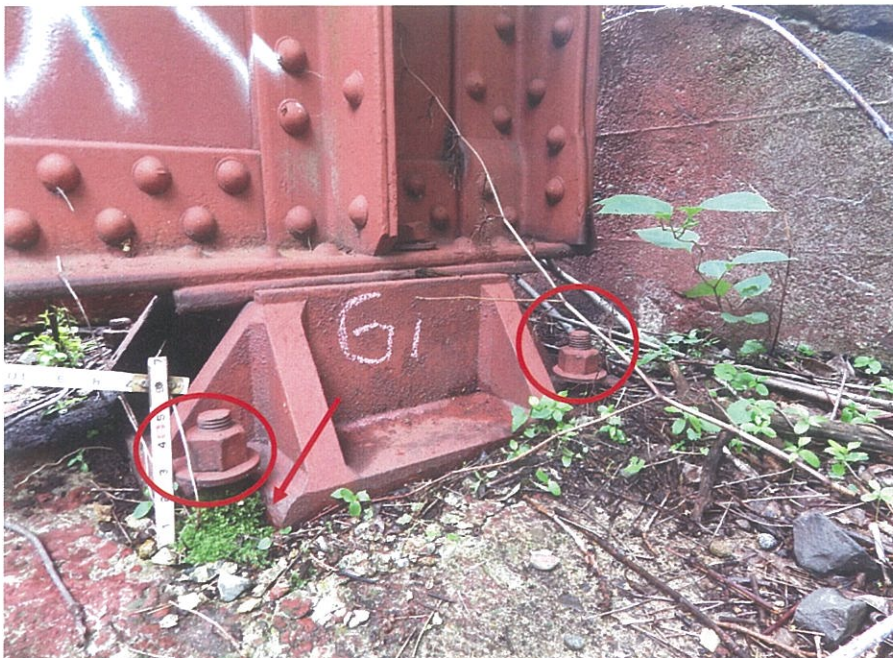
PHOTO 5-8: General view of bearing G1 over the east abutment, looking northeast. Note raised anchor bolt nuts (Circles) and broken masonry plate at the southwest corner of the bearing (Arrow).

8. Replace all holed through and severely deteriorated gusset plates (Photo 5-15).
9. Jack the superstructure, replace or reset the seized expansion bearings over the west abutment. Replace the severely deteriorated, missing anchor bolts and nuts throughout the fixed bearings over the east abutment. Secure all raised anchor bolt nuts and sole plate bolts over the east abutment (Photos 5-8, 5-16 and 5-17).

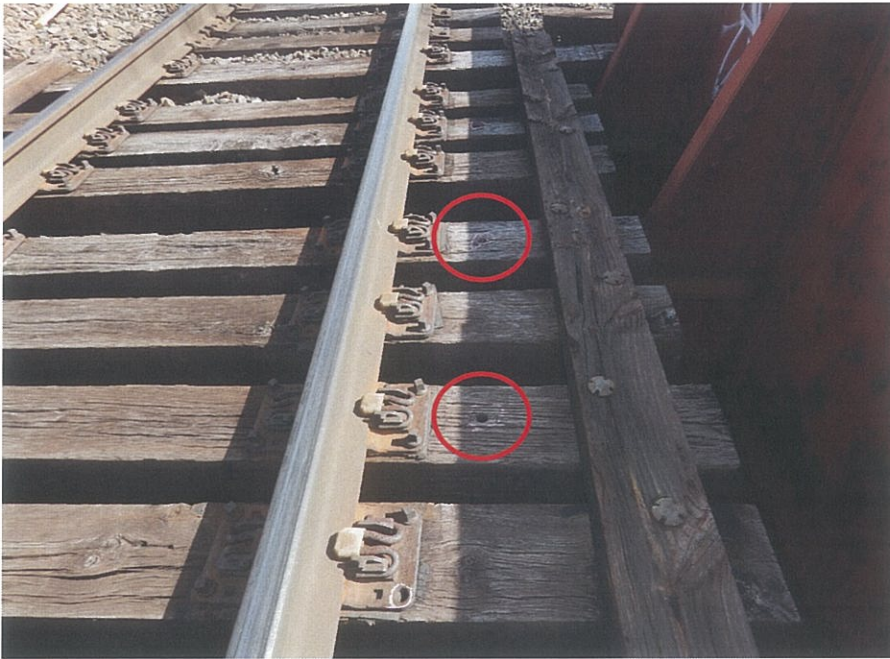
PHOTO 5-11 Missing J-hook bolts at the south side of Track #2, looking east.

3. Replace the missing J-hook bolts and secure the loose J-hook bolts on Tracks #1 and #2 (Photo 5-11).
4. Secure all raised spikes and loose tie plates on Tracks #1 and #2 throughout both approaches (Photo 5-12).

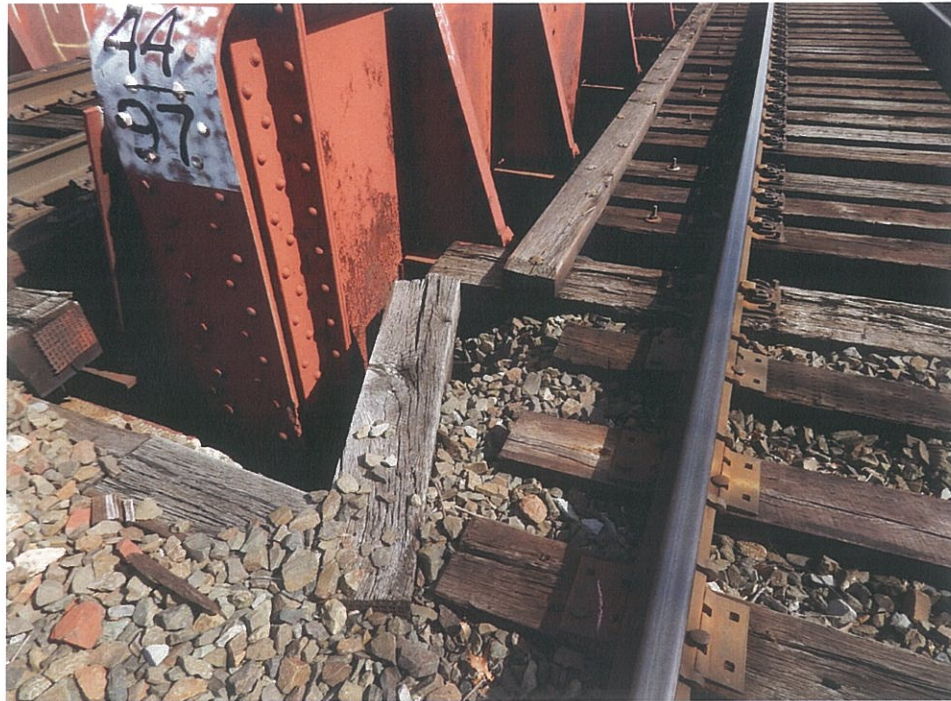
PHOTO 5-13: Displaced ballast retainer at the west end of Girder G3 on Track #2, looking northeast.

5. Reset the displaced ballast retainer at the west end of Girder G3 on Track #2 (Photo 5-13).
6. Backfill the eroded area at the northwest approach embankment (Photo 5-21).

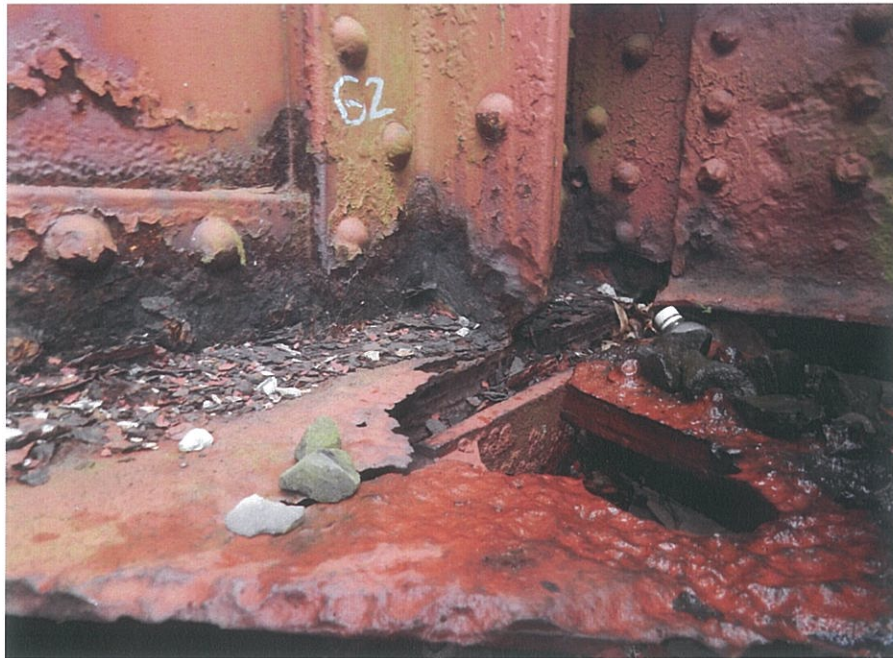
PHOTO 5-15: Severe section loss and holed through gusset plate at the south side of Girder G2 bearing over the east abutment, looking northeast.

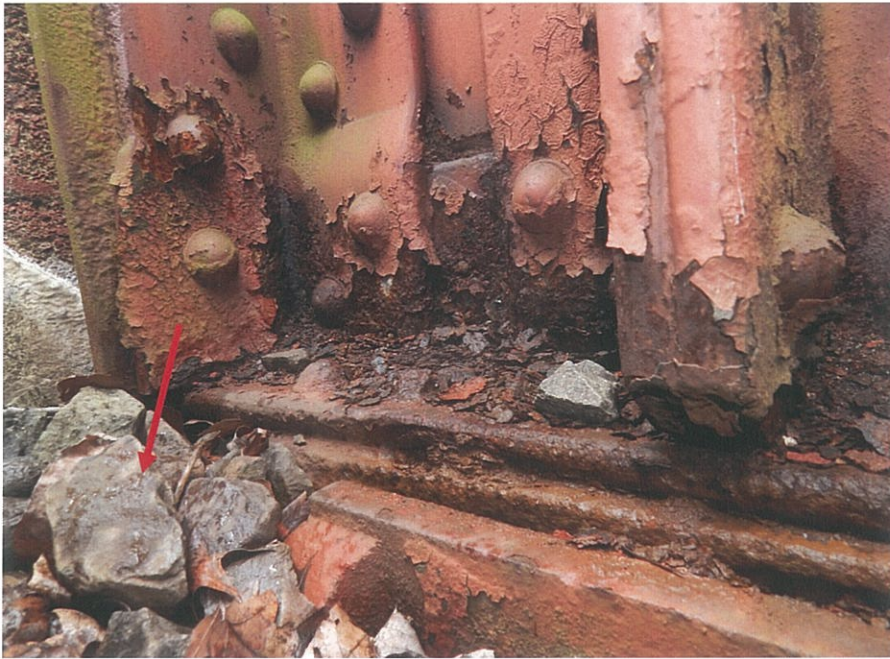
PHOTO 5-17: Missing sole plate bolt at the north side of Girder G3 bearing over the east abutment, looking southeast. Note the accumulation of ballast on the bearing seat.

12. Seal medium to wide cracks at both abutment backwalls with pressure injected epoxy sealant (Photo 5-20).
13. Remove accumulation of debris and ballast from the abutment bearing seats (Photo 5-17).

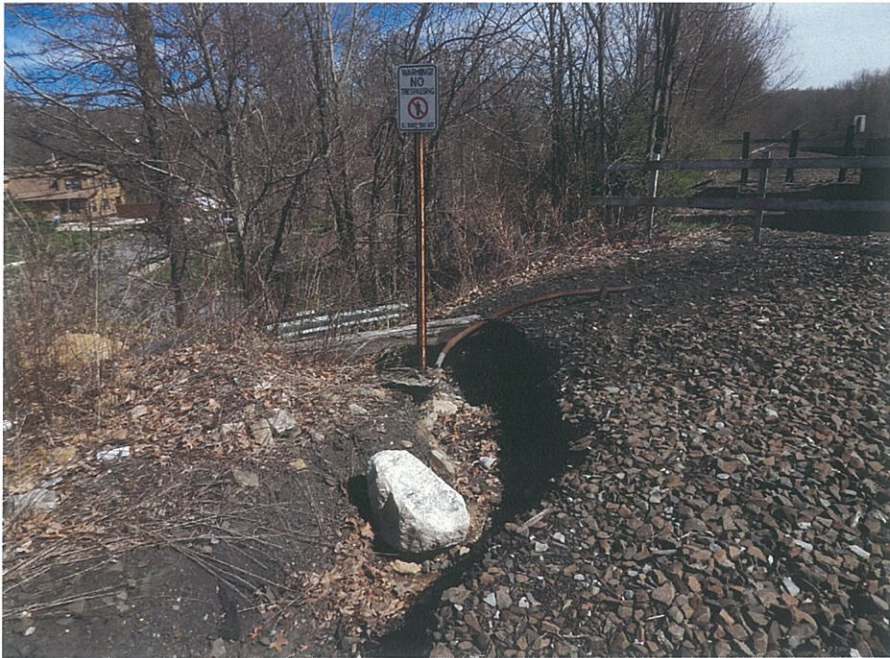
PHOTO 5-21: Erosion hole at the northwest approach embankment, looking northeast.

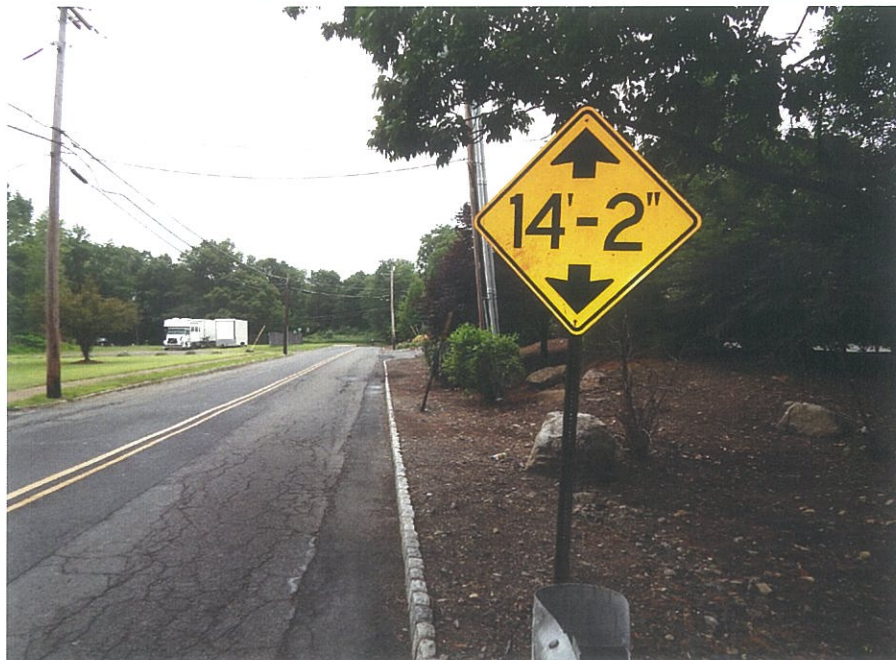
PHOTO 5-22: Work Done: 14'-2" Vertical clearance sign has been installed at the north approach of the Shippenport Road, looking south. Typical at south approach.

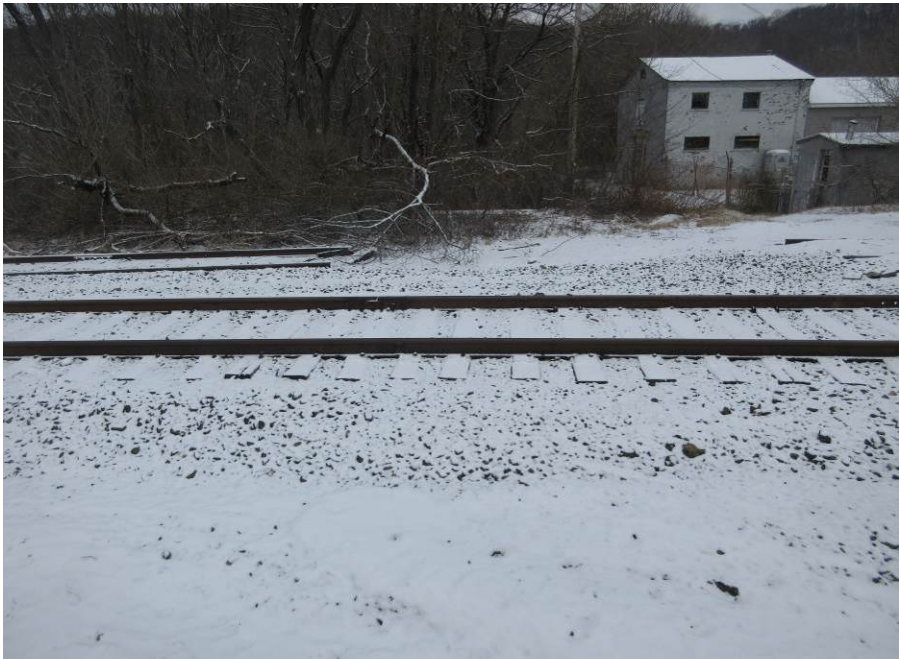
Photo No: 5-01
Location:	South elevation, looking north.	
Description:	General view (backfilled inlet opening).
