North Jersey Transportation Planning Authority

Concept Development Report

Hackettstown Bridge over Drain Weight Restriction Elimination Project

November 2020

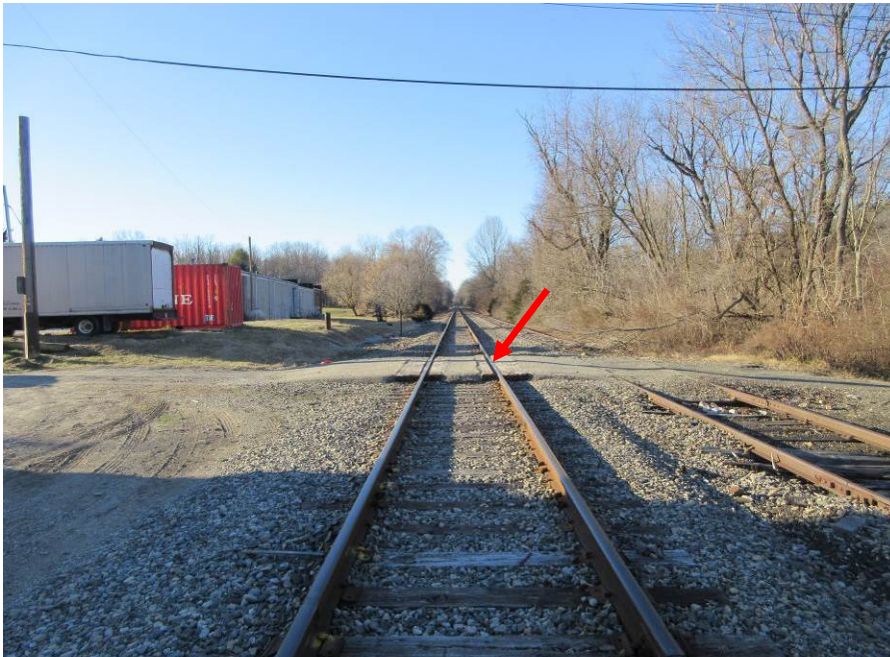
Photo No: 5-03

Location:	East approach, looking west.
Description:	General view. Note: Grade crossing covers some ties along the east approach. Work Done: Several ties have been replaced since previous cycle.

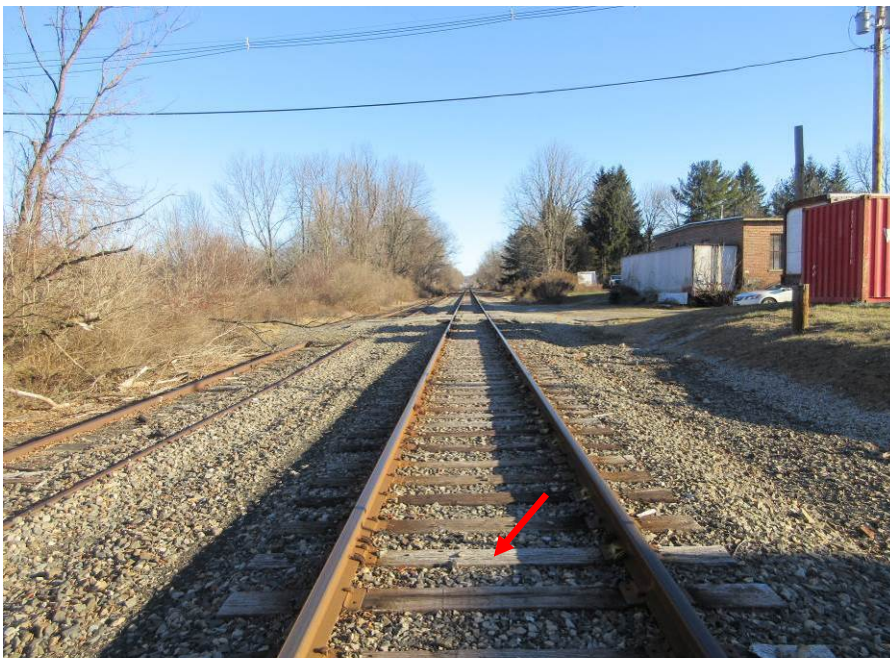
Photo No: 5-04

Location:	West approach, looking east.
Description:	General view. Note: Work Done: Several ties have been replaced since previous cycle.

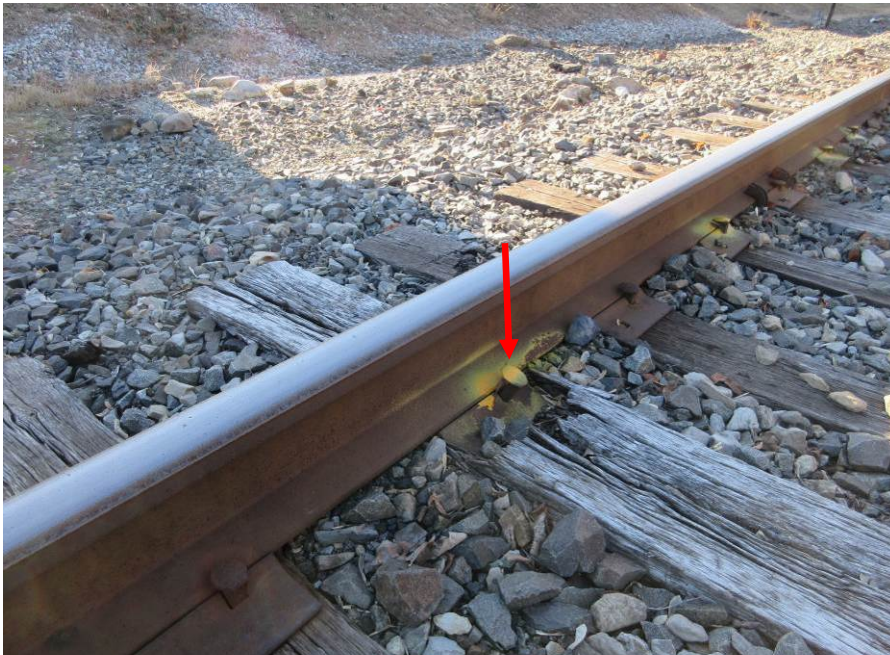
Photo No: 5-10

Location: South rail on bridge, looking southwest.

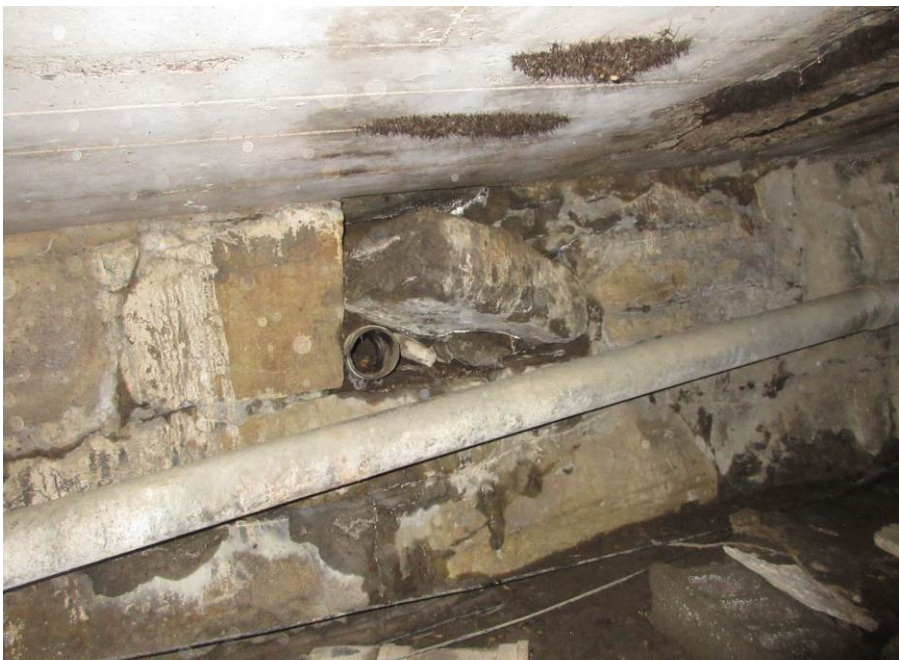
Photo No: 5-14
Location:	East abutment, looking southeast.	
Description:	Displaced stone over drain pipe approximately 15' from south end of structure.

3. Seal the medium crack in the north headwall with a pressure injected epoxy sealer ([Photo 5-02](#)).
4. Fill the voids with epoxy concrete at the north wingwalls and both abutments ([Photos 5-13](#) through [5-15](#)).

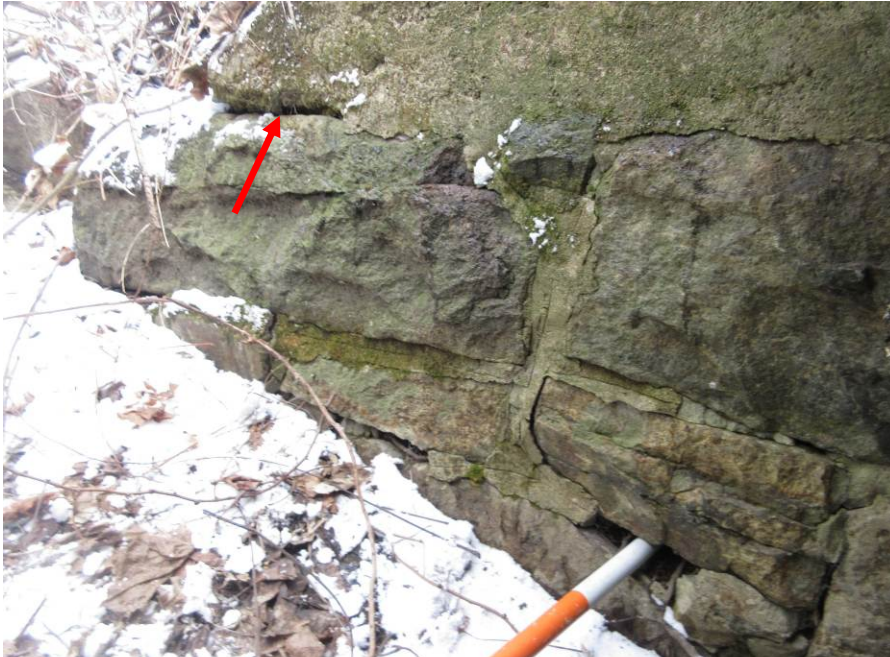
Photo No: 5-15

Location:	Northeast wingwall, looking northeast.
Description:	Void near base of wall and areas of missing mortar (typical at northwest wingwall).

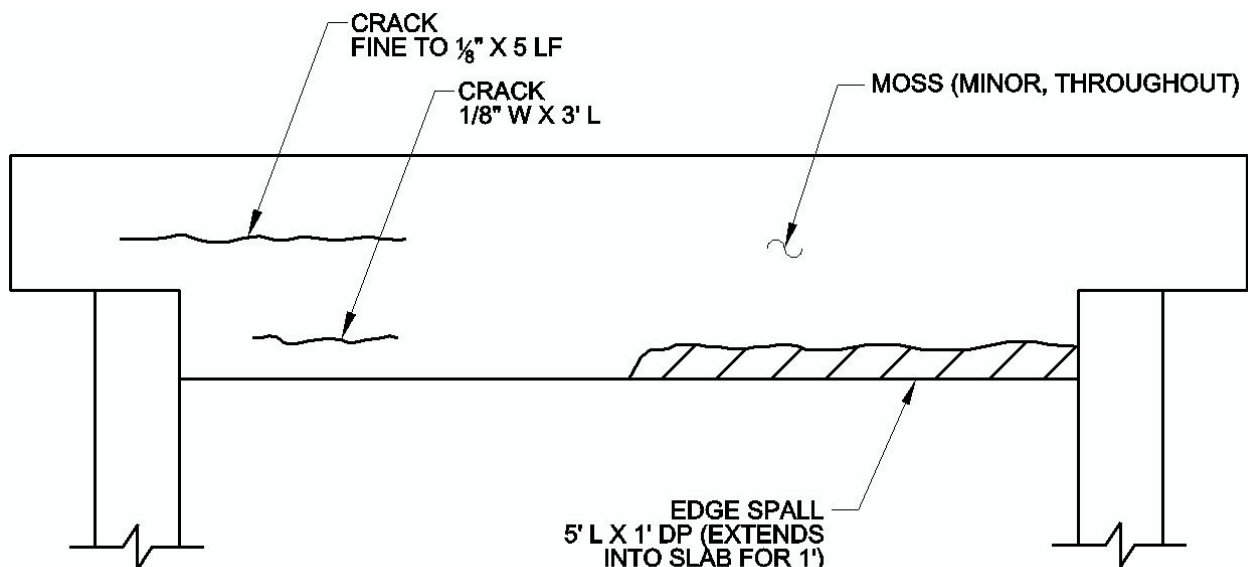
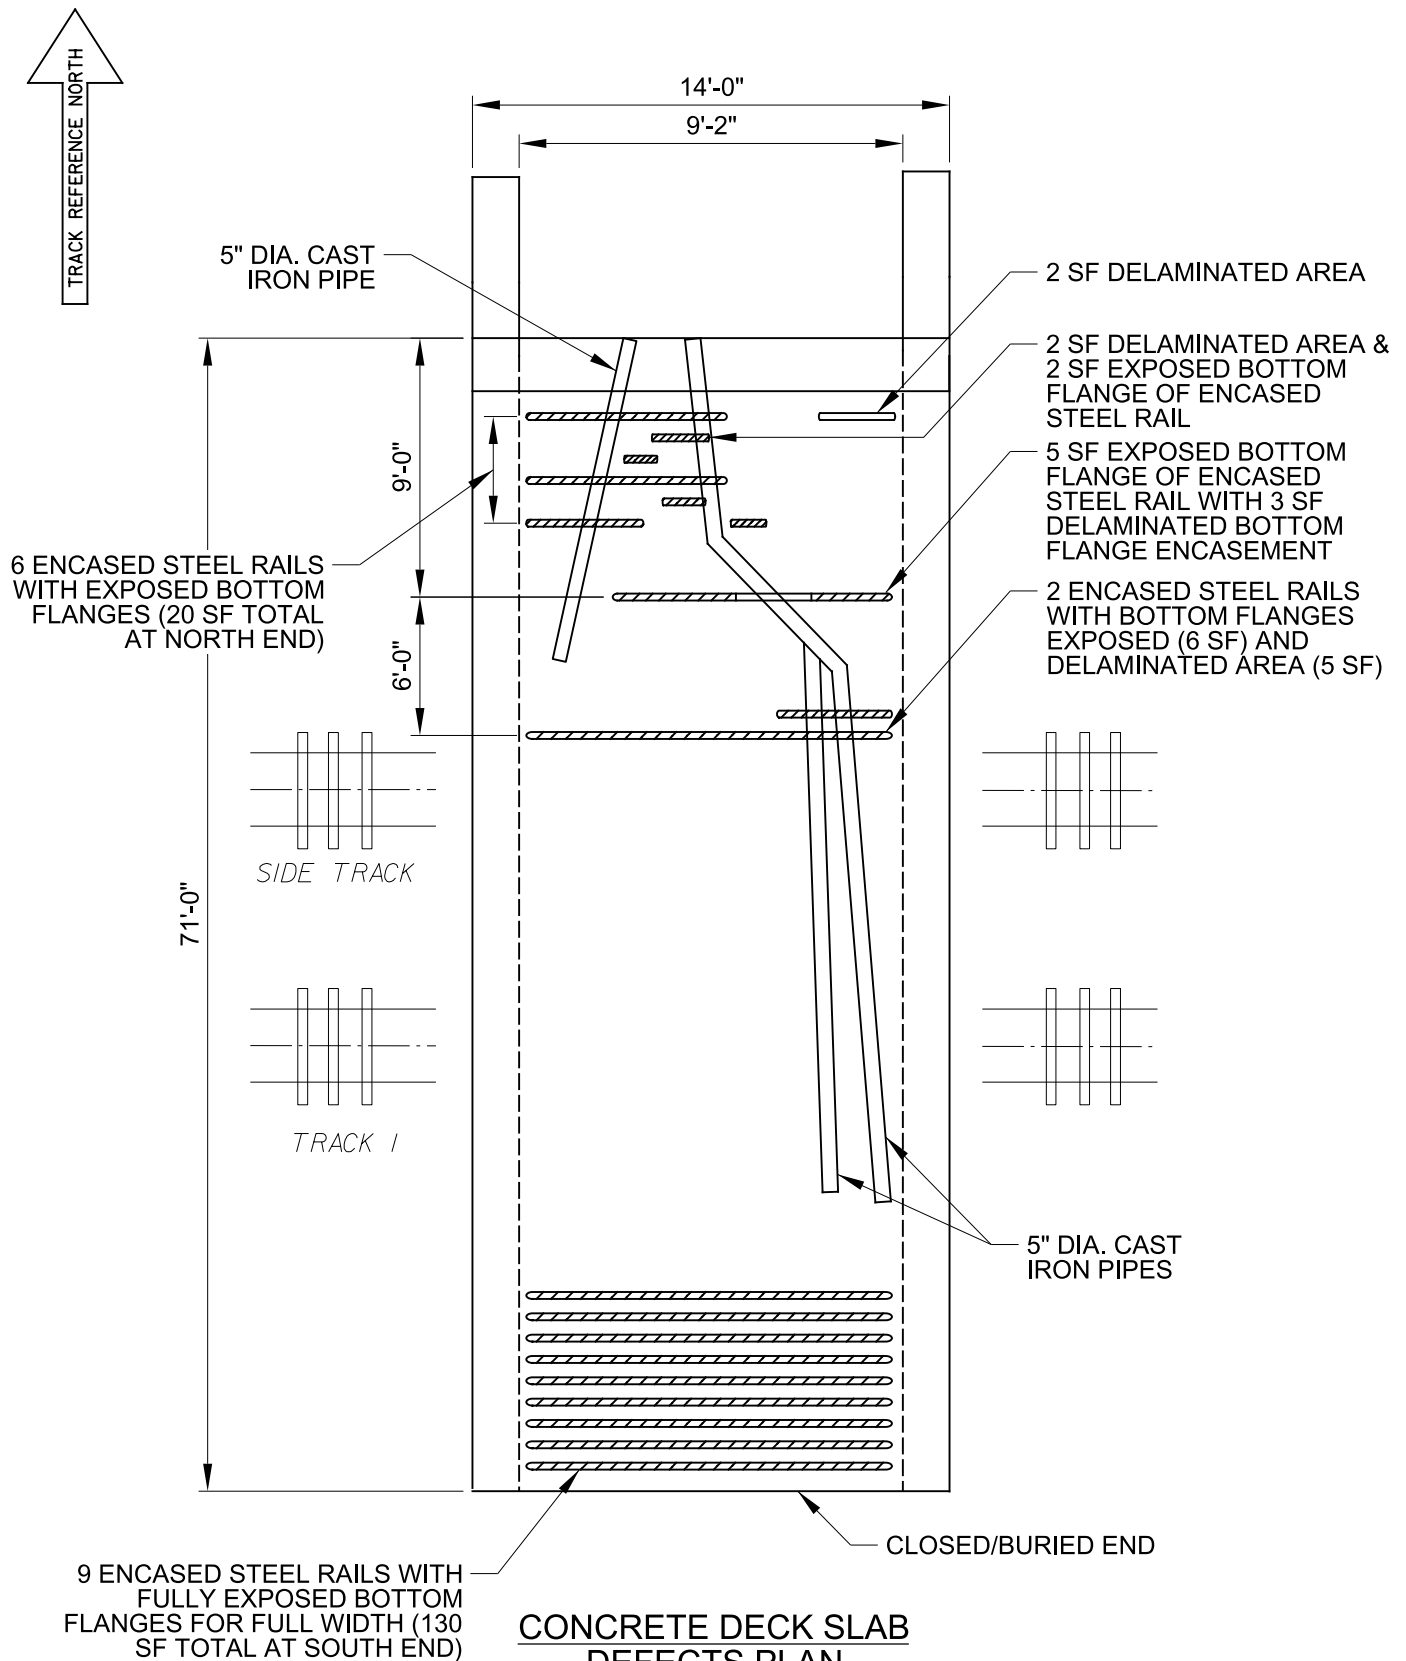
**CONCRETE DECK SLAB
DEFECTS PLAN**

SPALLS: North End: Several spalls on the underside of the slab, exposing the bottom flanges of 6 encased steel rails (20 SF total). Delaminated areas beneath two (2) steel rails (4 SF) (Photo 5-06).
South End: Spalls on underside of slab expose the bottom flanges of nine (9) steel rails for full width (Photo 5-12).
See concrete deck slab defects sketch on the following page for more details.

1. Install a waterproofing membrane throughout the slab and provide adequate drains in the slab ([Photo 5-11](#)).
2. Remove all unsound concrete, clean and paint any exposed steel rails and repair the spalls in the slab and north headwall with epoxy concrete ([Photos 5-06](#) and [5-12](#)).

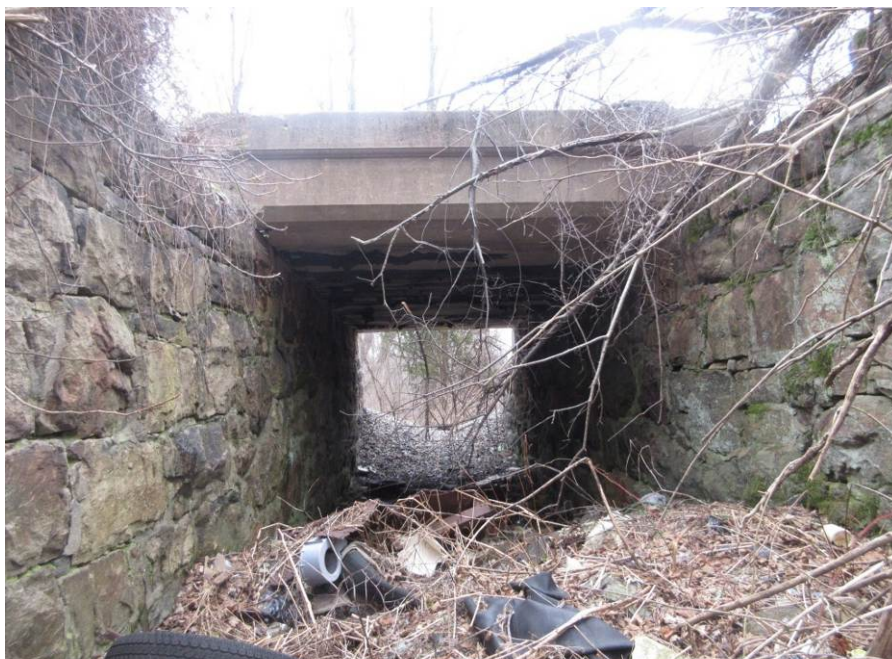
Photo No: 5-02

Description: General view. Note: Heavy debris under the bridge and along the wingwalls (typical throughout).

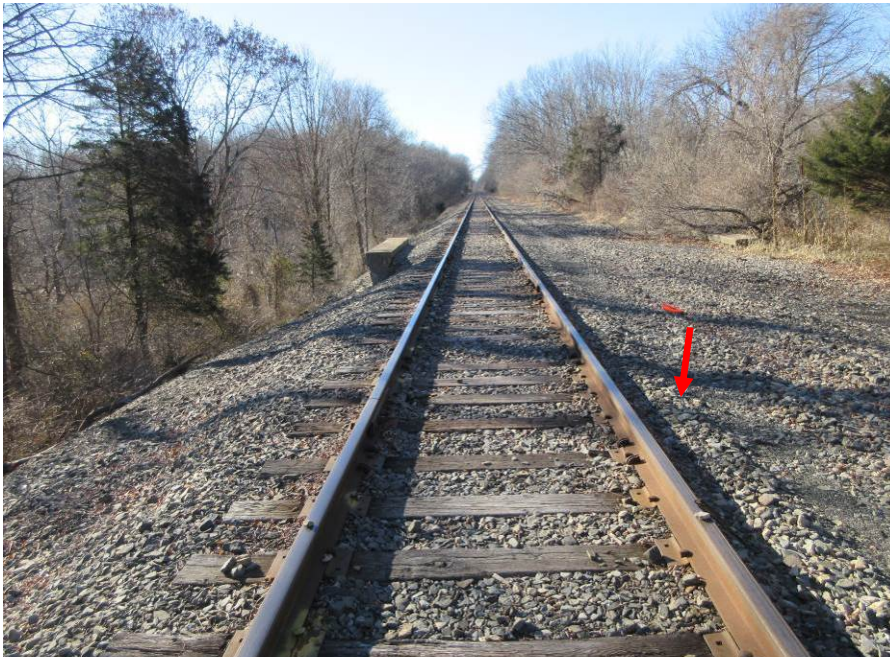
Photo No: 5-03

Description: General view. Note: Ballast overspilling ties outside of north rail.

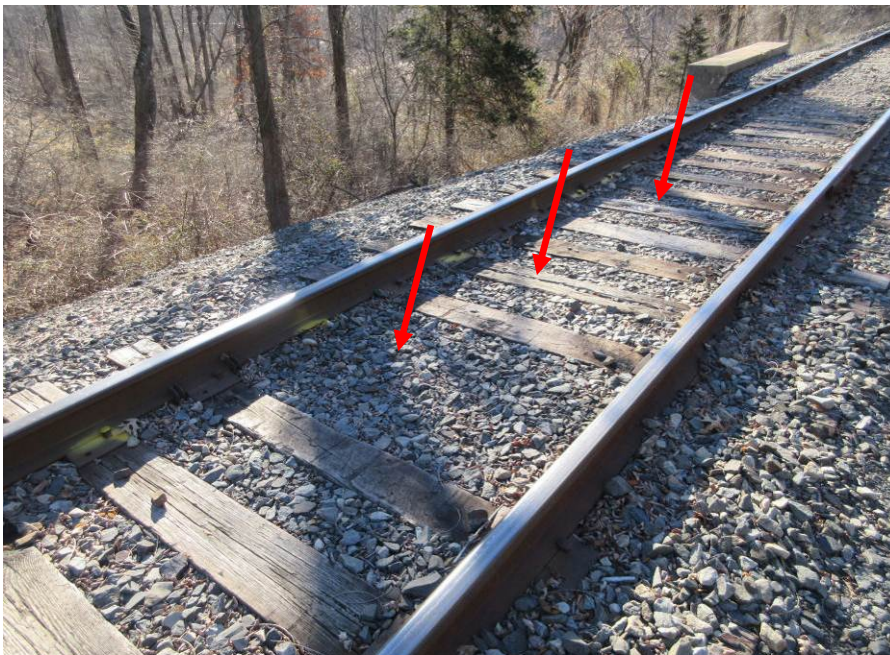
Photo No: 5-08

Description: One tie missing completely. Several ties exhibit wide splits and checks and require replacement (typical at west approach).

1. Replace the severely split and missing ties along both approaches ([Photo 5-08](#)).
2. Secure the loose tie plates and raised spikes and replace the missing spikes on the bridge and along both approaches ([Photos 5-09](#) and [5-10](#)).

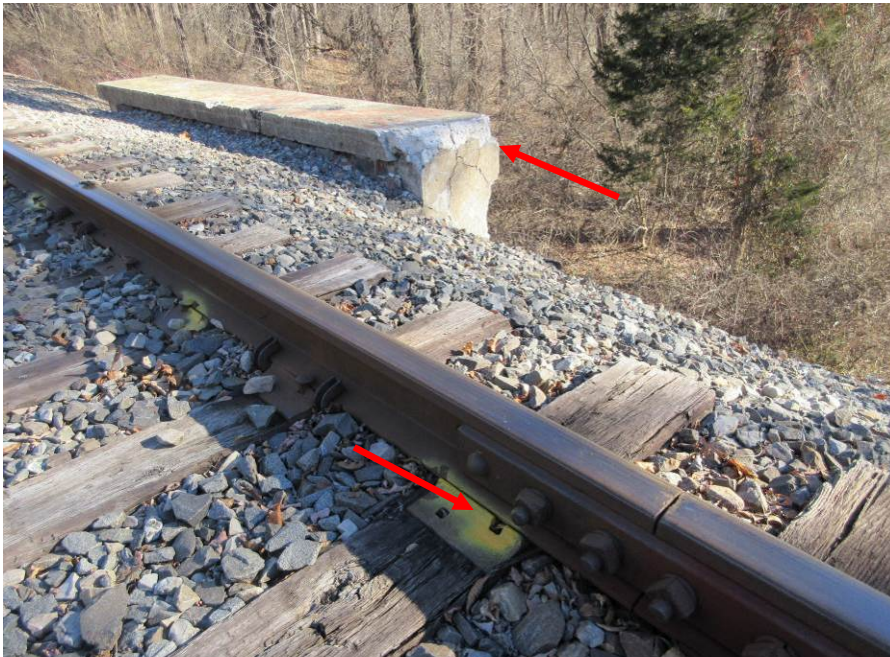
Photo No: 5-09

Description: Missing spike near rail joint. Spalled and delaminated area at west end of south parapet (spalling typical at north parapet).

SPIKES: CONDITION: Spikes typically exhibit moderate rust. Five (5) spikes raised $\pm 1 \frac{1}{2}$ ". 30% of spikes are raised $\pm 1/4$ ". Few spikes are slightly twisted, and there is a missing spike on the south rail near the bridge (Photo 5-09).

CONDITION OF PARAPET WALLS / CURBS: South Parapet: West end is spalled and delaminated for a 3 SF
x 3" deep area (Photos 5-09 and 5-12). East end is spalled (2 SF x 2" deep) and has a 1/8" x 2 LF crack in the south face at
the east end. Small popout on south parapet near midspan (8" x 4"). See other observations below.

3. Remove all unsound concrete, clean and paint any exposed reinforcement and repair the spalls in the parapets/slab at both fascias and abutment seat areas with epoxy concrete ([Photos 5-09](#), [5-12](#), and [5-15](#)).

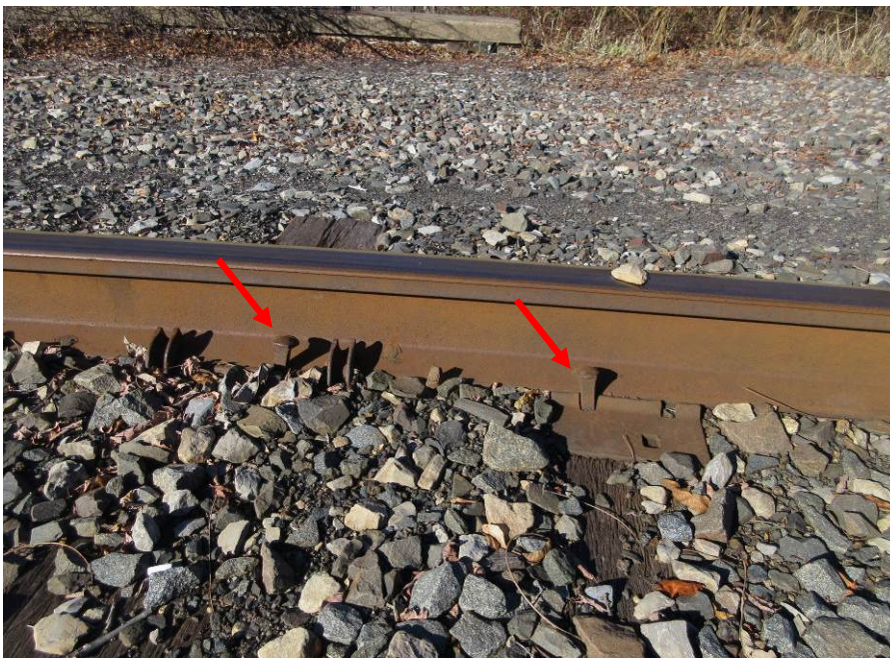
Photo No: 5-10

Location: North rail at east end of bridge, looking north.

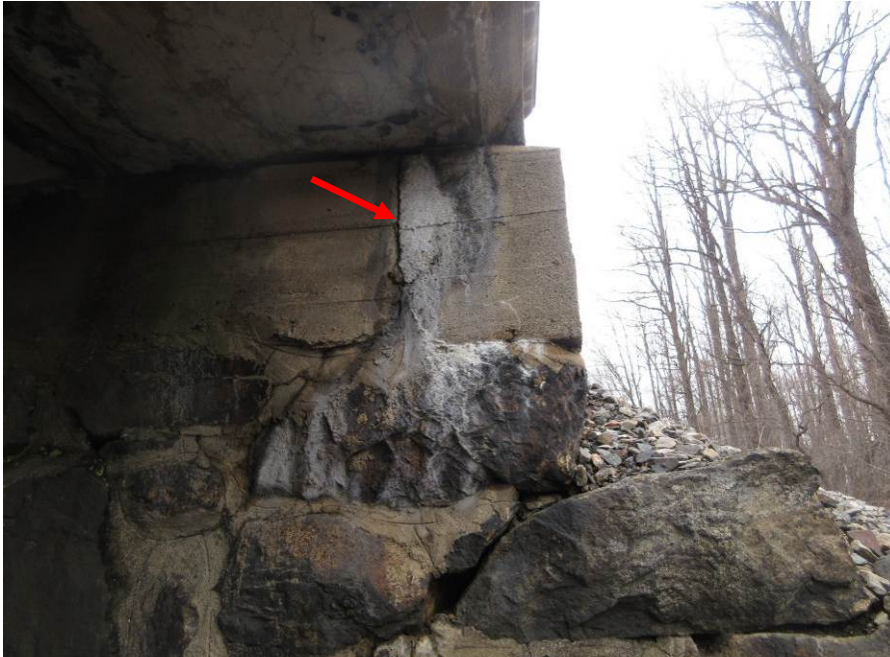
Photo No: 5-13

Description: Vertical crack in concrete with efflorescence and light map cracking.

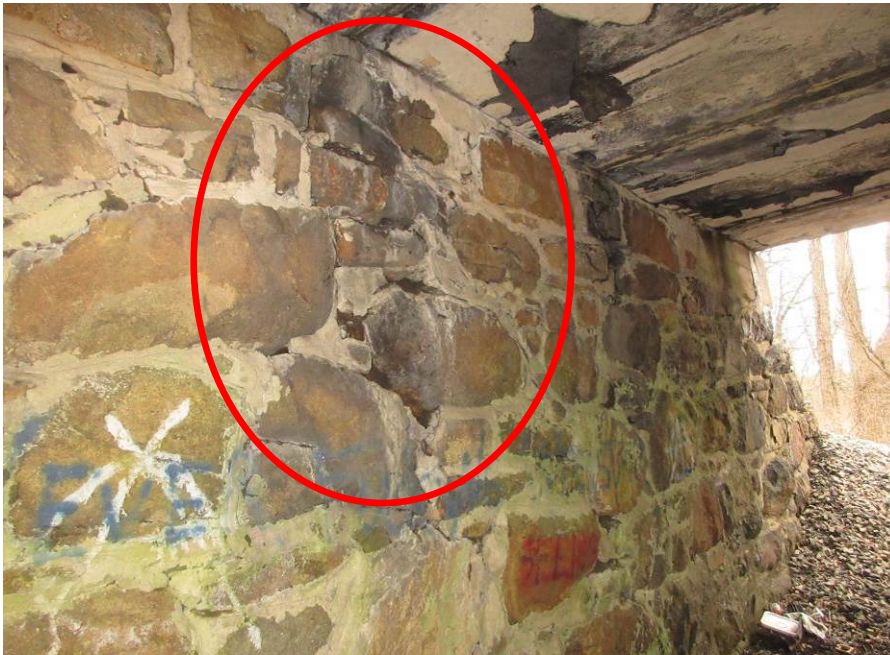
Photo No: 5-14

Location: East abutment near mid-length, looking southeast.

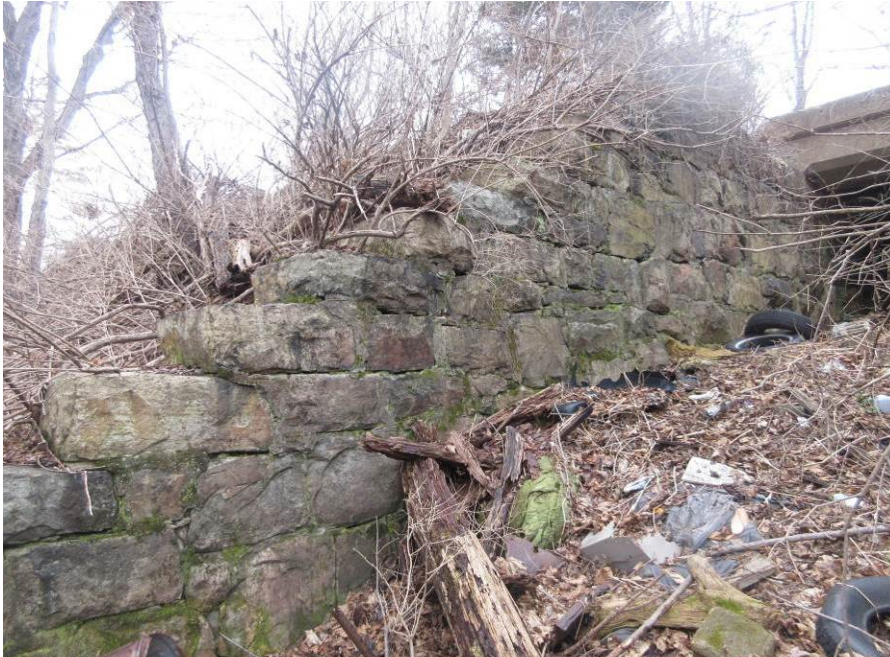
Photo No: 5-17

Location:	Northeast wingwall, looking southeast.
Description:	Loss of mortar throughout (typical at all wingwalls). Large accumulation of debris in front of wall and heavy vegetation on top of wall (typical at northwest wingwall).

Water staining on the face of the wall near the bridge and light moss growth (10%) throughout. Large accumulation of debris in front of the wall (Photo 5-17). See northeast wingwall sketch for details.

9. Install a waterproofing membrane and provide adequate drains throughout the slab ([Photos 5-06](#) and [5-11](#)).
10. Remove graffiti from both abutment breastwalls and the southeast wingwall and remove vegetation behind the north wingwalls ([Photos 5-16](#) and [5-17](#)).

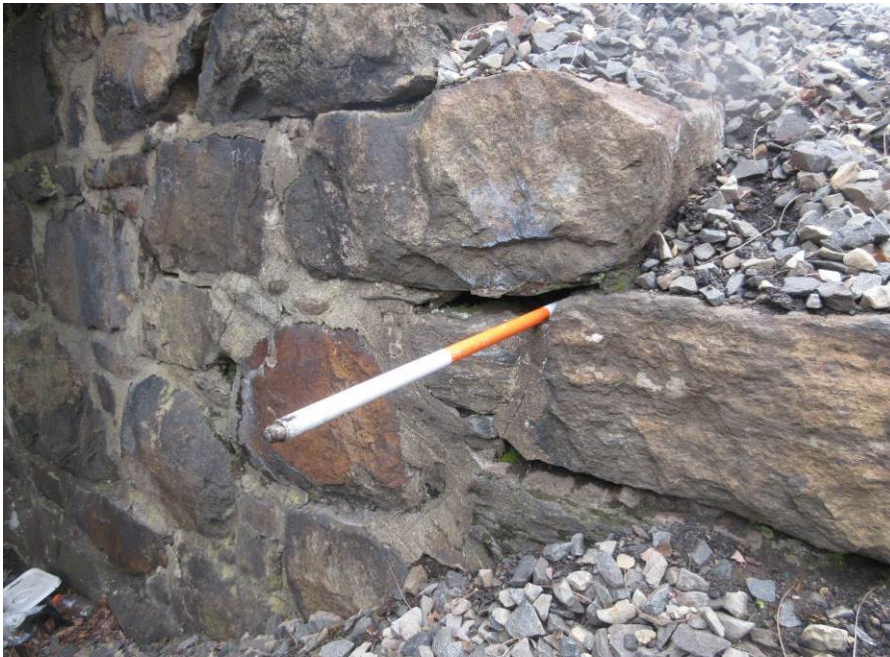
Photo No: 5-18

Location:	Southeast wingwall, looking northeast.
Description:	Void between stones. Loss of mortar throughout, and ballast accumulation at base and on top of wall (typical at southwest wingwall).

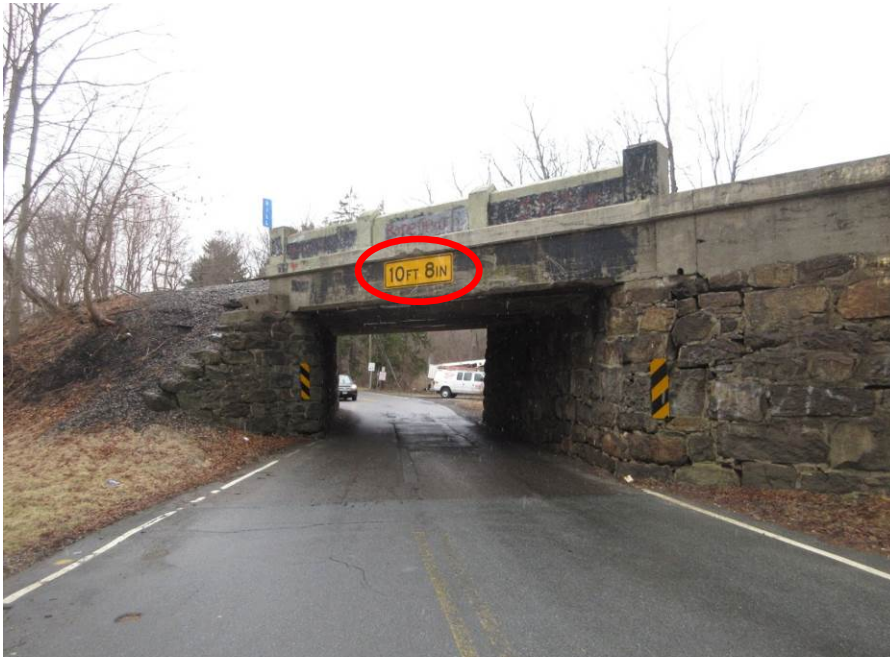
Photo No: 5-01

Location:	South elevation, looking north.
Description:	General view. Note: Vegetation growth behind the wingwall. Work Done: 10'-8" clearance sign installed on south fascia.

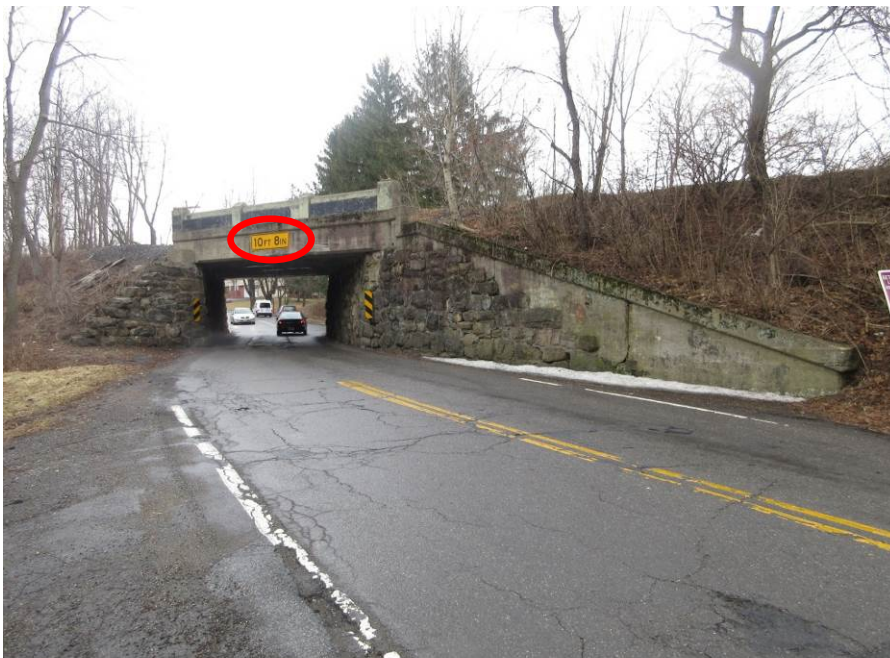
Photo No: 5-02

Location:	North elevation, looking south.
Description:	General view. Note: Vegetation growth behind the wingwalls. Work Done: 10'-8" clearance sign installed on north fascia.

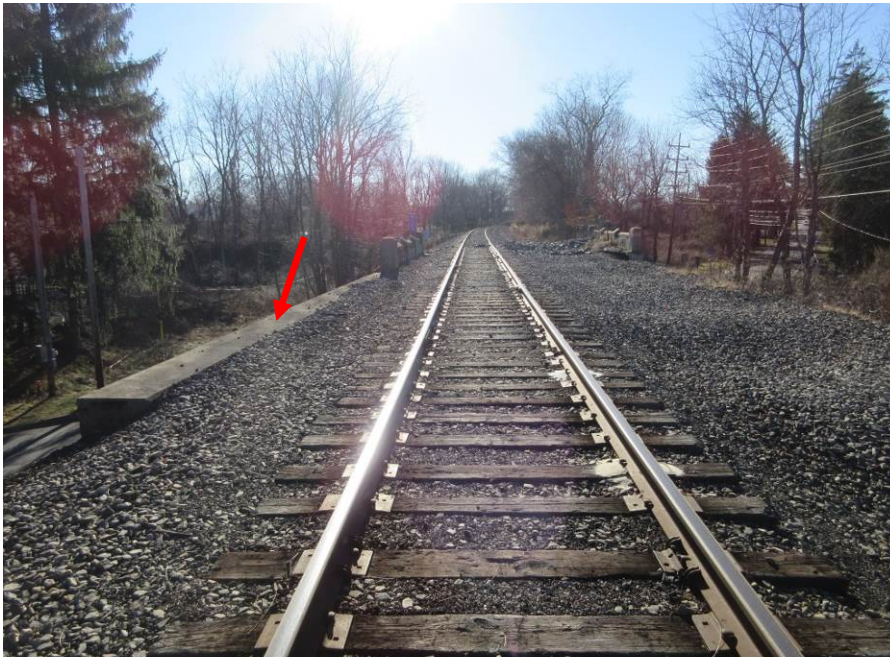
Photo No: 5-03

Description: General view. Note: No railing above low parapet on both sides of the bridge.

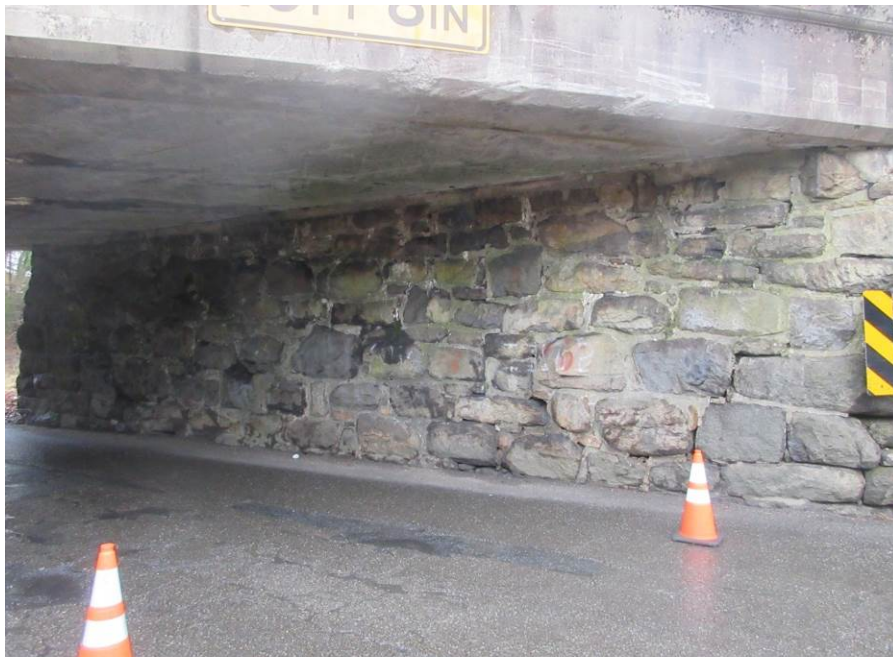
Photo No: 5-07

Location:	West abutment, looking southwest.
Description:	General view. Note: Missing/deteriorated mortar at several locations throughout wall with voids (typical at east abutment). Work Done: Previously observed phone cable running across the top of the west abutment has been removed.

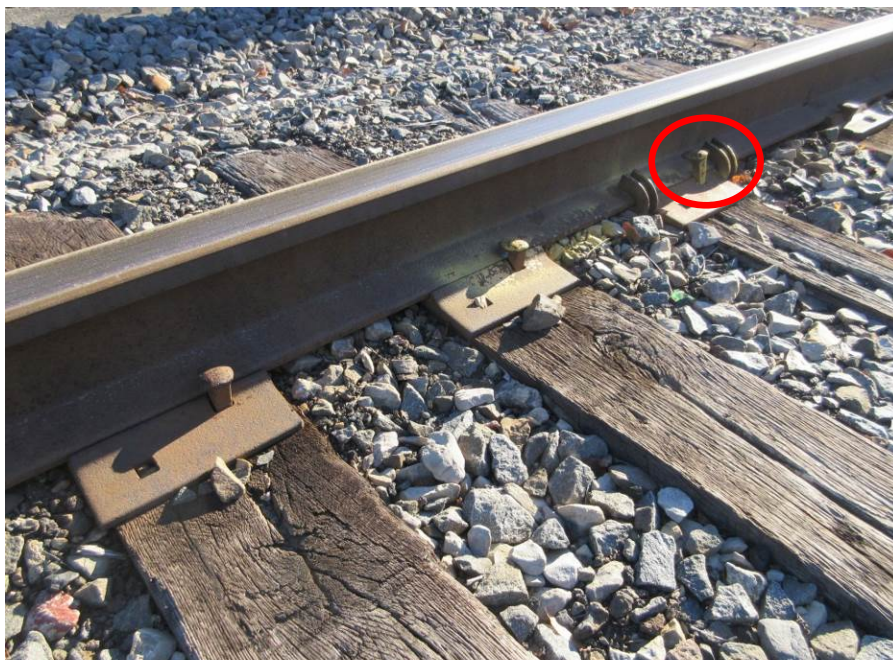
Photo No: 5-08

Location:	East approach near bridge, looking southwest.
Description:	Few spikes raised on east approach (typical on west approach and on structure).

SPIKES: CONDITION: Spikes typically exhibit moderate rust throughout. 25% of spikes are raised $\pm 1/2$ ", and ± 5 spikes are raised up to 1" (Photo 5-08).

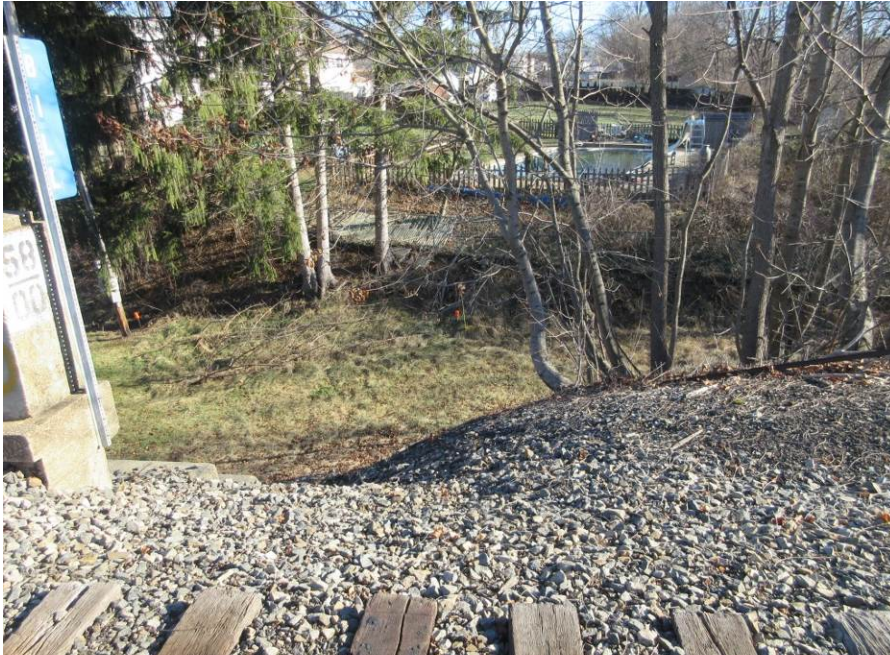
Photo No: 5-09

Location:	Southwest corner of bridge, looking south.
Description:	Ballast is unstable at west approach near south headwall and is mixed with dirt throughout the full length of the approach (typical at east approach and on structure).

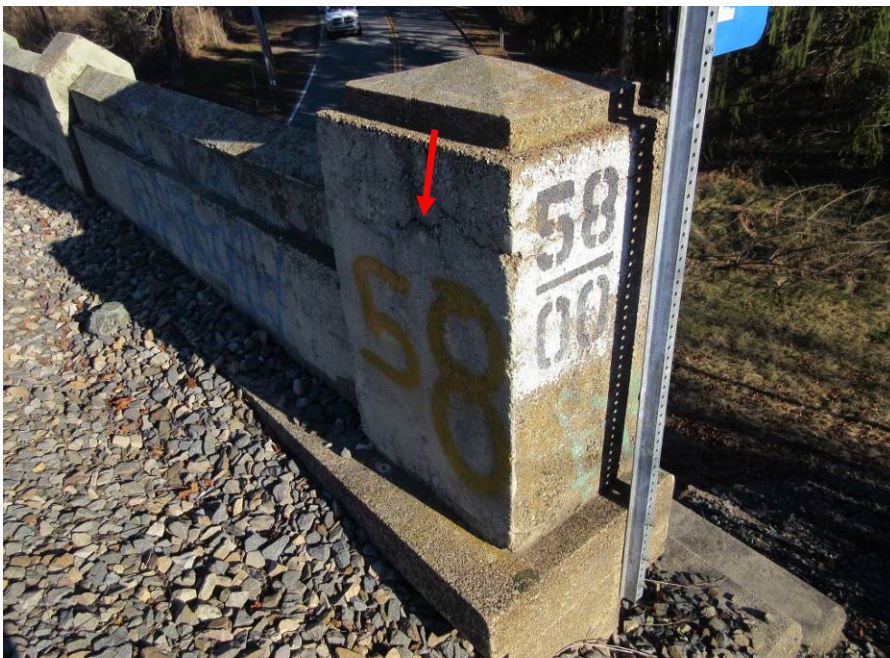
Photo No: 5-10

Location:	West end of south parapet, looking southeast.
Description:	Medium to wide cracks and light honeycombing in parapet pylon.

CONDITION OF (PARAPET WALLS) CURBS: South: Base of parapet is covered with vegetation and large stones
There are fine to medium cracks and light honeycombing at the top, north, and east faces (Photo 5-10).
North: Base of parapet is covered with ballast. Lower portion of east face exhibits scaling for 2.5 SF x 4" deep.

6. Seal the medium to wide cracks in the parapets and the southwest wingwall cap ([Photo 5-10](#)).
7. Replace the severely split and rotted ties along the east approach and on the bridge ([Photo 5-05](#)).

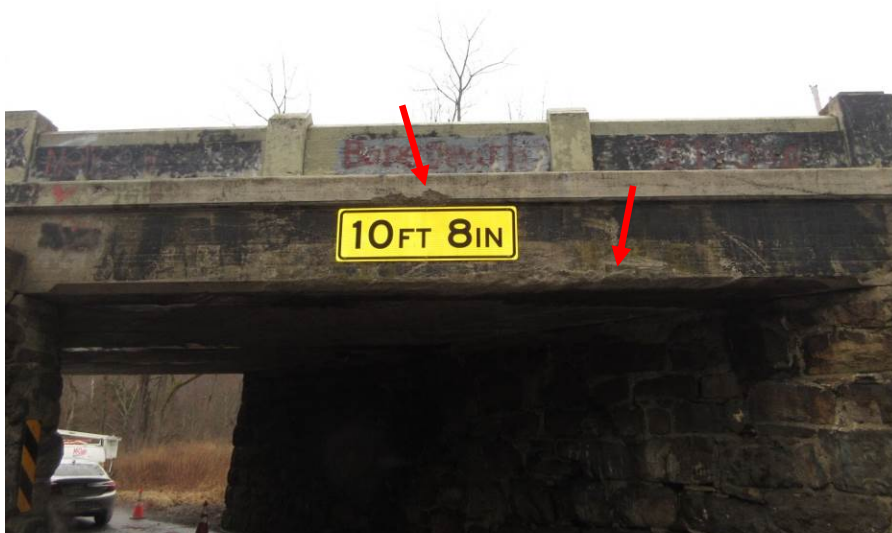
Photo No: 5-13

CONDITIONS: Areas beneath the fascia slab panels are filled with concrete (±5 LF at south end, ±8 LF at north end).
Vertical cracks (1/8" wide) with efflorescence in the concrete areas at both ends of the abutment (Photo 5-13).
Few small voids throughout near the base of the abutment (up to 18" deep) and near mid-height at the south end
of the abutment. There is a 3 SF area of voids (up to 18" deep) with missing mortar and missing stones near the
center of the wall (Photo 5-14). See abutment sketch for more details.

Location:	South fascia, looking north.
Description:	Spall above clearance posting. Minor edge spalling and scrape marks to base of headwall due to impact damage. Note graffiti on parapet.

1. Install a waterproof membrane and provide adequate drains ([Photos 5-06](#) and [5-12](#)).
2. Patch concrete spalls in the underside of the deck slab, parapet, fascias and northwest wingwall cap ([Photos 5-06](#), [5-12](#), and [5-13](#)).

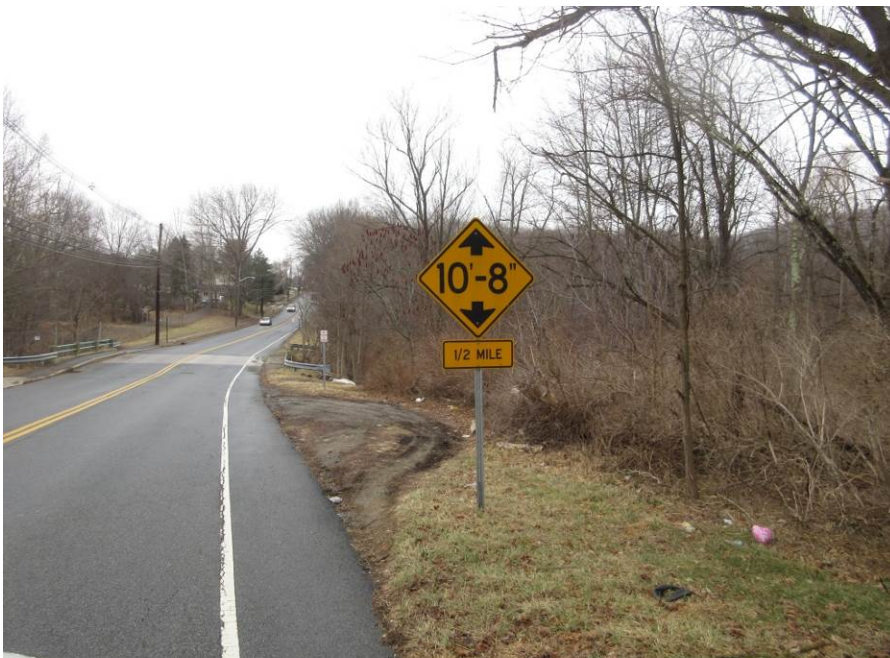
Photo No: 5-16

Location:	South approach roadway, 1/2 mile from bridge, looking north.
Description:	Work Done: 10'-8" clearance posting with "1/2 MILE" sign installed along south approach. Similar postings at south approach (10'-8" clearance postings with "2000 FT" sign installed), north approach (10'-8" clearance posting with "1/4 MILE" sign installed), and at the intersection of Grand Avenue and 5 th Avenue (10'-8" clearance posting with right arrow sign installed).

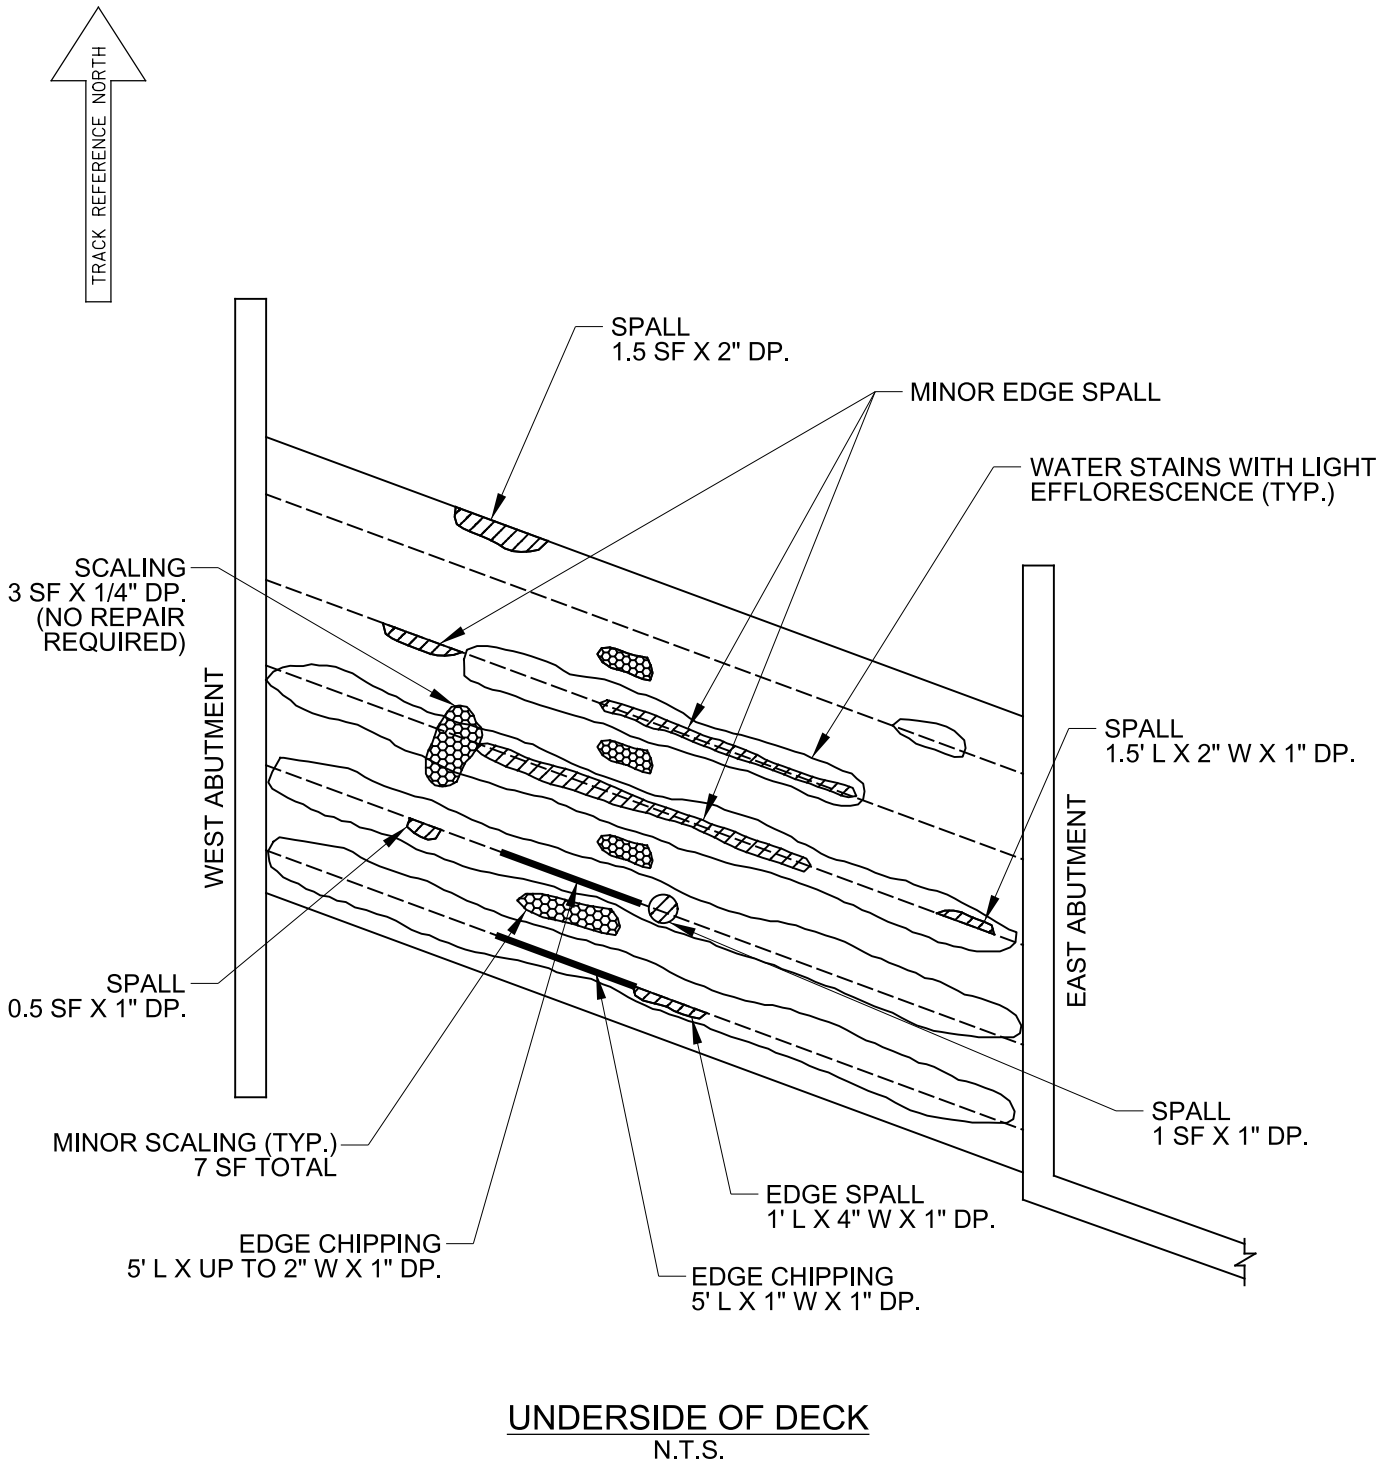
PHOTOS 5-06, 5-12

SPALLS: Spall (1.5 SF x 2" deep) at the north fascia due to impact damage. Minor edge spalling (up to 1" deep) and water staining with light efflorescence are typical at slab panel joints (Photos 5-06 and 5-12). Localized areas of moderate scaling near midspan (7 SF total). See underside of deck sketch for more details.

OTHER OBSERVATIONS: The waterproofing membrane has completely deteriorated. Minor impact damage (scrape marks and minor chipping) are present on both the north and south fascias and throughout the underside of the deck (Photos 5-06 and 5-12).

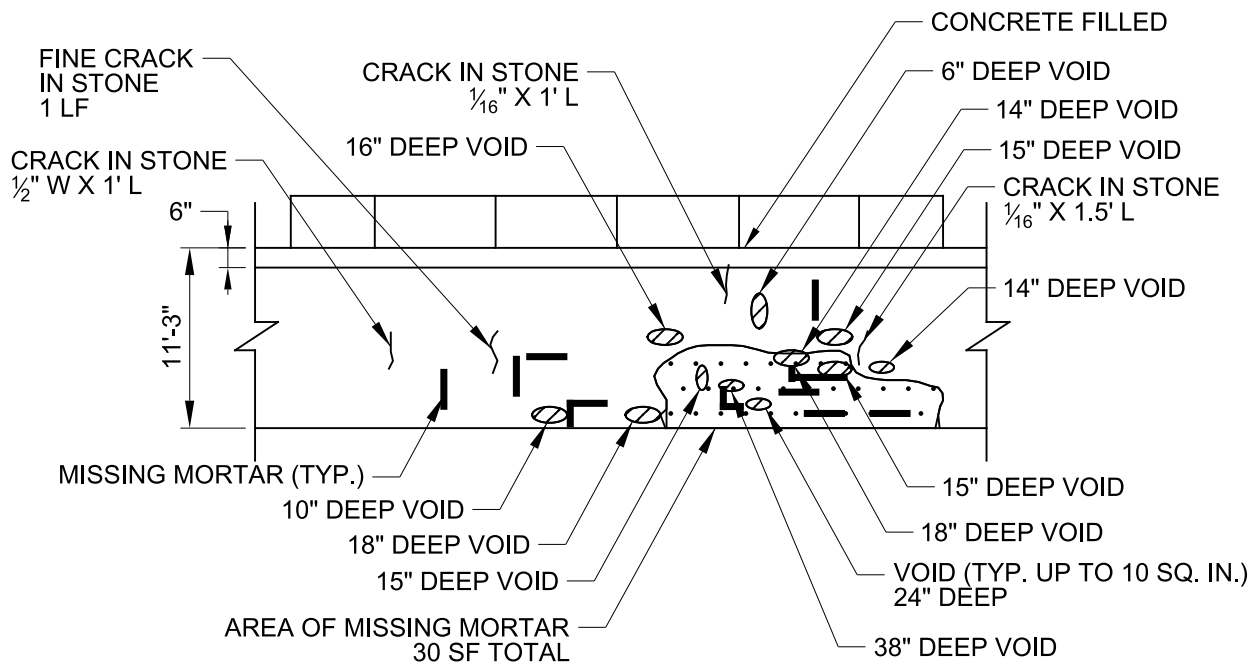
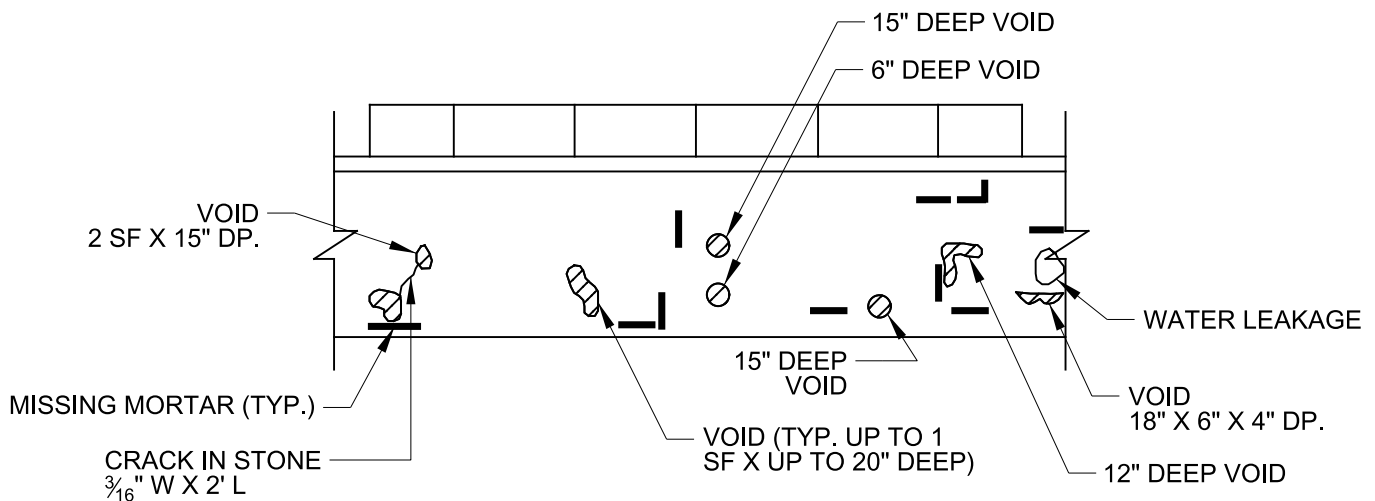
LINE MORRISTOWN MP 58.00 PHOTOS 5-07

OTHER OBSERVATIONS: There is graffiti on the wall (10 SF). The upper ±6" of the wall is concrete filled and is in good condition with minor leakage stains. Work Done: Previously observed phone cable running across the top of the west abutment has been removed (Photo 5-07).

3. Repoint areas of deteriorated and missing mortar and seal the wide cracks in the abutments and wingwalls ([Photos 5-07](#) and [5-14](#)).
4. Reset the loose and bulging stones in the southeast and northwest wingwalls ([Photo 5-15](#)).
