North Jersey Transportation Planning Authority

Concept Development Report

Hackettstown Bridge over Drain Weight Restriction Elimination Project

November 2020

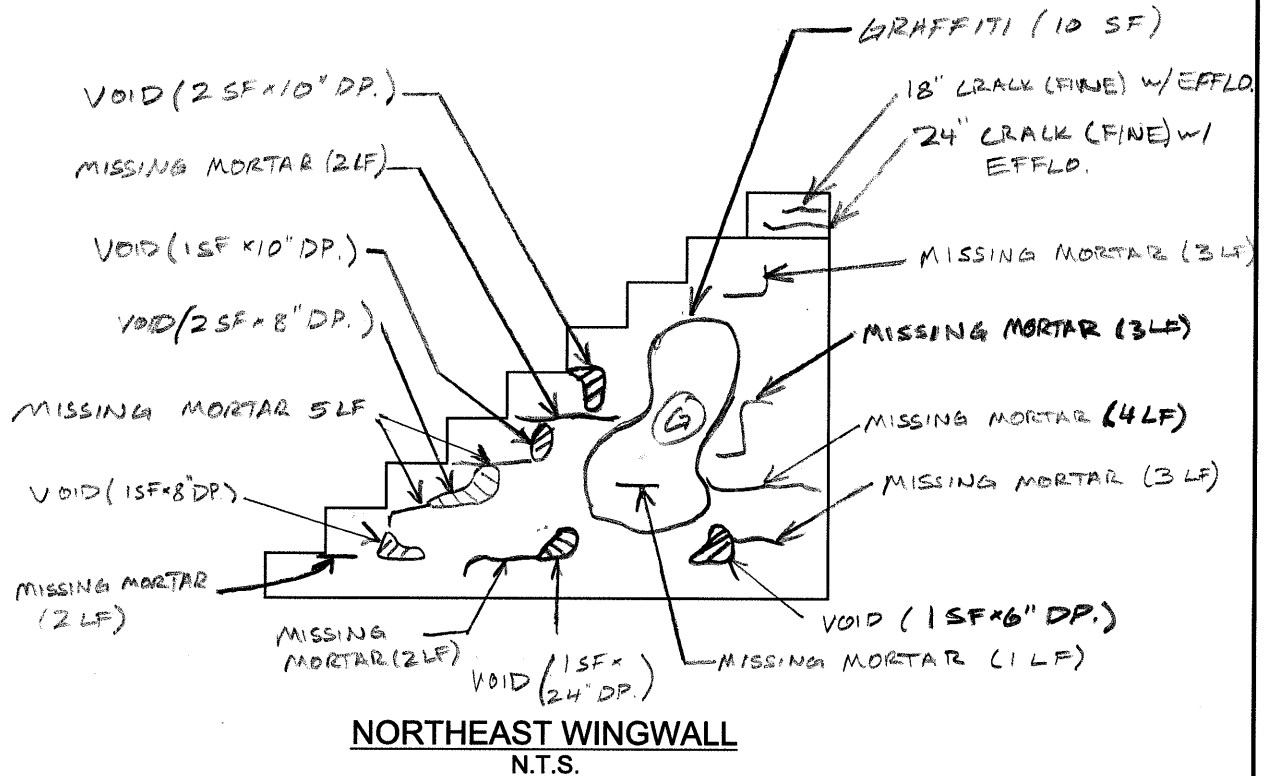
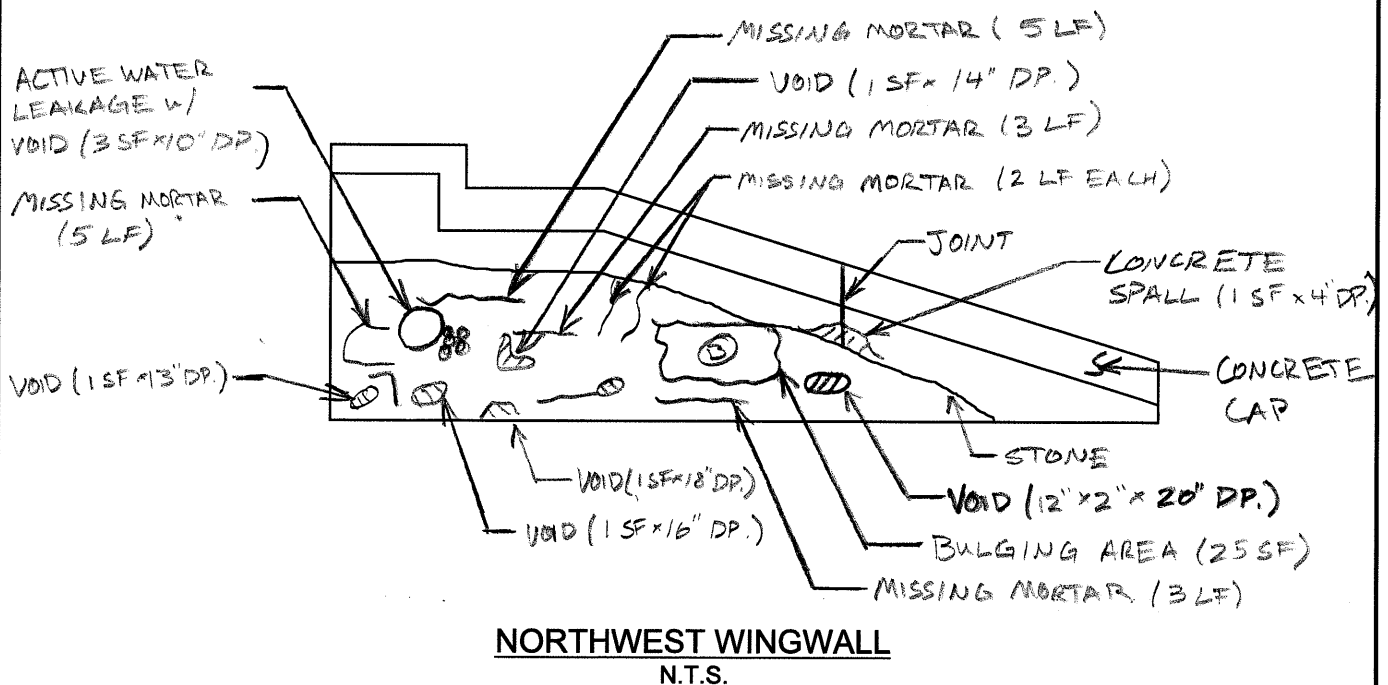
LINE MORRISTOWN MP 58.00 PHOTOS 5-14

CONDITIONS: There is missing/deteriorated mortar at several locations throughout the wall (±30 LF) with voids up to 24" deep (±10 SF total). There are two fine cracks with efflorescence in the concrete cap at the top of the wall (±3' L total). Work Done: Small tree on top of wall has been cut at base , stump remains on top of wall (Photo 5-14).

3. Repoint areas of deteriorated and missing mortar and seal the wide cracks in the abutments and wingwalls ([Photos 5-07](#) and [5-14](#)).
4. Reset the loose and bulging stones in the southeast and northwest wingwalls ([Photo 5-15](#)).
