# Walkable Community Workshop

**Newark-Pompton Turnpike,  
Pequannock, NJ**

prepared by:  
**County of Morris**  
**Department of Planning & Development**  
**Division of Transportation**  
**February 2011**

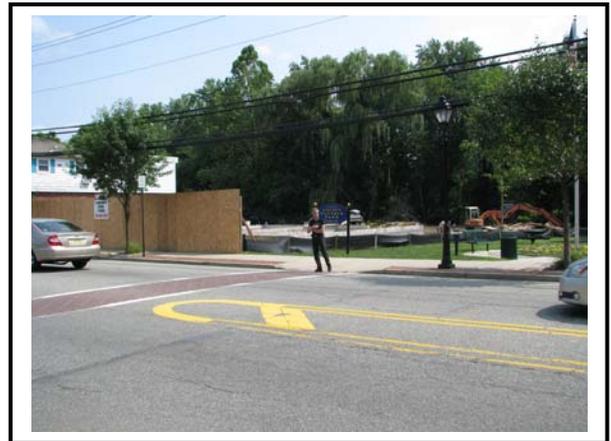
Pedestrian waiting for gap in traffic

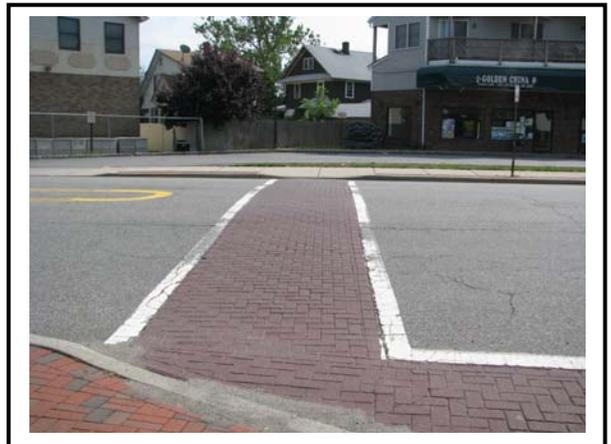
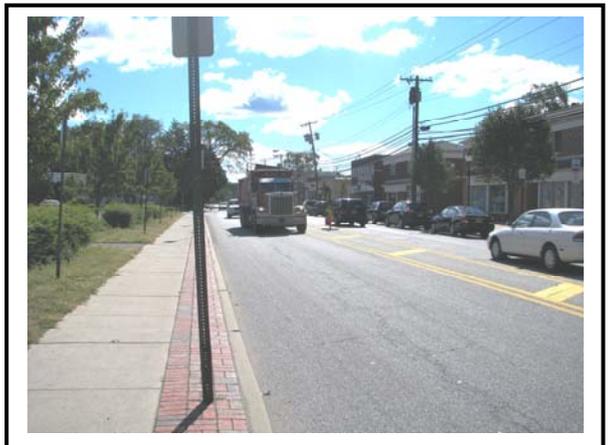
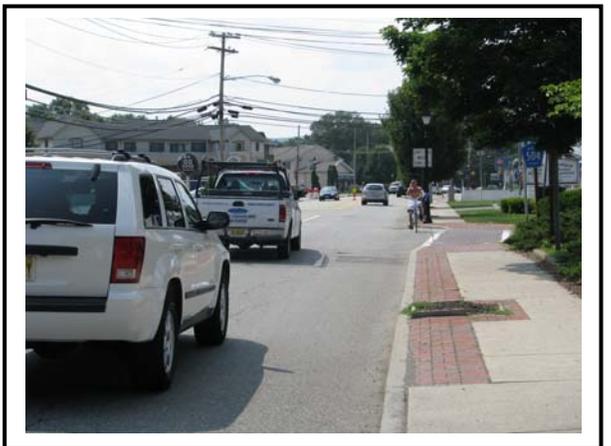
The existing crosswalks in the study area are red stamped asphalt and are outlined with white strips. The color differentiation and edge lines assist to highlight the crossing locations. However there are only five designated crosswalks (Irving Street, Demott Avenue, New Read Street, Richards Street and Franklin Avenue) located within the  $\frac{3}{4}$  of a mile study area.

Top: Existing enhanced crosswalk  
Middle & Bottom: Traffic along CR 504

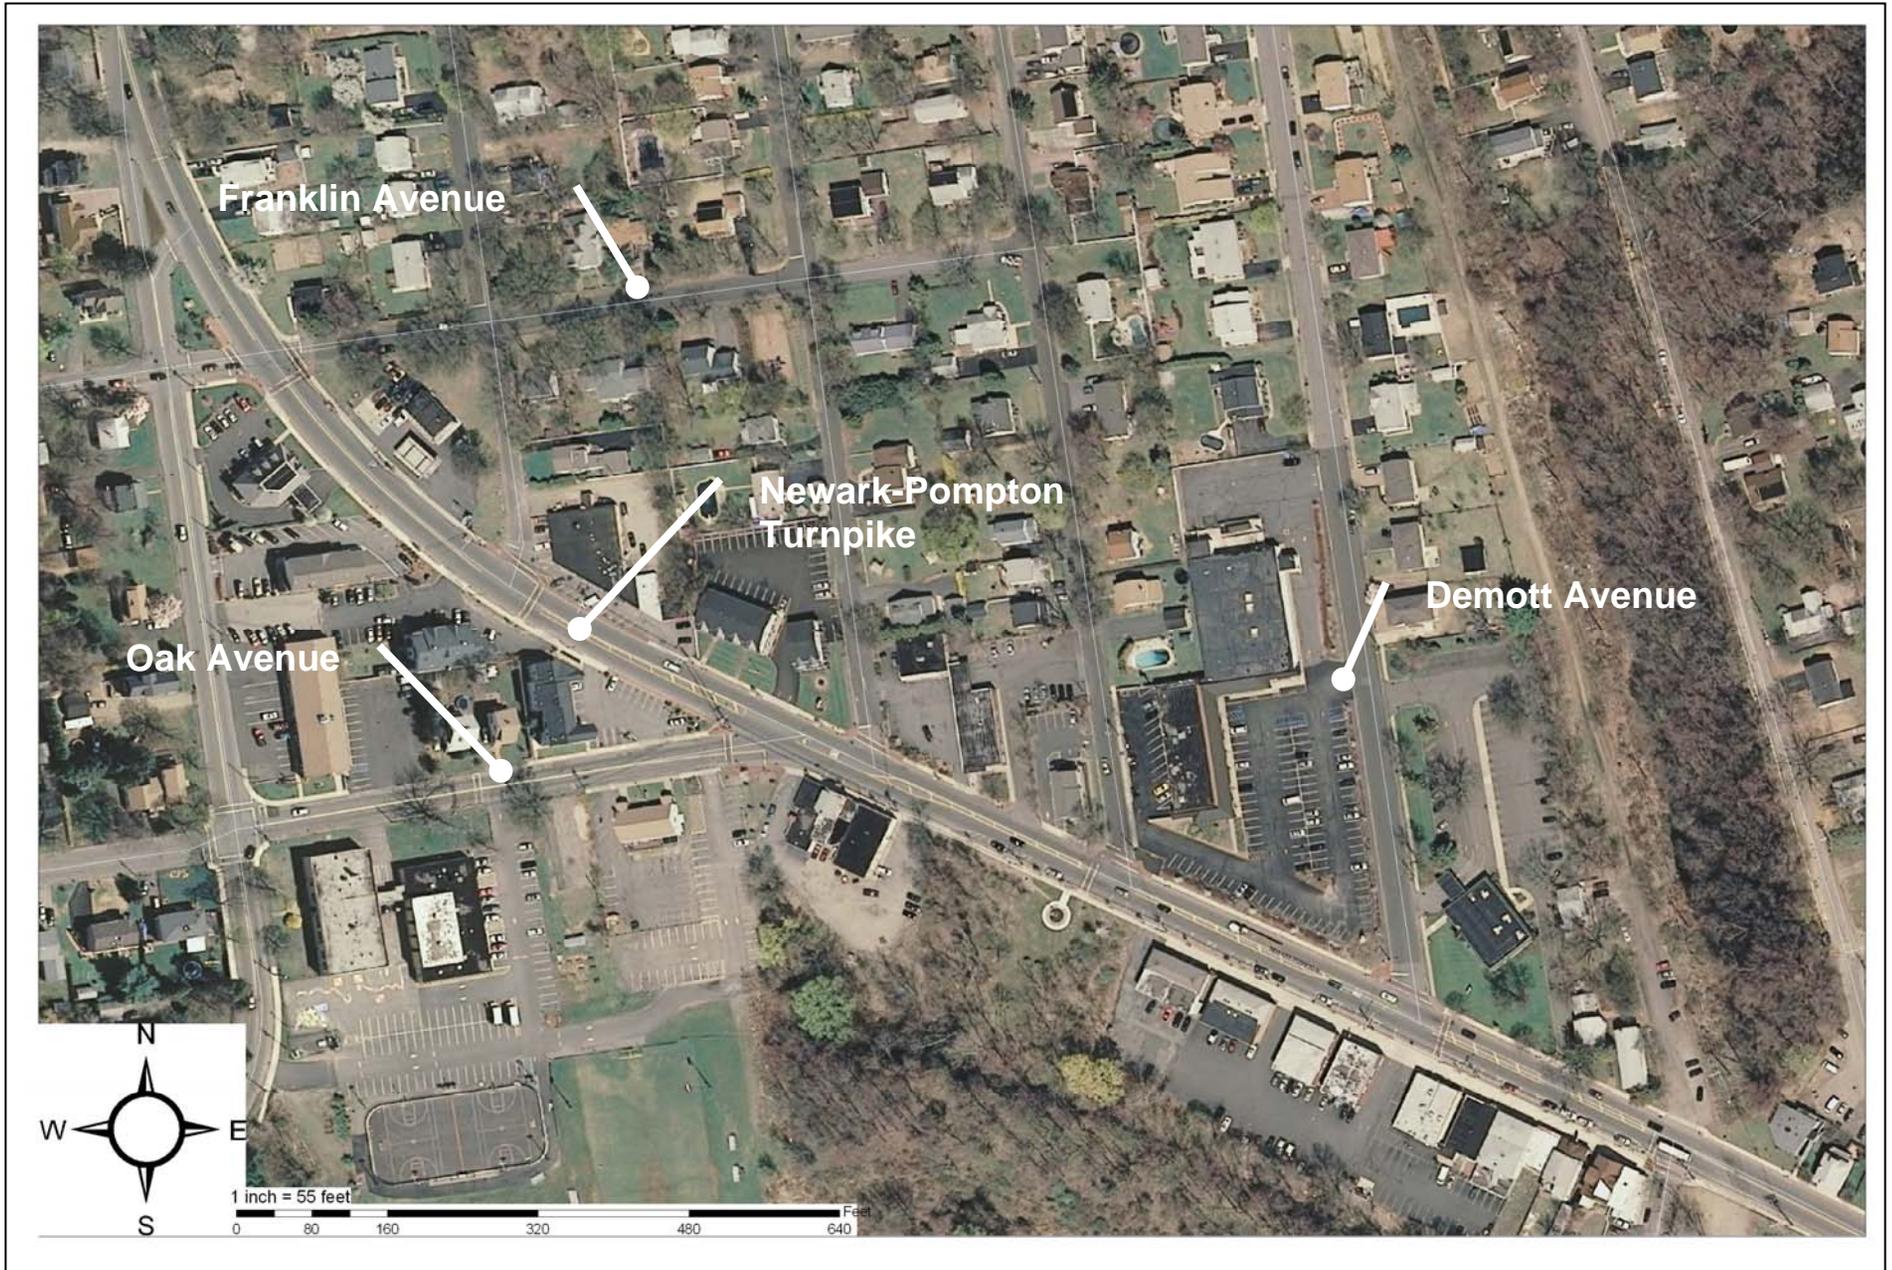
Figure 1 - Newark-Pompton Turnpike

The study area consists of the southern section of Newark-Pompton Turnpike from the south beginning at the municipal boarder with Wayne (mile post 5.24) extending north for approximately  $\frac{3}{4}$  of a mile to the intersection of Franklin Avenue (mile post 4.5). Figure 1 shows a vicinity map of the study area.

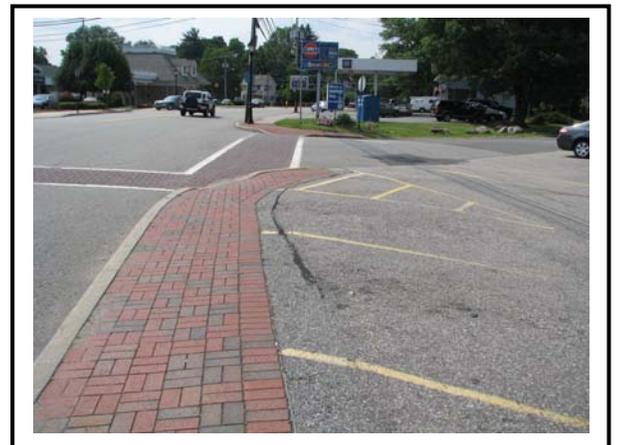
Although the Township has an adequate sidewalk network in place there are several obstacles that disrupt pedestrian access along the Newark-Pompton Turnpike corridor forcing them to walk in the street and cross at inappropriate locations. This mainly occurs along the northbound travel lanes between Hilton Street and Richard Street. The existing parking configuration in front of the shops encroaches onto the sidewalk and no physical barrier prevents drivers from exiting the parking lot over the sidewalk, a frequent occurrence according to some workshop attendees.

Parking area encroaches onto sidewalk

Another way to increase the visibility of crossing locations is to remove several of the existing parking spaces that obstruct visibility because they are located too close to crosswalks and intersecting streets. NJ Statute R.S.39:4-138 states that parking spaces must not be located within 25 feet of the nearest crosswalk.

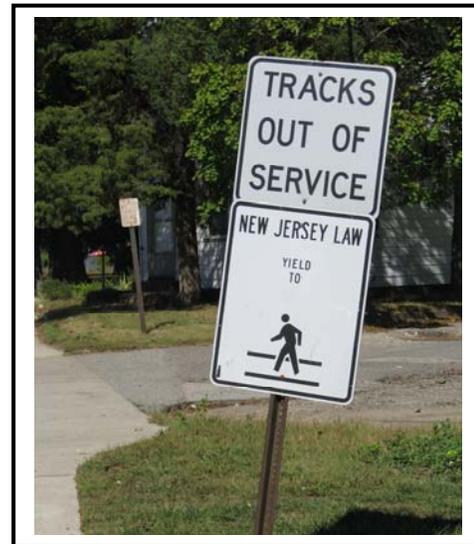
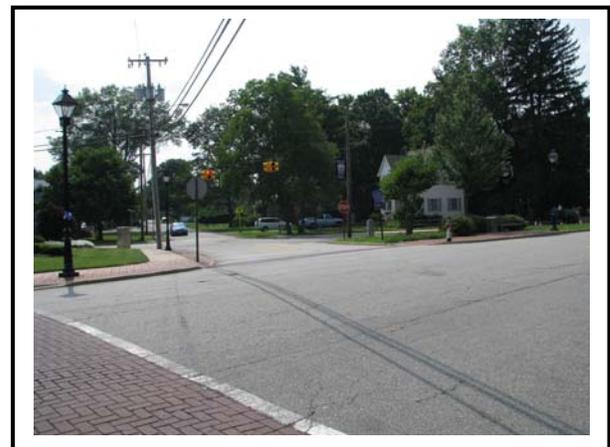
Top: Faded signs along CR 504  
Bottom: Intersection of CR 504 & Franklin

- Traffic control and driver orientation is confusing at the intersection of Franklin Avenue
- High crash rates throughout the study area, particularly at the intersections of Franklin Avenue and Demott Avenue

- Lack of advanced warning signs for existing crosswalks
- Several of the existing signs are blocked and/or faded
- Pedestrians are forced into the street due to parked vehicles obstructing the sidewalks in front of strip shopping center

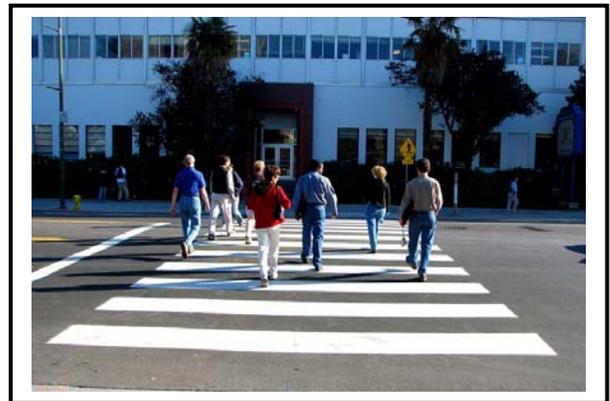
Example of high visibility crosswalk

Although the existing crosswalks are nicely distinguished in red and outlined with a white strip, more can be done to increase their visibility, such as adding:

- Ladder style markings
  - Advanced warning signs
  - Reflective strips on sign poles
  - Advanced stop bars, indicating to drivers where to stop
  - Curb extensions (painted or raised) at intersecting streets and driveways (where appropriate)
  - Pedestrian scale lighting
  - Crosswalks on all legs of an intersection (where appropriate)
  - Pedestrian activated flashing sign
-

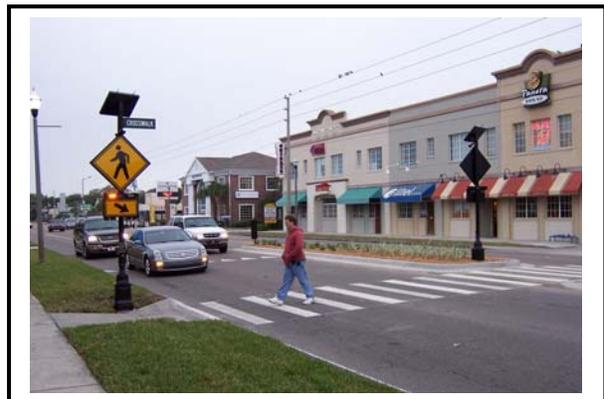
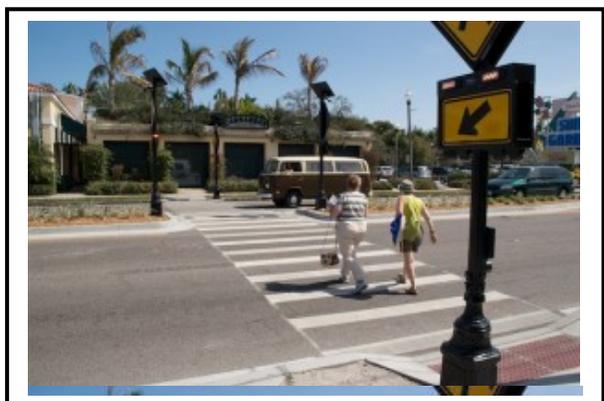
Top: Example of Rapid Red Flashing Beacon (RRFB)  
Bottom: Example of center median

The existing painted median should be enhanced and extended. The purpose of the median is to reduce the width of existing travel lanes-squeezing traffic, in turn reducing speeds. The median can be dropped at strategic locations to allow for turns, but continued through others locations to limit the excessive number of access points.

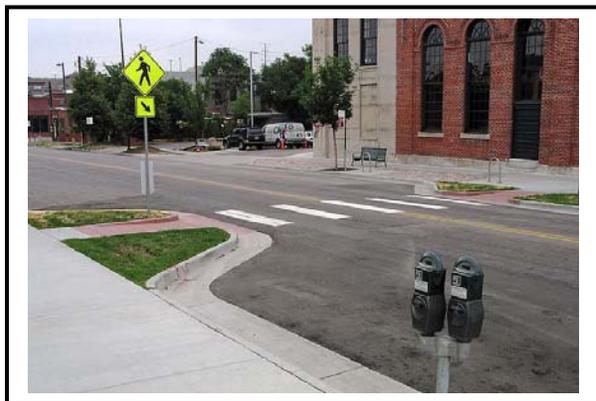
Example of curb extension

Curb extension, also referred to as bulb-outs or neckdowns are also a recommended traffic calming measure. They serve to enhance and open up the visibility of crossing locations, so that pedestrians can see oncoming traffic and drivers can see pedestrians attempting to cross. Curb extensions also serve as pinch points for drivers, squeezing them at critical locations such as crossings. Curb extensions can be painted or raised, but are most effective if they are raised.

Curb extensions are proposed along Newark-Pompton Turnpike at the intersections of:

- Oak Avenue (reconstruct to reduce corner radii)
- New Read Street (west side)
- Demott Avenue (west side)
- Irving Street (both)

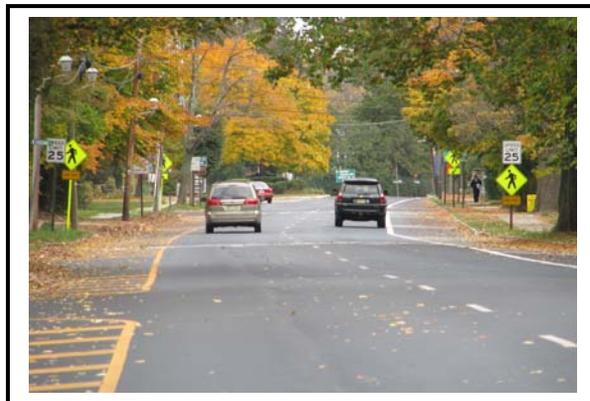
Example of advanced warning signs of pedestrian crossings

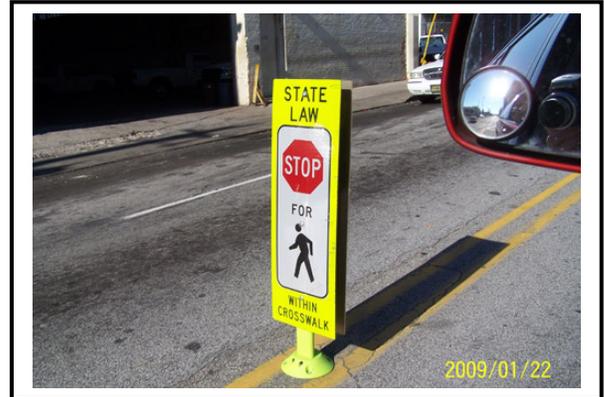
Example of in-road bollard, "Stop for Pedestrians"

The combined goal of advancing priorities 1 and 2 above are to reduce speeds and increase driver's compliance with the law "Stop for Pedestrians". Therefore, additional signs should be installed that will reinforce these as important community goals. Signs should include:

- MUTCD advanced warning signs
- "Stop for Pedestrians" in-road bollards
- Announcements on Variable Message Sign indicating that speed limits and stopping for pedestrian laws are enforced. The fines for each of these offenses should also be announced.

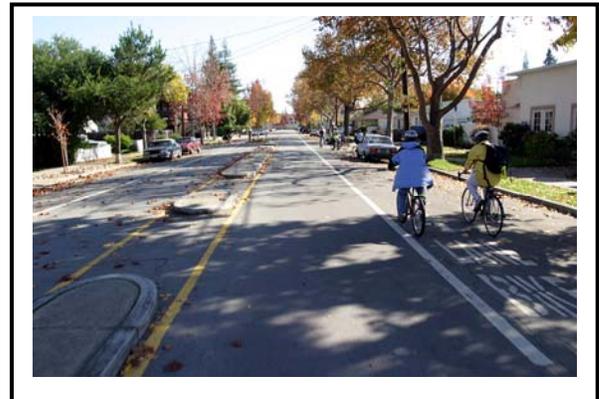
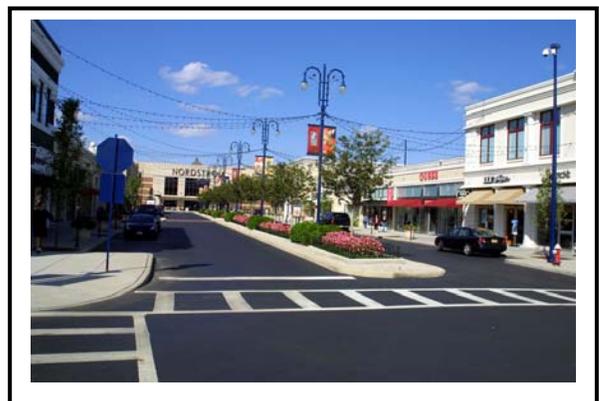
Top & Bottom: Examples of center median

Upon review, it would appear that crashes at the intersection of West Franklin Avenue can be attributed to the short distances between Lincoln Park Boulevard and Newark-Pompton Turnpike. Additionally, the limited sight distance for traffic turning left onto Newark-Pompton Turnpike from East Franklin Avenue contributes to high crashes.

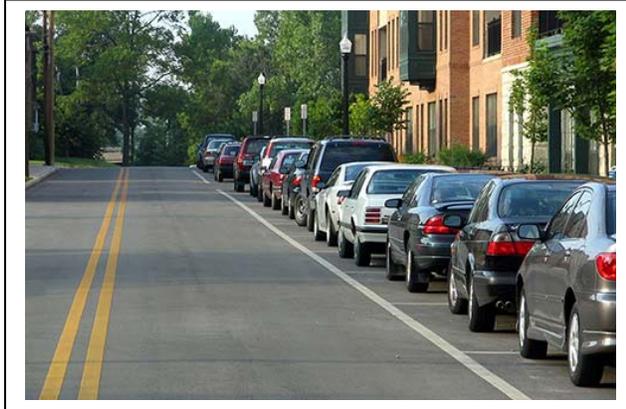
Striped Parking

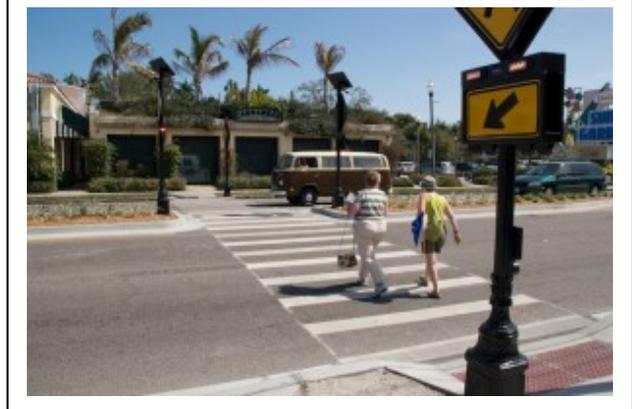
Center Median & Rapid Red Flashing Beacon (RRFB)

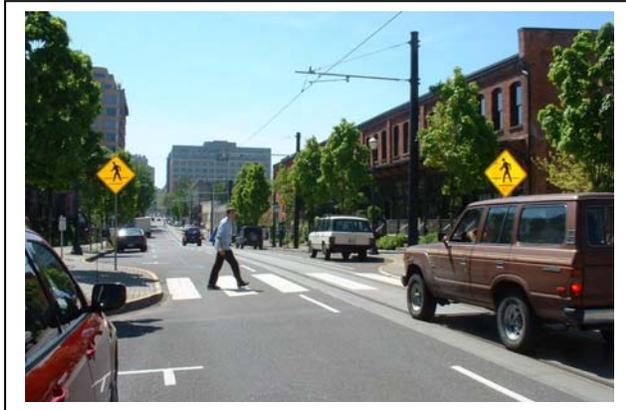
Curb Extension with enhanced signs and striping

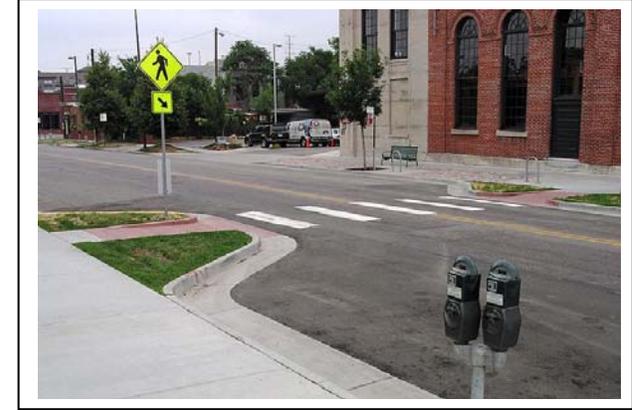
Curb Extension with enhanced signs and striping

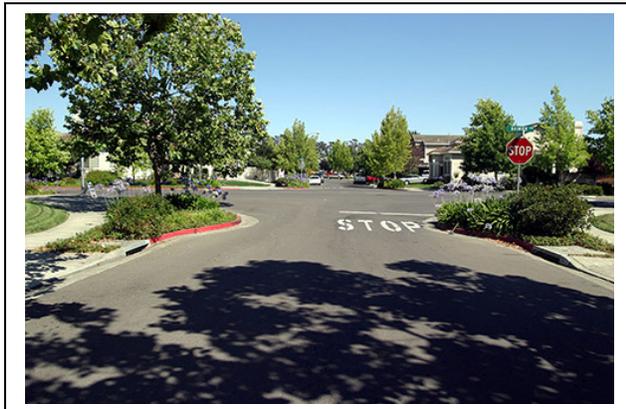
Curb Extensions

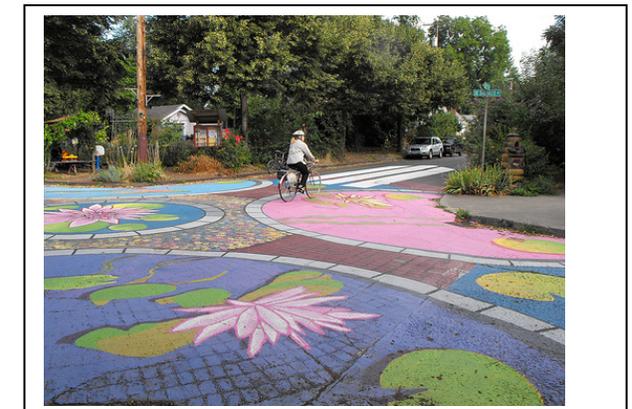
Enhanced Intersection
